# Large Woody Debris Assessment and Mitigation Plan

Final Report  
June 2011

KWL File No. 713.054

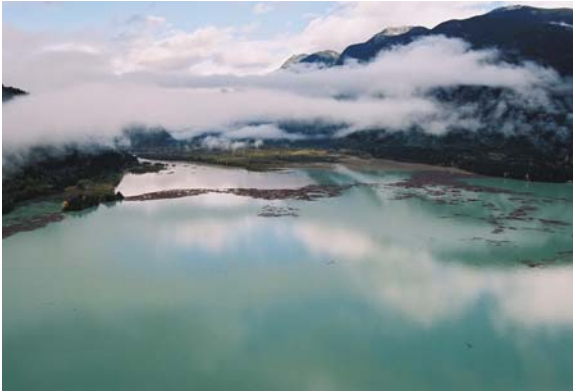
**Photo 3-1**  
**Wood in Lillooet Lake (November 5, 2003)**

Photographs taken following the 2003 flood event are shown below. Photo 3-1 gives an indication of the amount of wood transported into the Lillooet Lake during the October 2003 event. Photo 3-2 shows a debris jam upstream of the Lillooet delta under high flow conditions following the 2003 flood event.

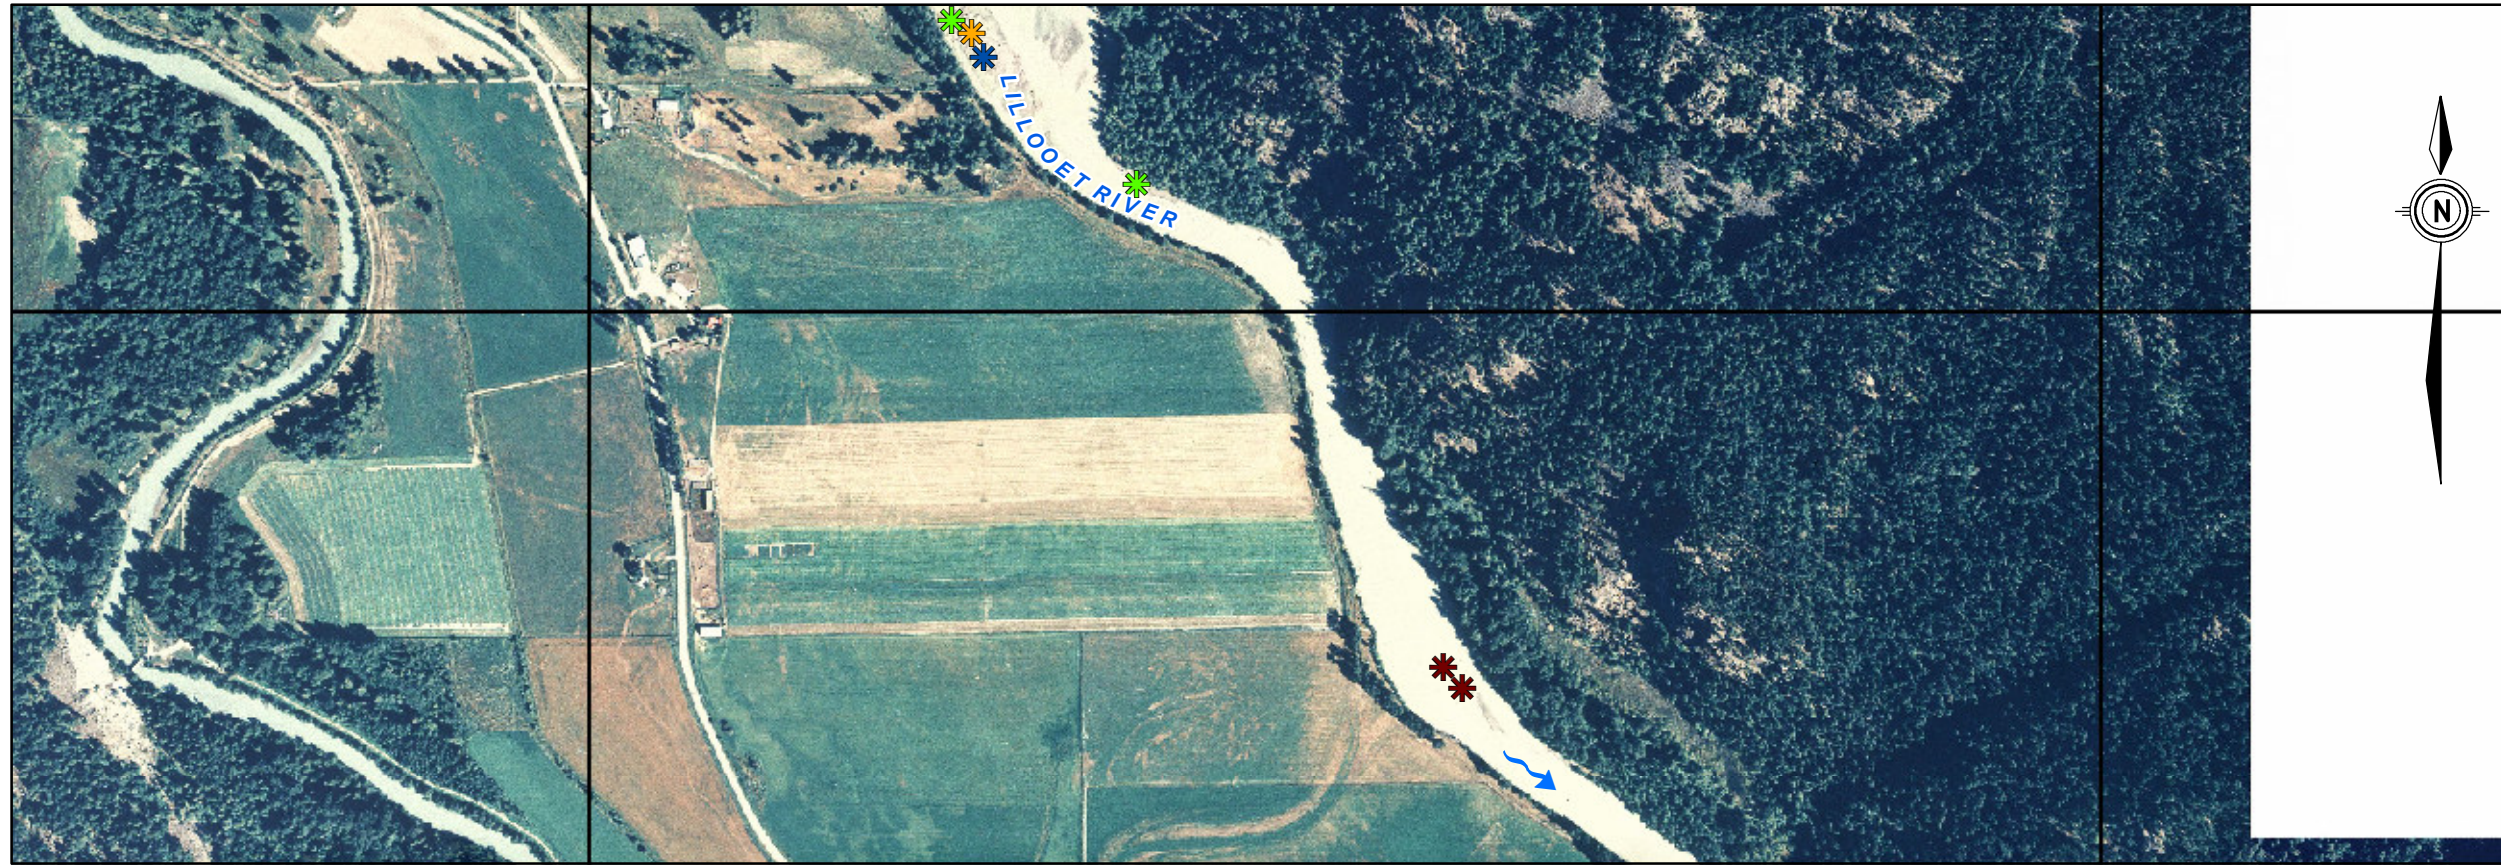
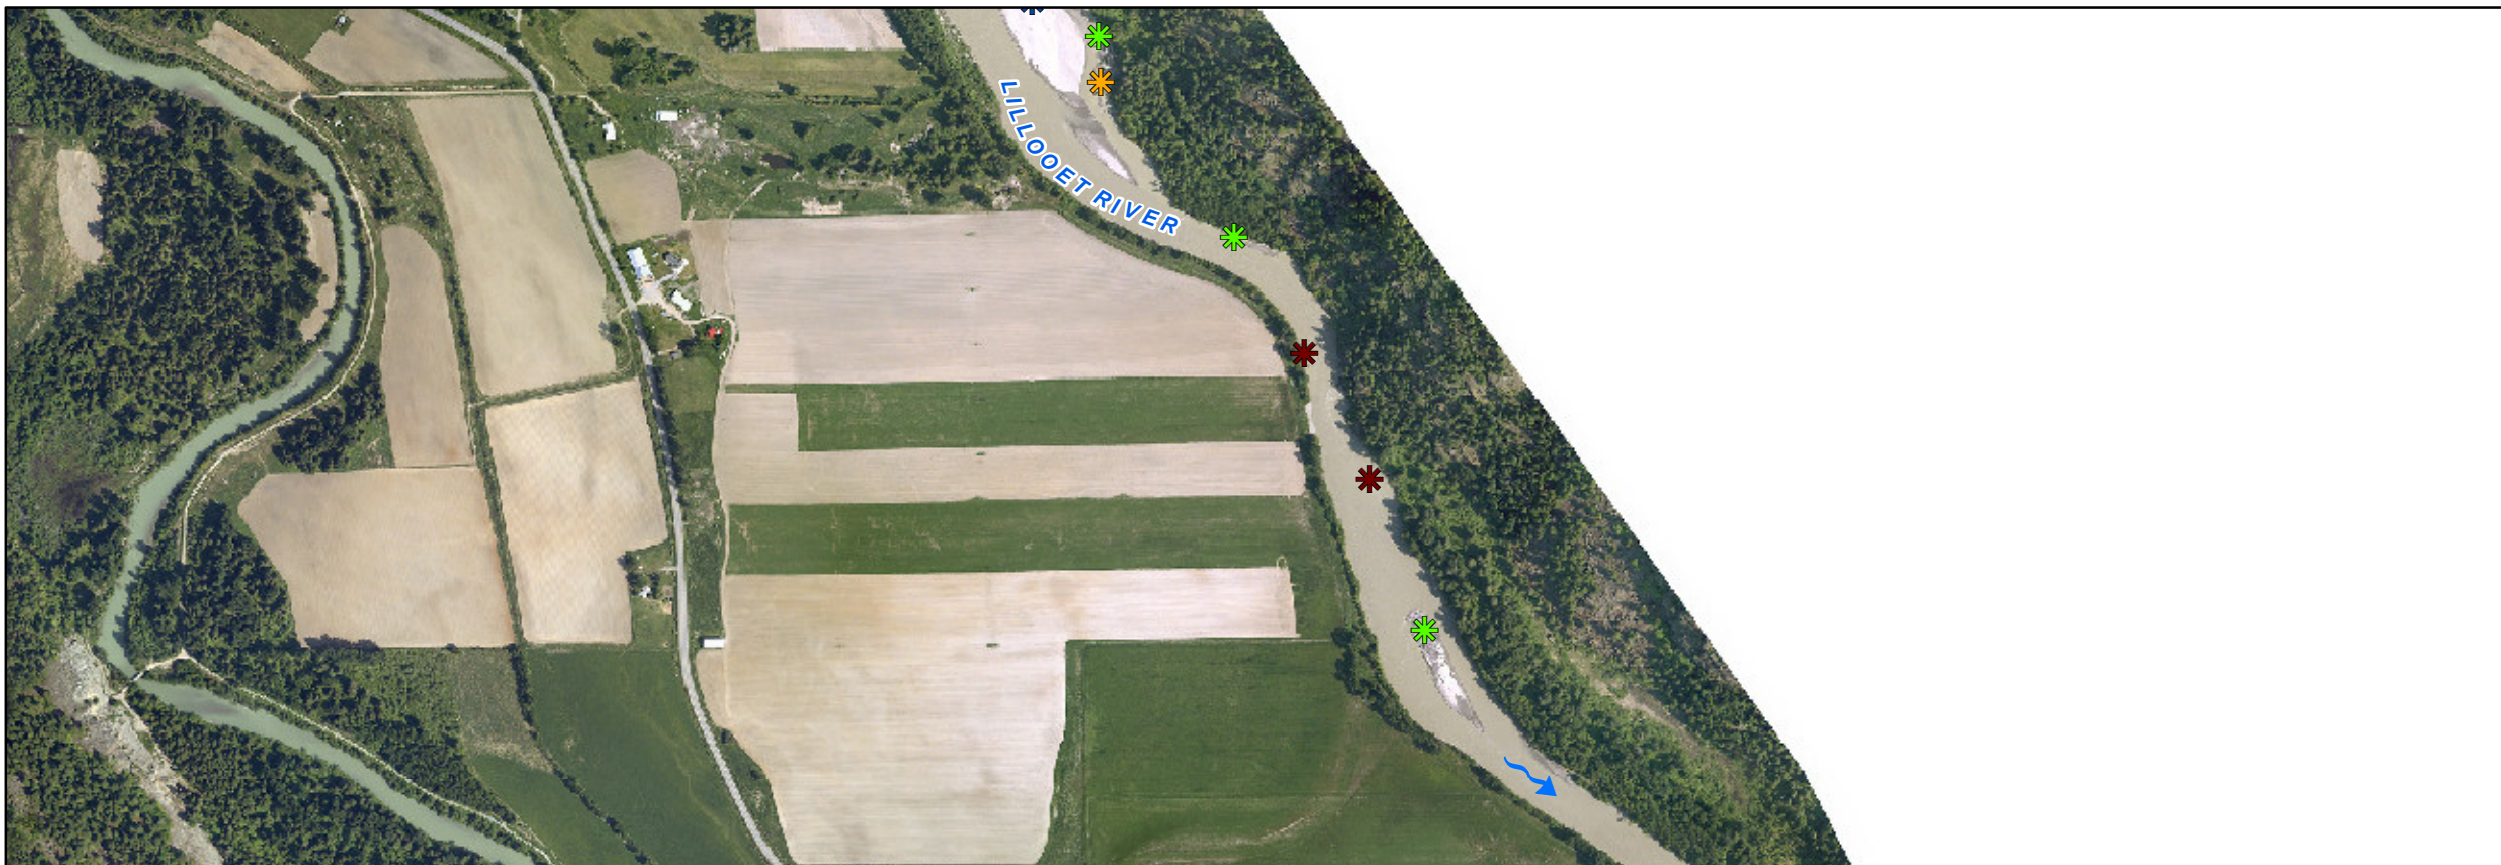
**Figure 3-3**

The largest change noted between 1999 and 2009 in the dyked reach is shown in Figure 3-3. At this location a single log is visible in the 1999 photos and a bar apex jam has formed in the 2009 photos. The single log (in combination with a small gravel bar) may have recruited more LWD to form a stable jam. This log jam, referred to as the ‘Miller Log Jam’, was examined in more detail during the May 2011 field investigations.

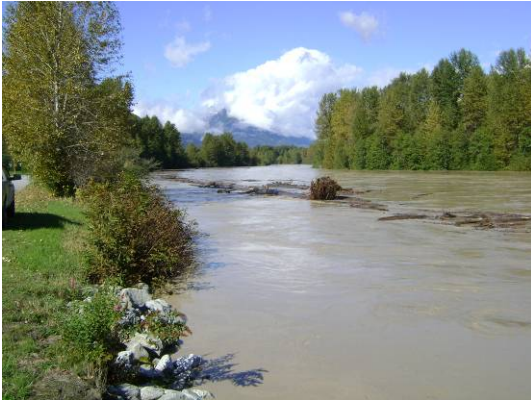
**Photo 3-3**  
**Airport Road (September 28, 2010)**  
(Photo courtesy of Jeff Westlake)

On September 28, 2010 (post-landslide), a 10- to 20-year return period flood event occurred on the Lillooet River. During the event, mobilization and transport of LWD was observed within the dyked reach (e.g. Photos 3-3 and 3-4 below). It is expected that some LWD material from the landslide event would have been mobilized and redistributed in the river or transported to the lake during the high flow event (and therefore would not have been observed during the May 2011 field investigations).

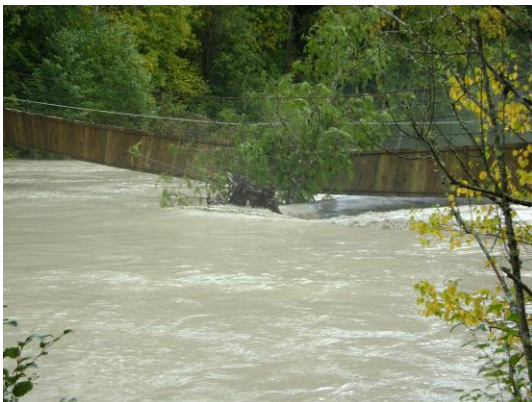
**Photo 5-1**  
**Footbridge Collecting LWD**  
**(September 28, 2010)**

The footbridge crossing near the Miller Log Jam (Photos 5-1 and 5-2, Figure 5-1). This crossing is low and has a high potential to accumulate wood during a flood event (Photo 5-1). The PVDD should consult with the local land owner regarding the potential to remove the footbridge to prevent LWD accumulation and/or failure.

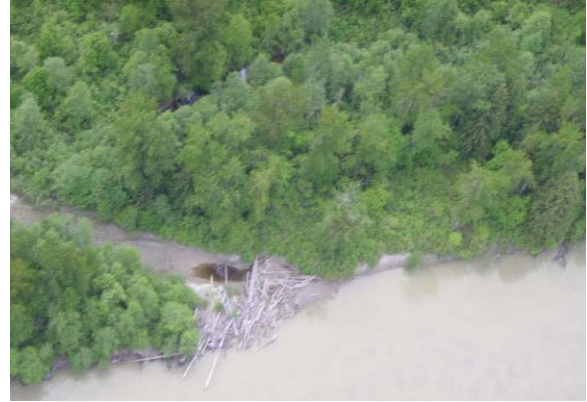
**Photo F-2**  
**Log Jam Downstream of Dyked Reach (2)**

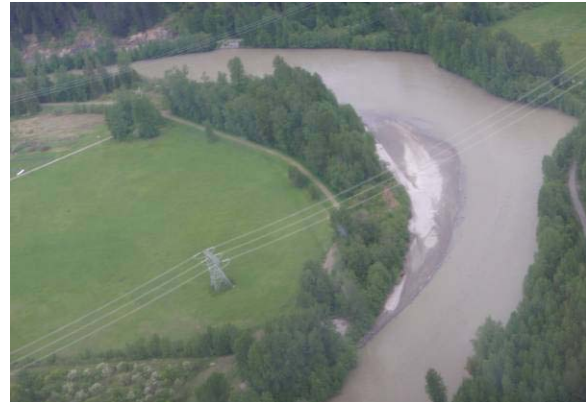
**Photo F-4**  
**Simple Bars with Little or No Wood in Dyked Reach**

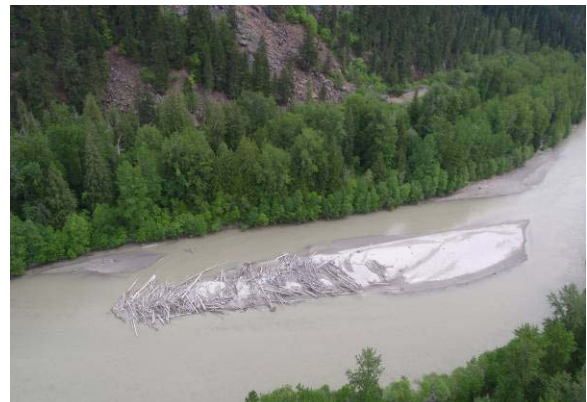
The Miller Log Jam (Appendix B, Map 7 of 11) creates a channel constriction that may result in increased flood levels. The erosion protection along the dyke should be monitored for signs of wear and possible failure.

**Photo F-6**  
**Miller Log Jam**

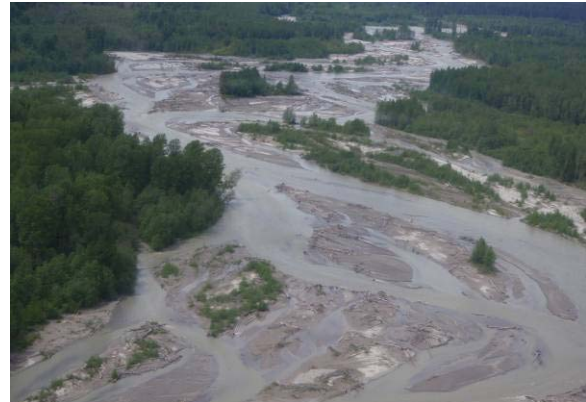
**Photo F-8**  
Braided Channel Upstream of Forestry  
Bridge Showing Wood Storage in the Reach

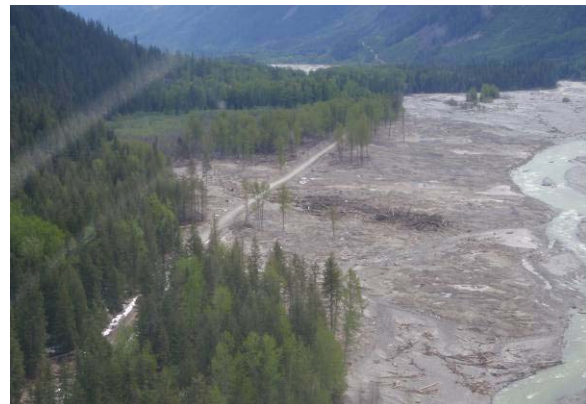
**Photo F-10**  
LWD Pushed by the Landslide Higher Onto  
the Floodplain (Over the Forestry Road)

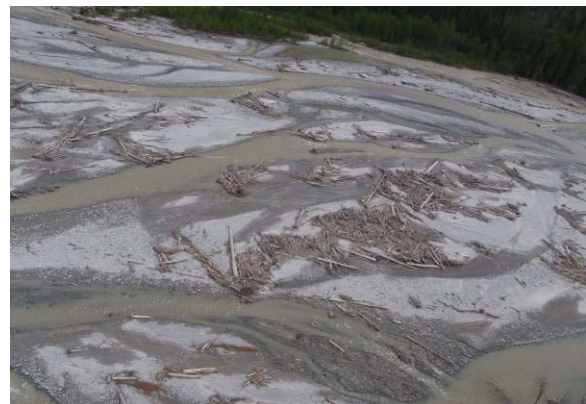
**Photo F-12**  
Much of the Wood Material Appears to Have  
Shattered into Smaller Pieces During the  
Landslide Event (2)
