PEMBERTON VALLEY FLOOD MITIGATION PLANNING

FINAL REPORT

5 June 2020

NHC Ref. No. 3004610

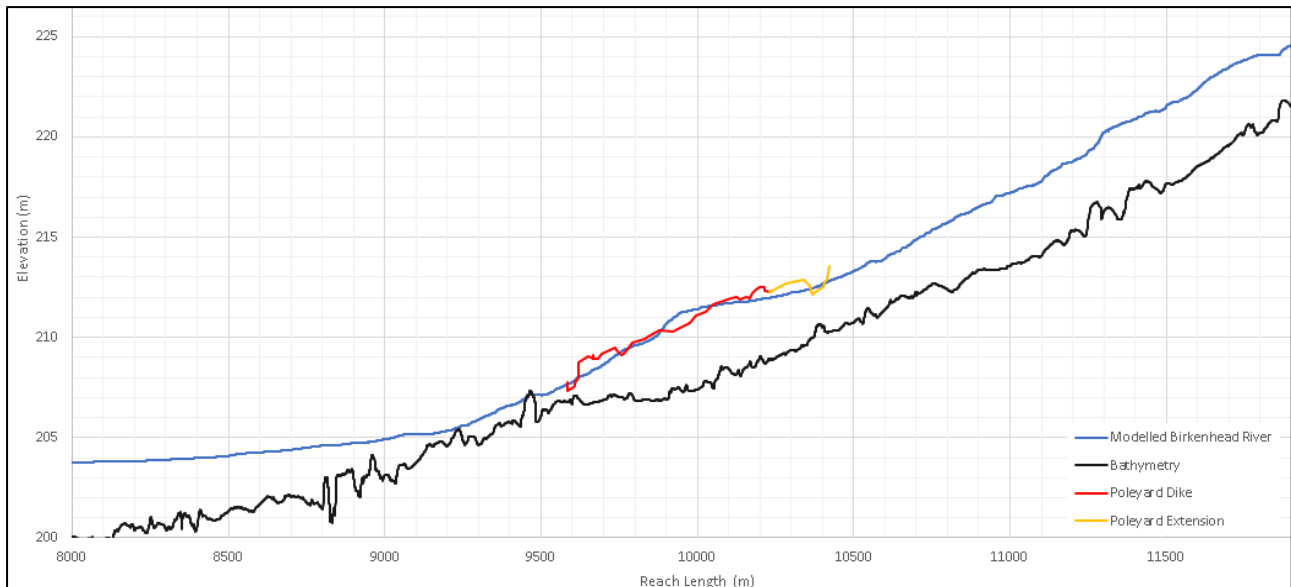
Figure 8. Birkenhead River simulated 200-year flood profile and existing dike/ground profile.

- The existing ground upstream of the dike can overtop and the dike must be extended upstream by about 140 m to tie into higher ground at the railway embankment.
- The flood profile plotted in **Figure 8** shows that the dike generally has insufficient freeboard and would likely overtop over an approximately 100 m long section.
- The dike has inadequate erosion protection and the current dike geometry does not meet provincial standards.
- The dike upgrade will not provide protection against Lillooet River flood events. However, these do not impact the developed areas higher on the fan.
