Ryan River Floodplain Study

Northwest Hydraulic Consultants Ltd.

March 15, 2023
Final Report, Rev. R1

Pemberton Valley Dyking District

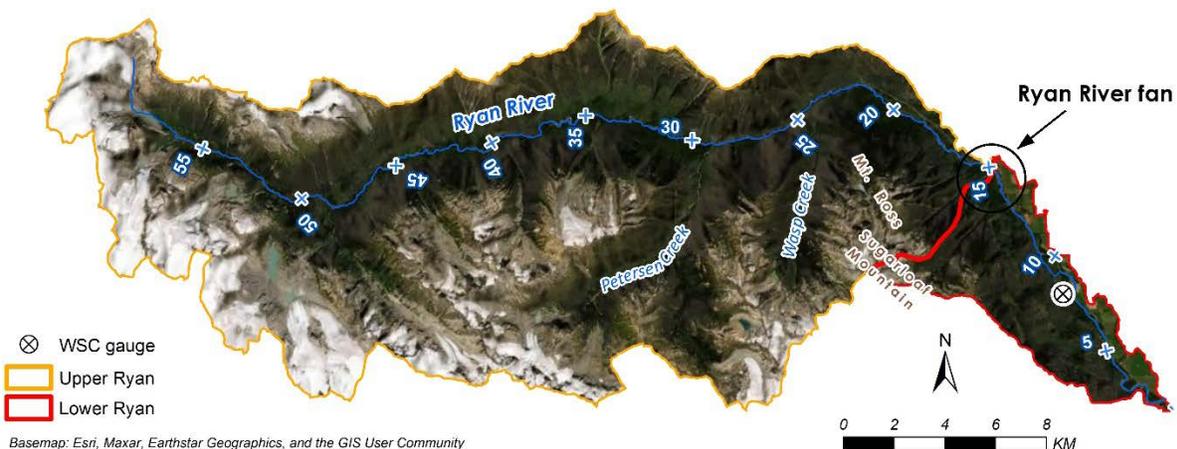
Figure 3.1 Overview of the upper and lower Ryan River watersheds separated by the Ryan River fan. Crosses represent chainage markers, which are measured (in km) upstream of the mouth of the Ryan River.

The lower 41 km² sub-basin of the Ryan River watershed includes most of the Lillooet River floodplain and the steep hillslopes of Mt. Ross and Sugarloaf Mountain (Figure 3.1). The river flattens from an average slope of approximately 5% at the Ryan River fan to approximately 0.05 % at the confluence with the Lillooet River, over a distance of 15 km. The lower 4 km of the Ryan River is underfit and flows through the historical channel of the Lillooet River, which was diverted to its current location as part of

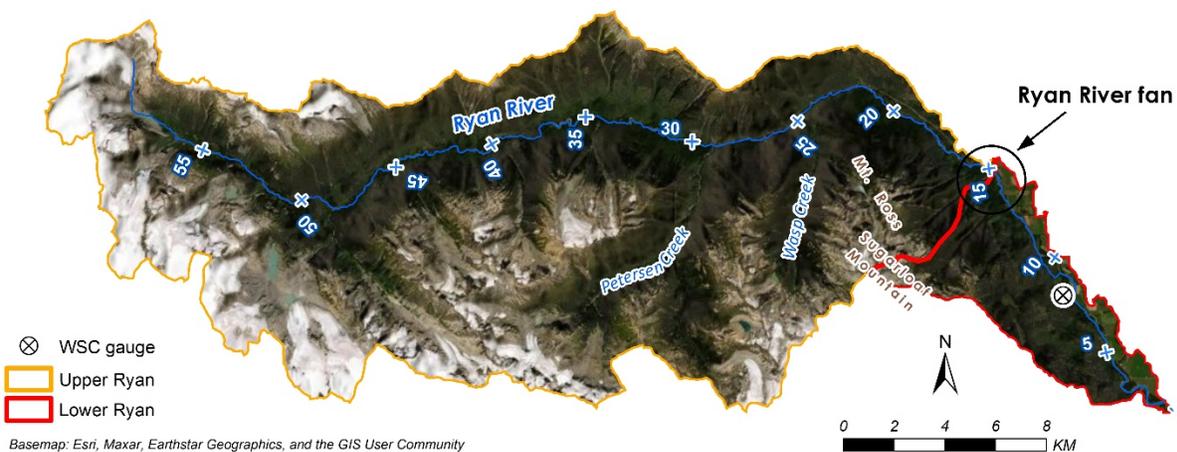
Figure 2.1 Overview of the upper and lower Ryan River watersheds separated by the Ryan River fan.

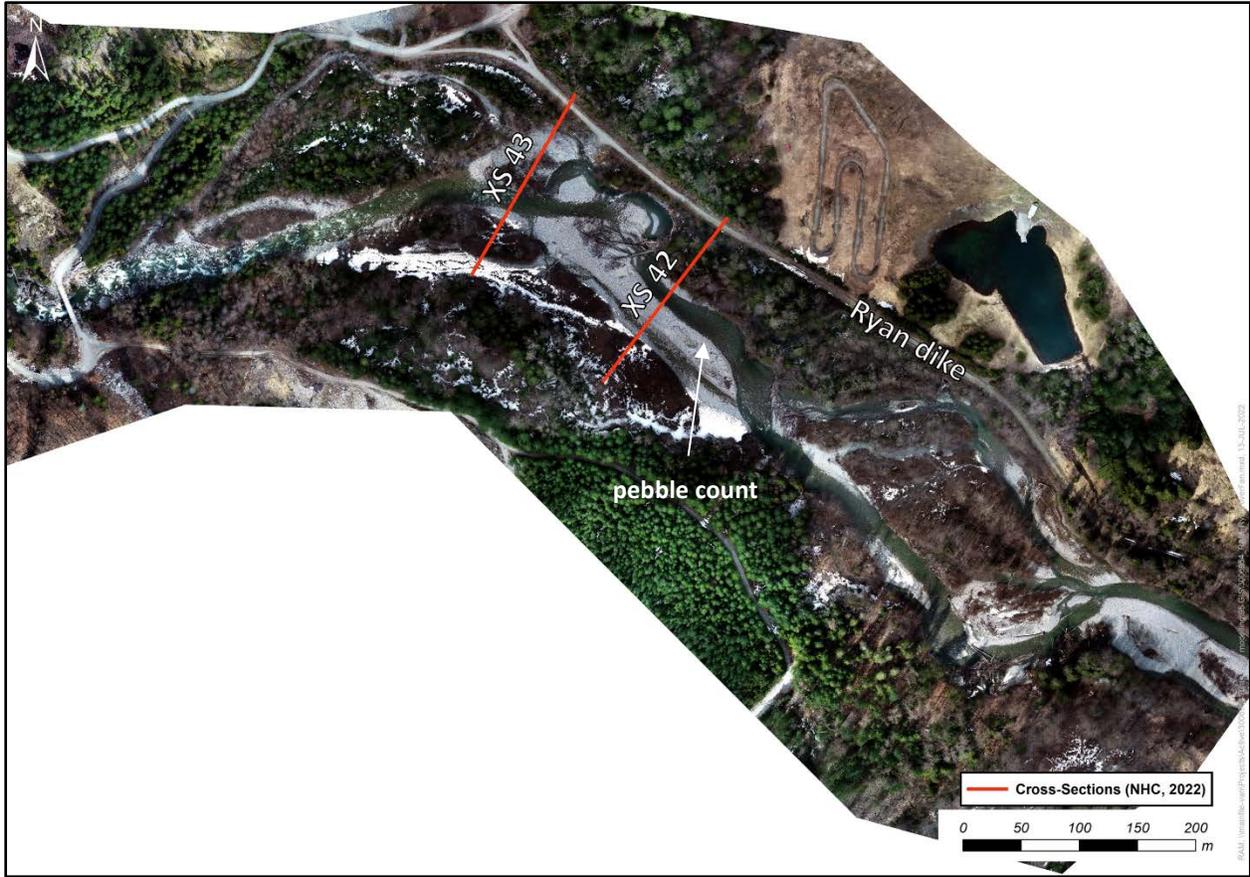
Figure 7.3 Ryan River fan study area (2022 NHC UAV orthophoto).

Surficial sediment on bars ranges in size from sand to boulders. A Wolman-style pebble count (Wolman, 1954) was collected along the bar margin shown in Figure 7.3. The median size of surficial sediment at this location is 97 mm and the 84th percentile material is 168 mm (Figure 7.4). This sample reflects sediment likely mobilized by annual floods, collected adjacent to the low-flow main channel.

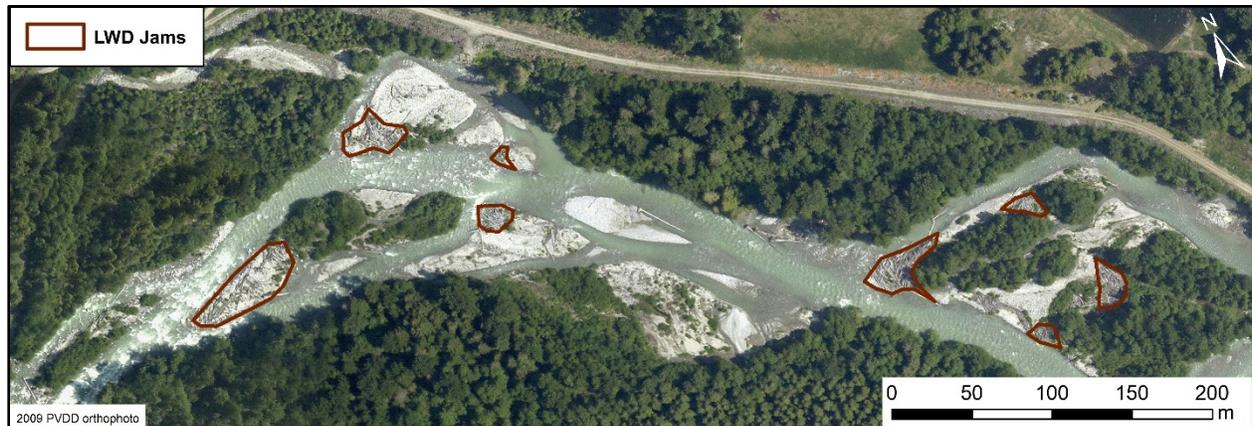
LWD and vegetation appears to be an important control on the morphology of the channel through this reach on an annual basis. Logs floated downstream from the upper watershed tend to accumulate on bar surfaces, at the head of islands, and at the entrance to side channels (Figure 7.5). These can plug channels and divert flow into secondary channels, such that over time the LWD jams form and maintain the multi-thread channel pattern, causing and mediating the frequency of channel avulsions and patterns of erosion and deposition (Collins et al., 2003). During periods between large floods, vegetation establishes and matures in the lee of these jams, stabilizing substrate and leading to island formation (Corenblit et al., 2007; Gurnell et al., 2001).

Figure 7.5 Example of the spatial distribution of LWD accumulations from 2009.

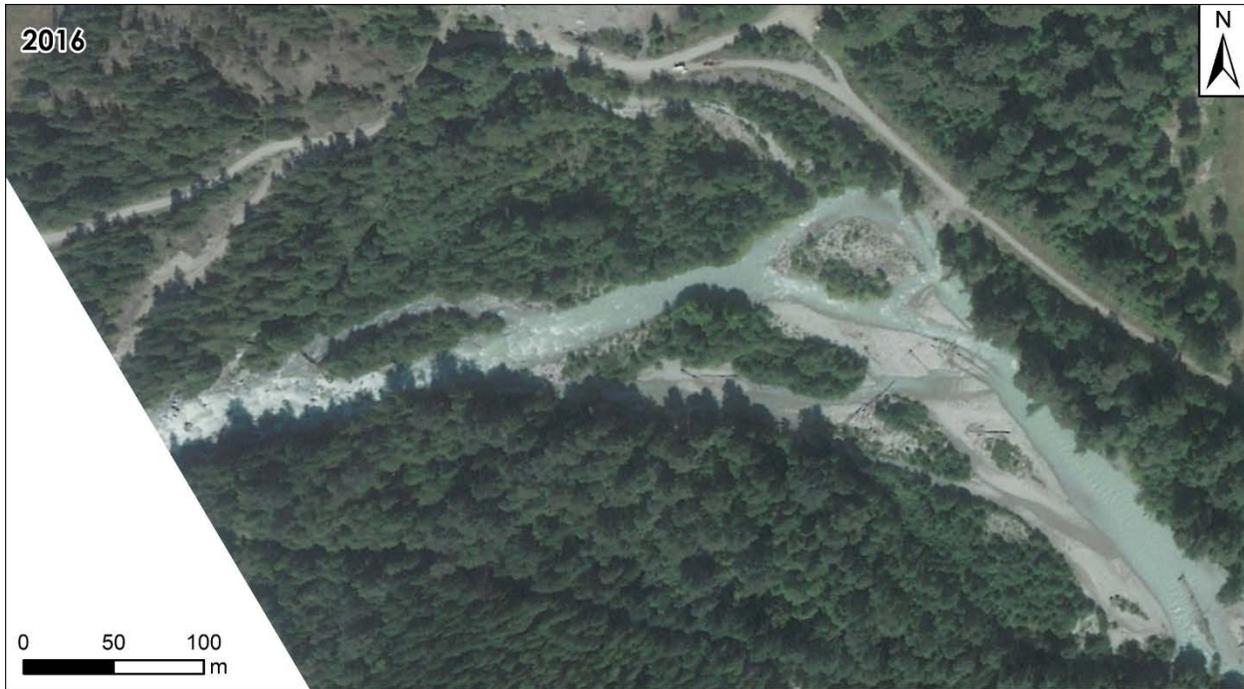
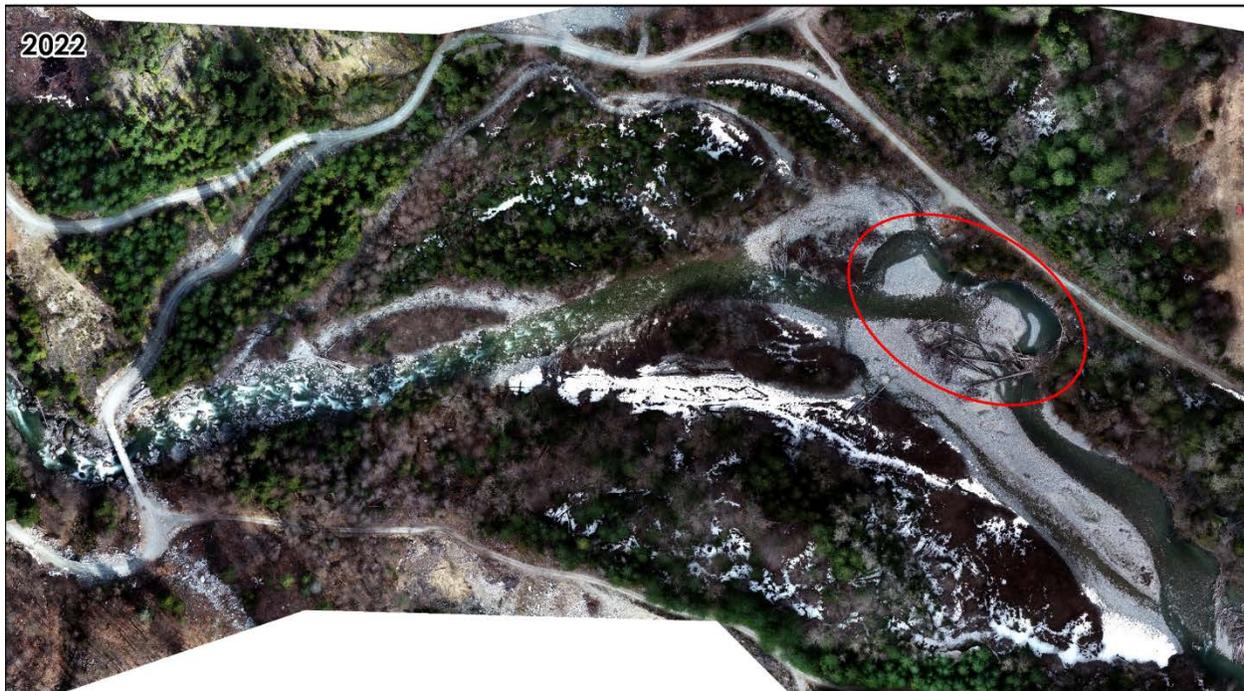
Figure 7.8 Comparison of the Ryan River fan in 2016 (UBC air photo) and 2022 (NHC UAV orthophoto).

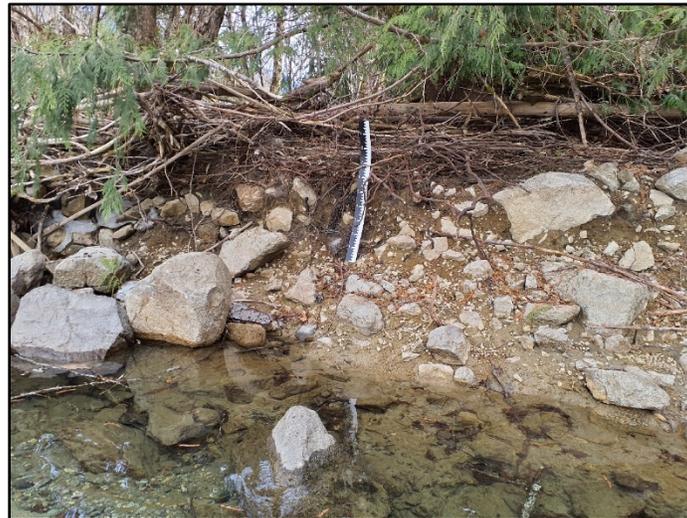
Photo 7.1 The Ryan River erodes into a poorly sorted mix of sediment consisting of angular coarse fragments in a fine-grained matrix, likely reflective of a debris flow deposit from Mt. Ross to the southwest.

In addition to the air photo evidence and field observations of past debris flow deposits near the Ryan River fan, NHC assessed the Melton ratio and watershed length for each of the gully sub-basins identified in Figure 6.11 to discriminate between the dominant watershed processes: clearwater floods, debris floods, or debris flows. In Figure 7.12, steep creek processes for watersheds in British Columbia and Alberta are plot as a function of watershed stream length and Melton ratio with the Mt. Ross and Sugarloaf Mountain gullies data plot overtop. Two of the three gullies fall within the 'mixed debris floods

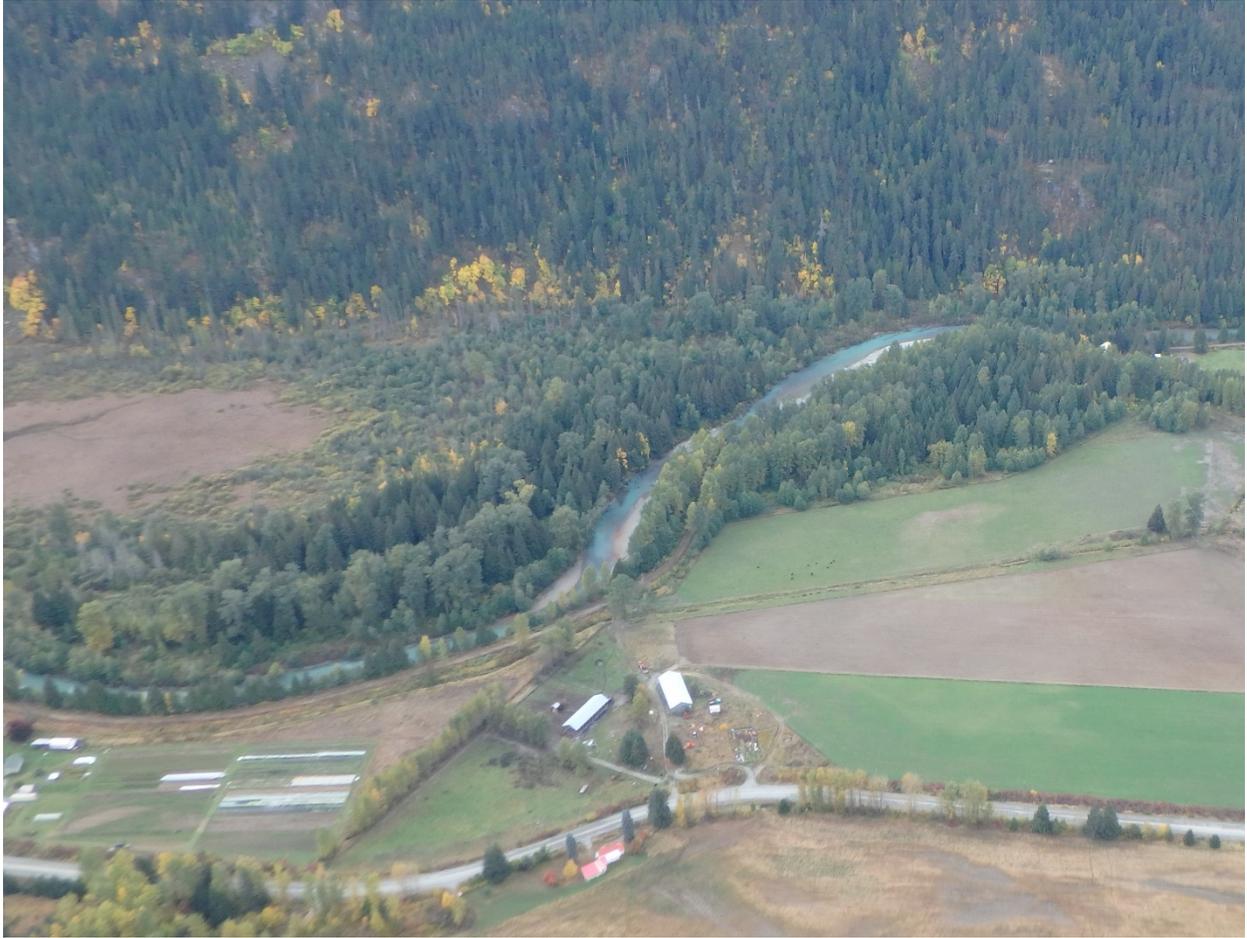
Photo 7.2 Photo from 2017 of the Ryan River near RK 9 shows bar formation through the lower reach.
