Pemberton Valley Dyking District April 13, 2017 Annual General Meeting Report

November 9th, 2016 Pemberton Valley High Water Event Summary

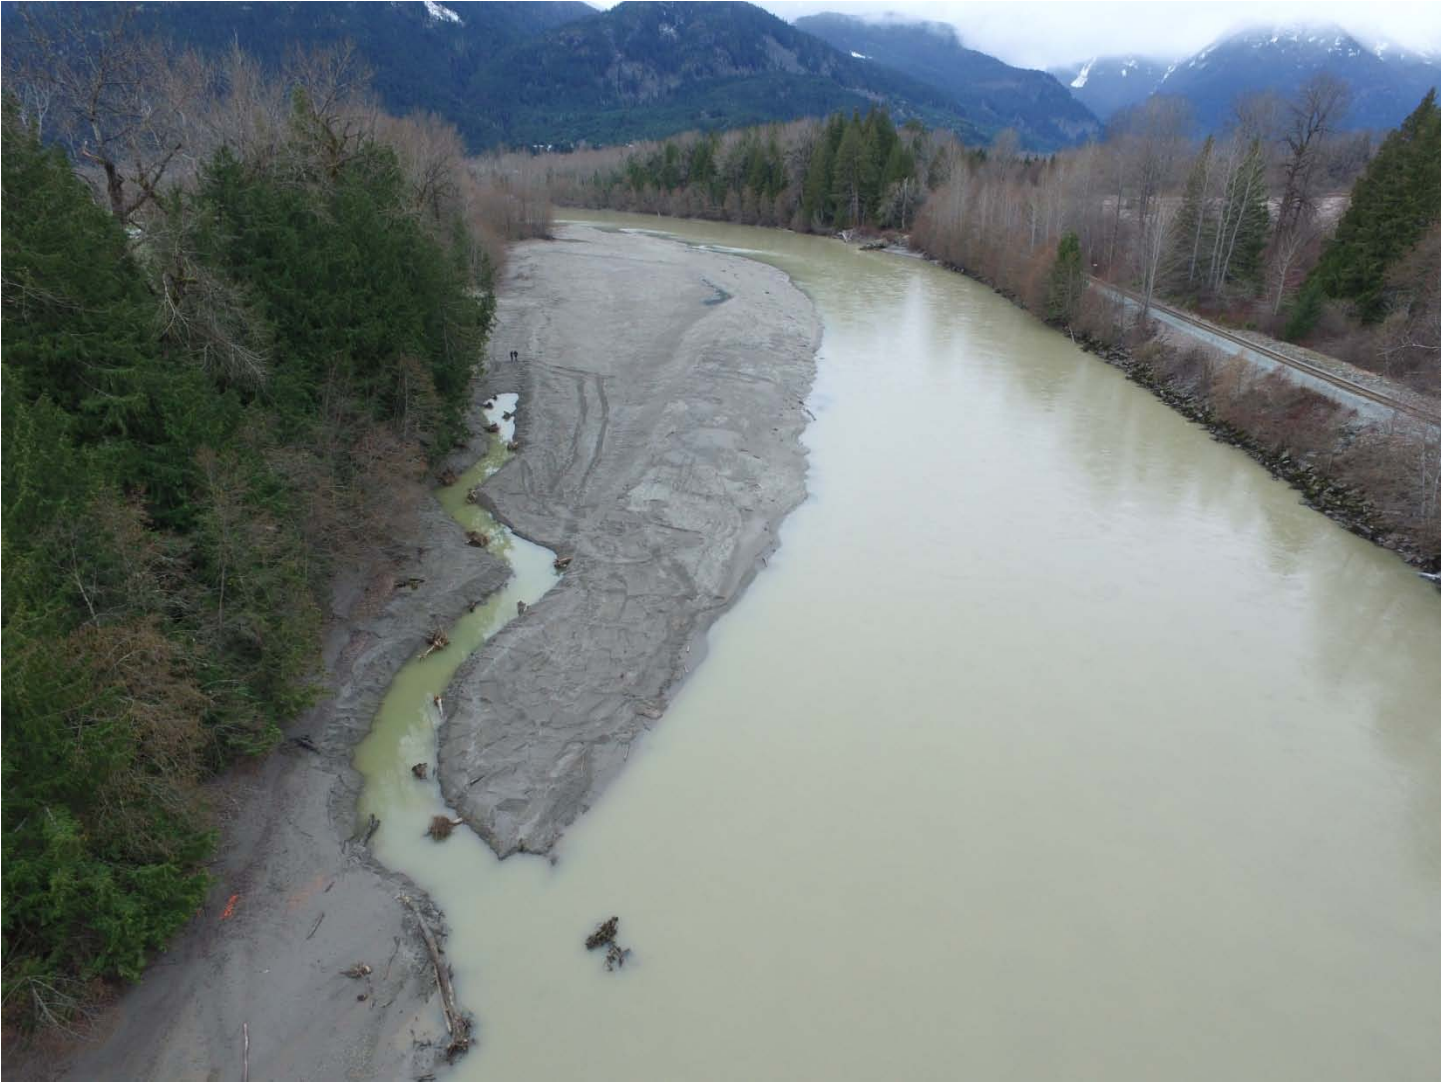
The work was accomplished during the months of February and March 2016 and the final volume removed was 18,000 m³. The extra 3,000 m³ was a result of additional works to construct back channels that create valuable fish habitat as shown below.

Beem Bar April 2016.

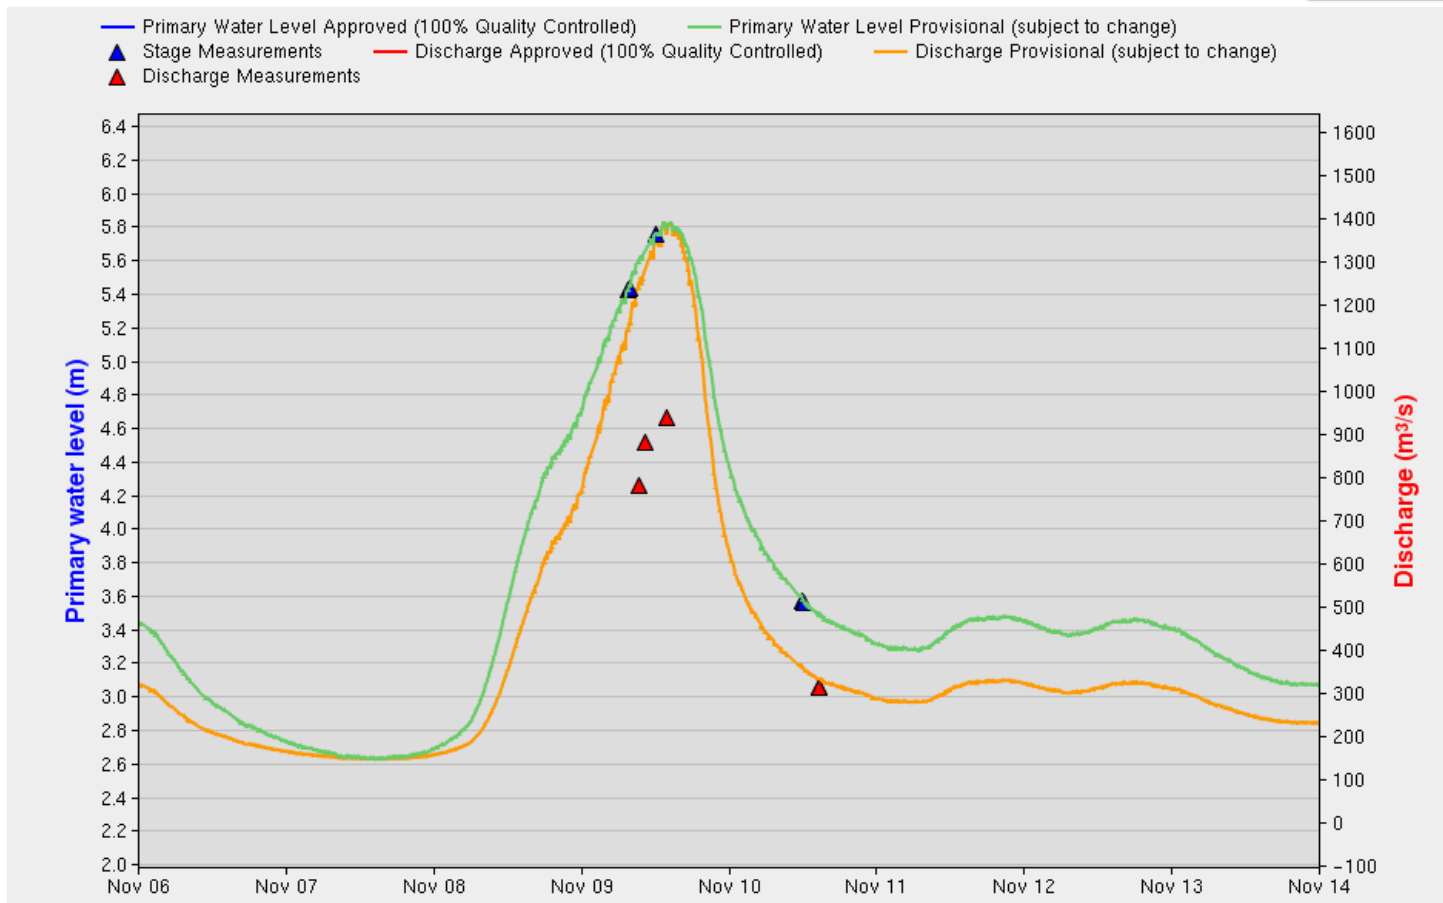
Figure 1 – WSC Lillooet River Gauge Near Pemberton

- At 2:00am the PVDD noted that the Lillooet River gauge was showing 850 m³/sec and was not rising, 1 patrol person was watching the Ryan River for potential flooding over Meadows road.

Lillooet River – The Lillooet River Crested at 1:00pm at the Forestry Bridge and 11:00pm at the Lillooet Highway 99 Bridge at 1400 m³/Sec. My thought is Lillooet Lake influenced the slow elevation drop in Pemberton.

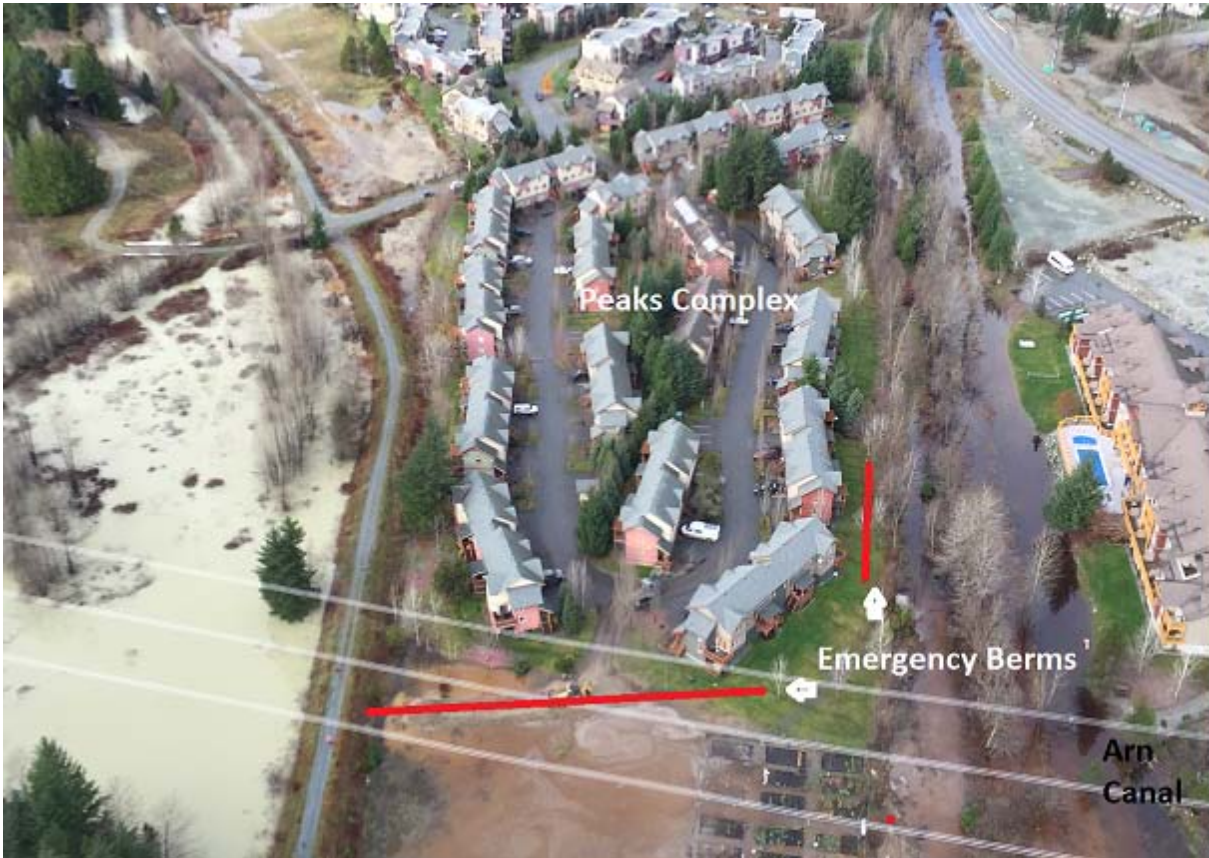
- **Arn Canal** – The Lillooet had back flowed up Pemberton Creek and closed the outlet gates on the Arn canal. This situation causes the Arn to rise steadily until the Lillooet River drops to approx 700m³/sec. The construction of an emergency berm and pumping was required to protect the Peaks town home community from certain

flooding. This commenced at 7:30am and was completed at 9:30 pm on Nov 9th. Work was accomplished under a VOP task number. The PVDD and VOP co-managed this project.

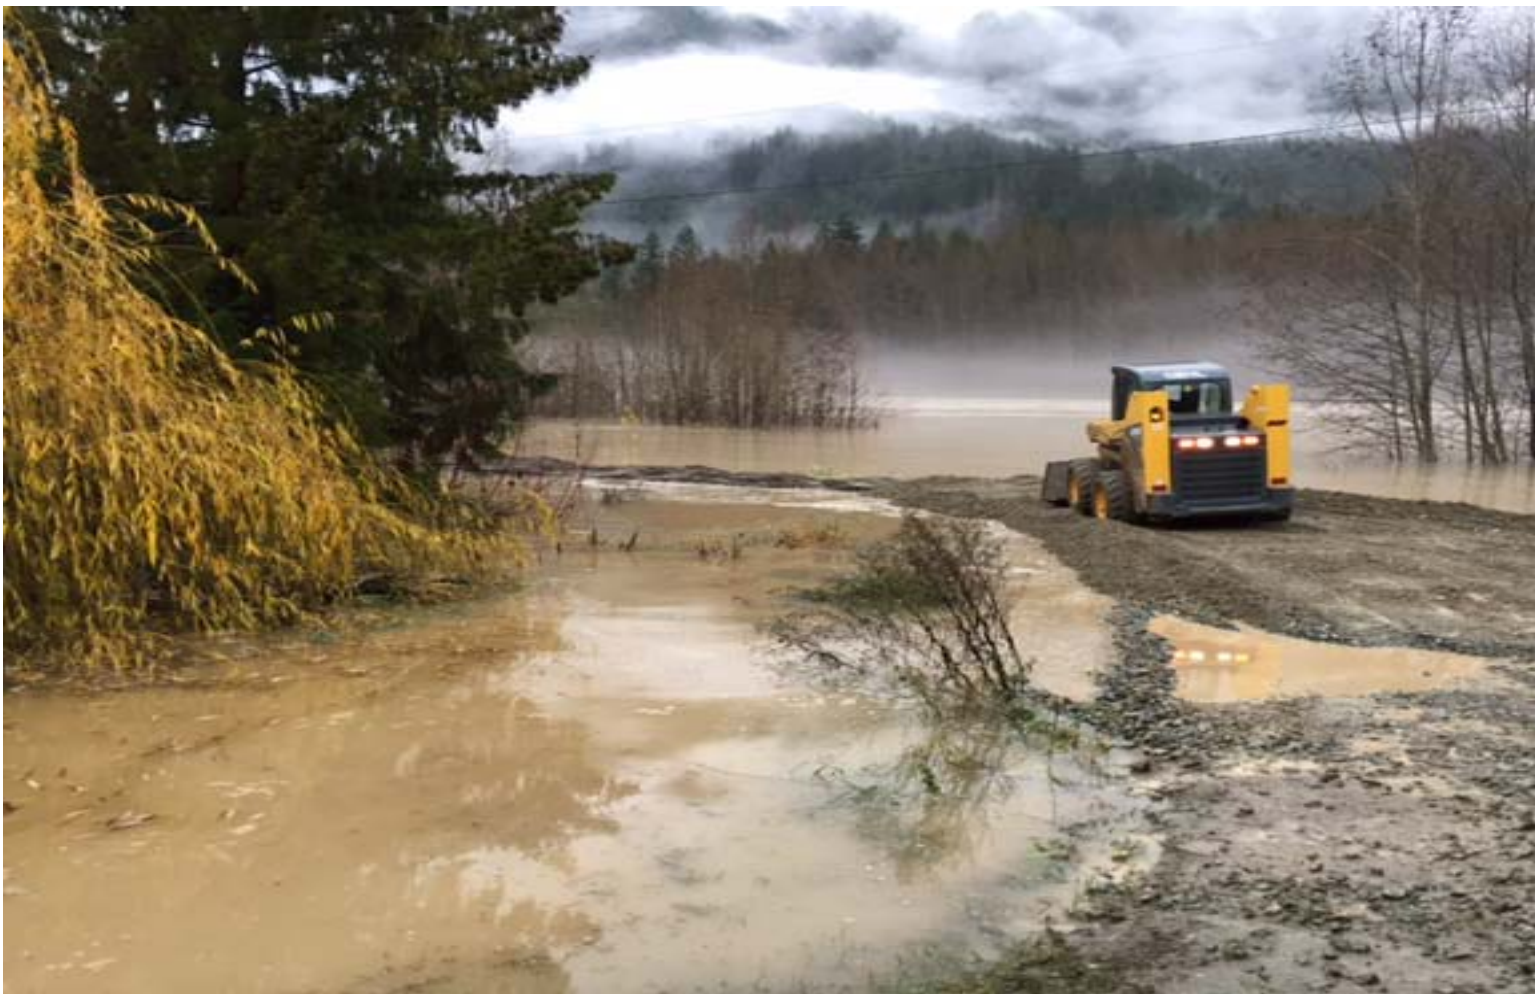
- **Ole Jensen** – At 9:00am Nov 9th, the PVDD attended Ole Jensen’s property to find that the Lillooet was overtopping the berm constructed during the Sept 20, 2015 high-water event. Additional material was brought in to increase the berm elevation.

Ole Jensen's Nov 9 10:00am.

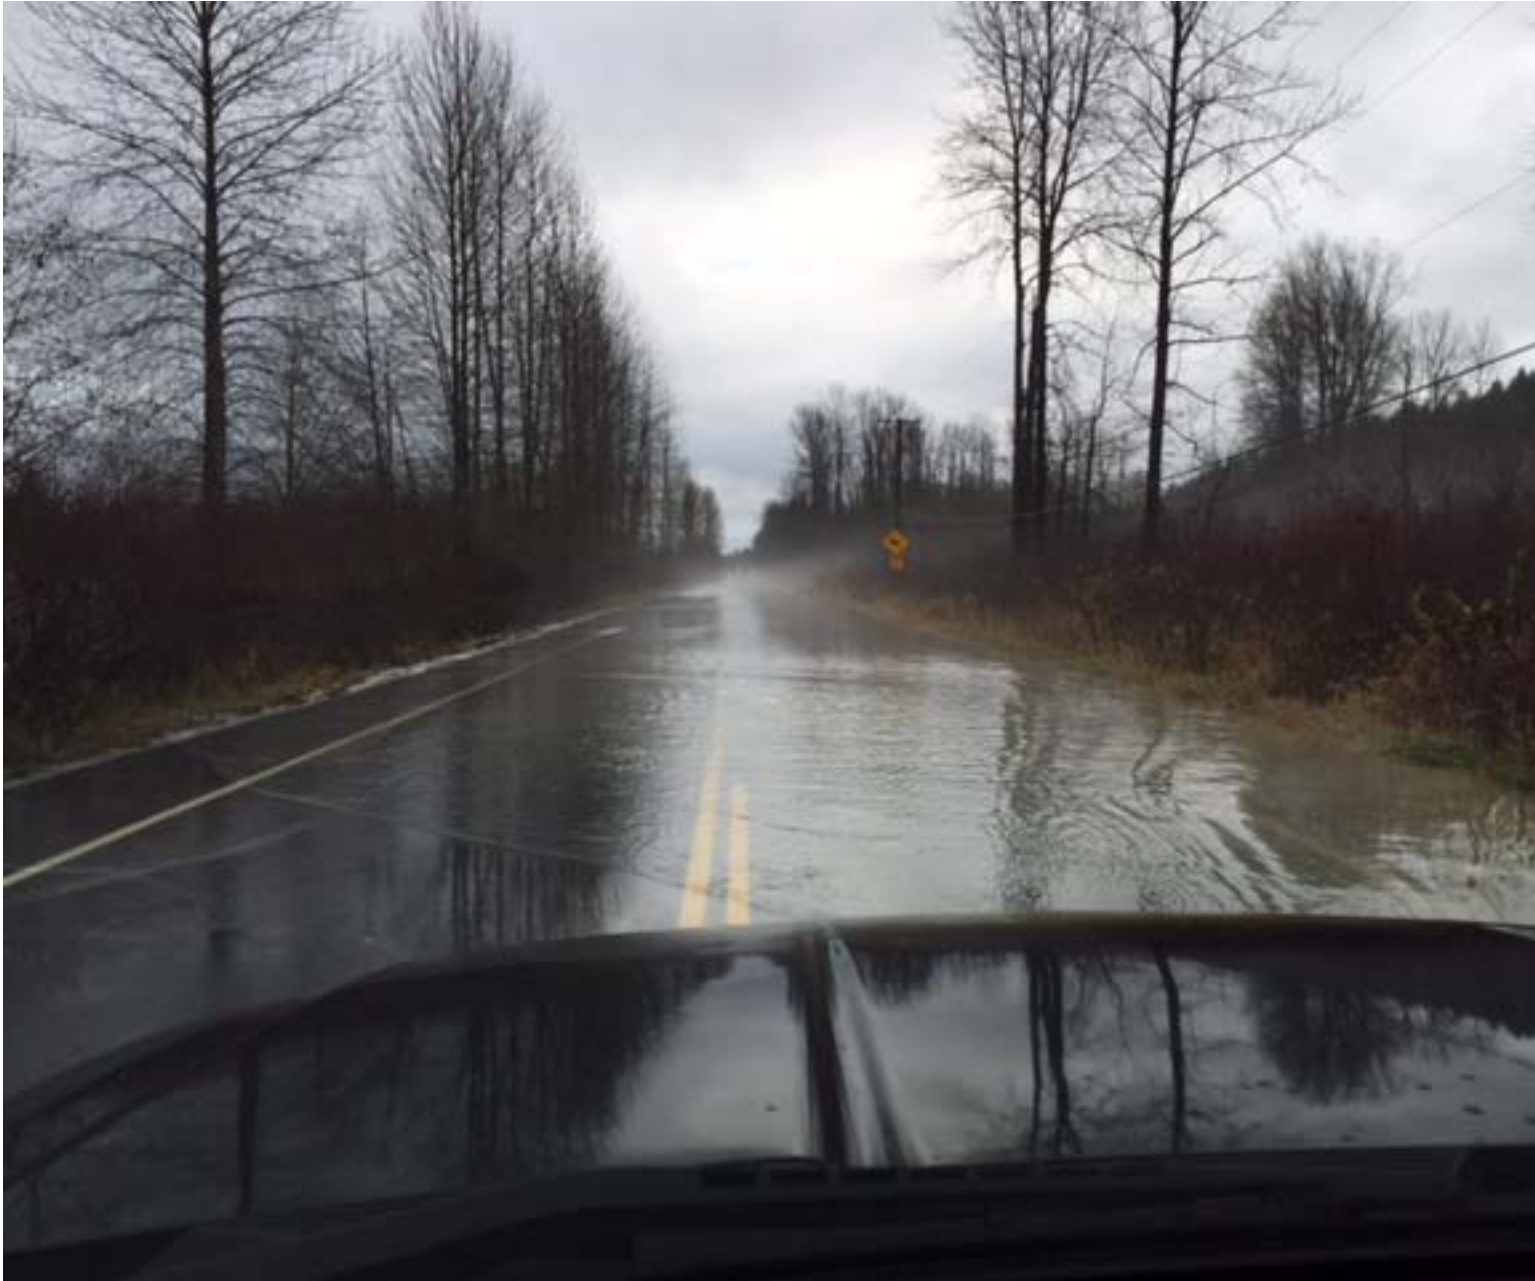
- **Ryan River** – At 8:00 the Ryan River overtopped Meadows Road but the road remained open with caution signs posted.

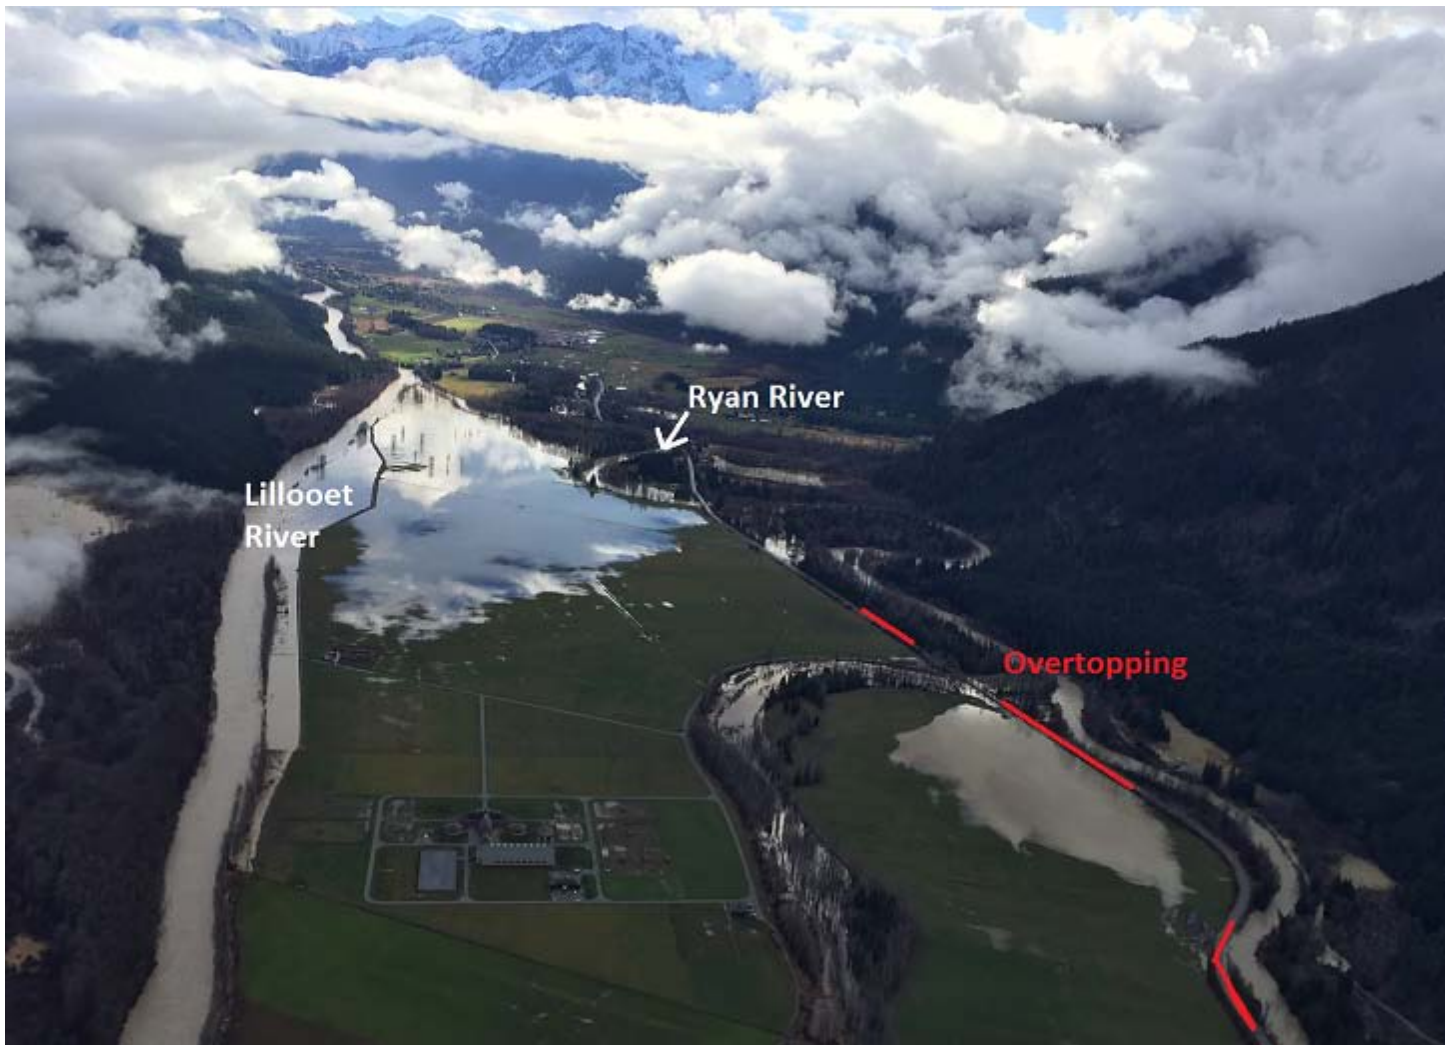
Lillooet and Ryan River at 12:00pm on Nov 9th, 2016

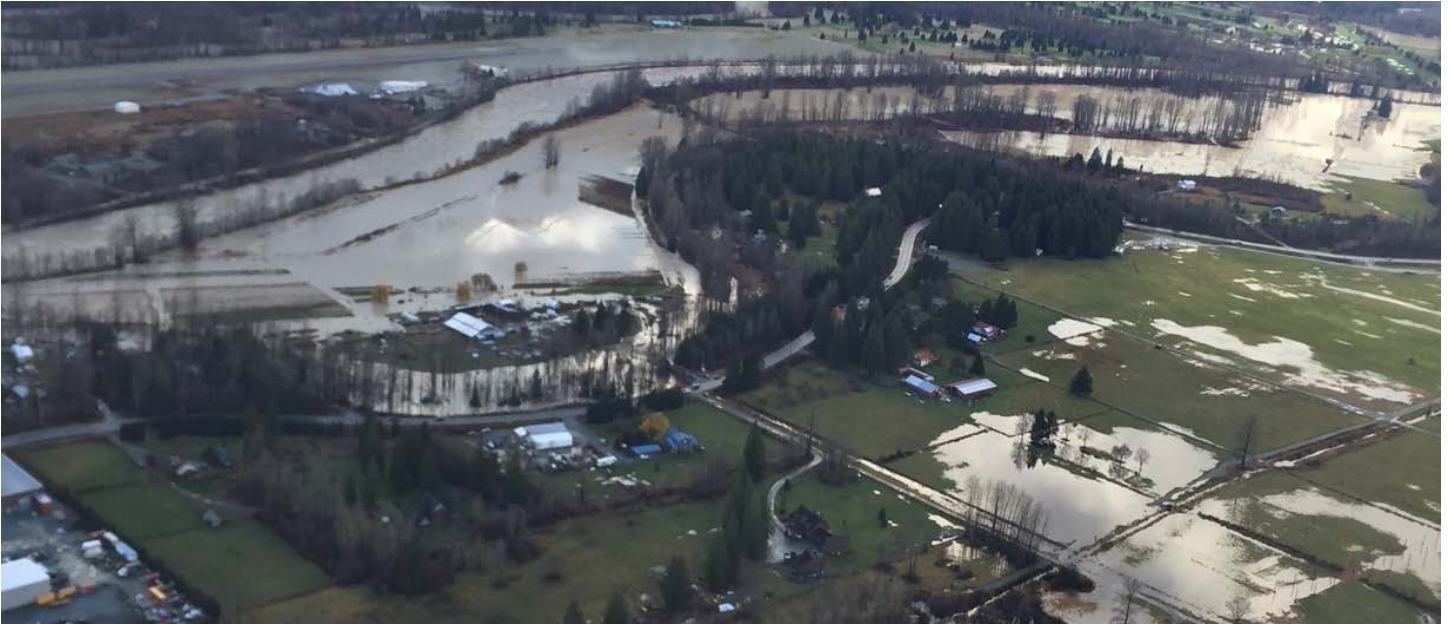
- **Sturdy Farm** – At 11:00am the PVDD attended the Sturdy farm at the owners request. It was found that the Lillooet River had overtopped the bank and was flowing into the farm. The owner was notified by the PVDD that the river was forecasted to crest by mid afternoon Nov 9th and that if assistance was required to contact the SLRD EOC.

Sturdy Farm 12:10pm Nov 9th.

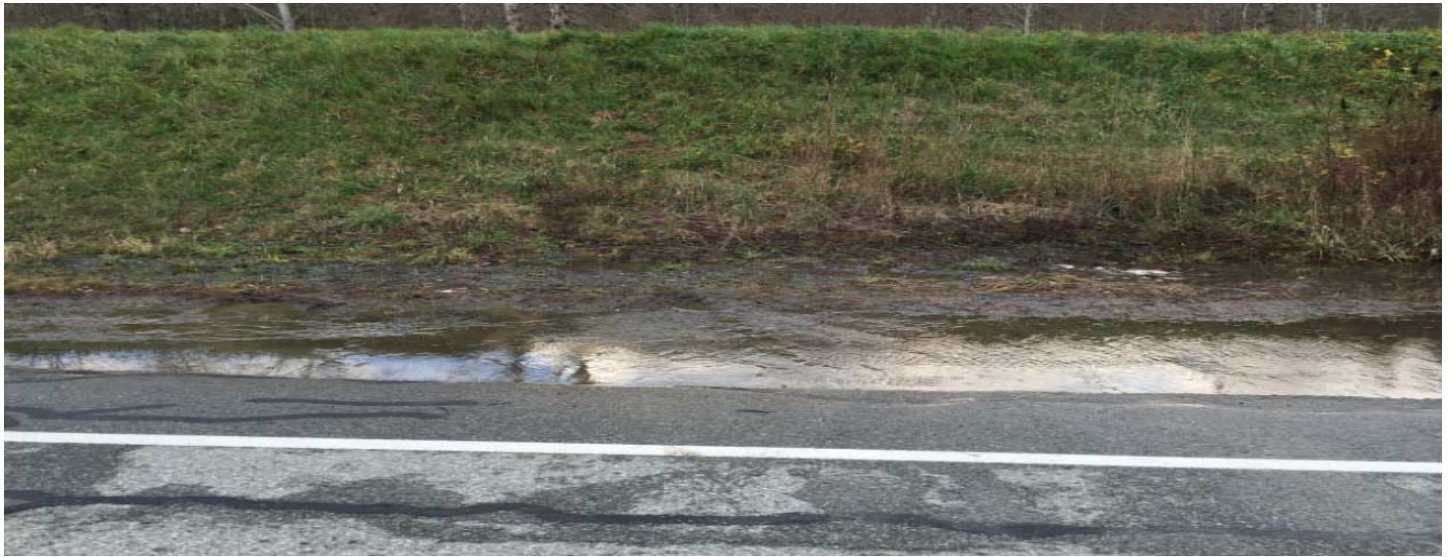
- **Miller Lilloet Dyke** – The PVDD was notified at 3:00pm on Nov 9th that piping under the Miller Lilloet Dyke was occurring in 3 locations near the McEwan farm and one location near the highway 99 Lilloet River Bridge. The PVDD attended and noted piping and called John Paddle with FLNRO Deputy Inspector of Dikes for assistance and he suggested to monitor and have materials on hand to contain the boils if required. The PVDD also requested an engineer to evaluate, this happened on the morning of Nov 10th at 8:30am.

Piping Miller Lillooet Dike at Gilmore farm Nov 9th 3:00pm

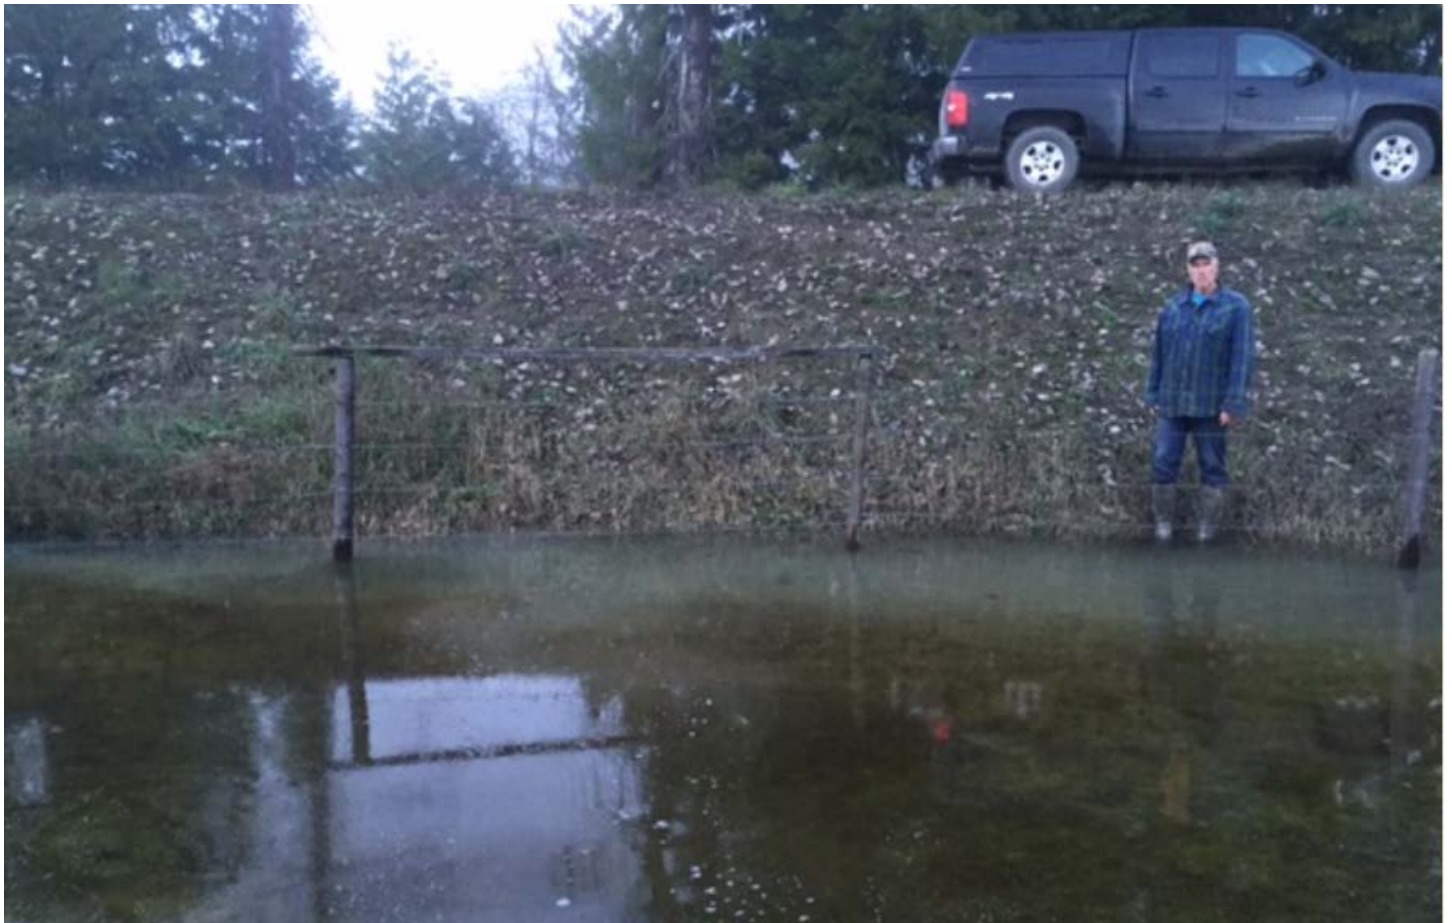
Piping Miller Lillooet Dike near McEwan Farm Nov 9, 2016 4:15pm

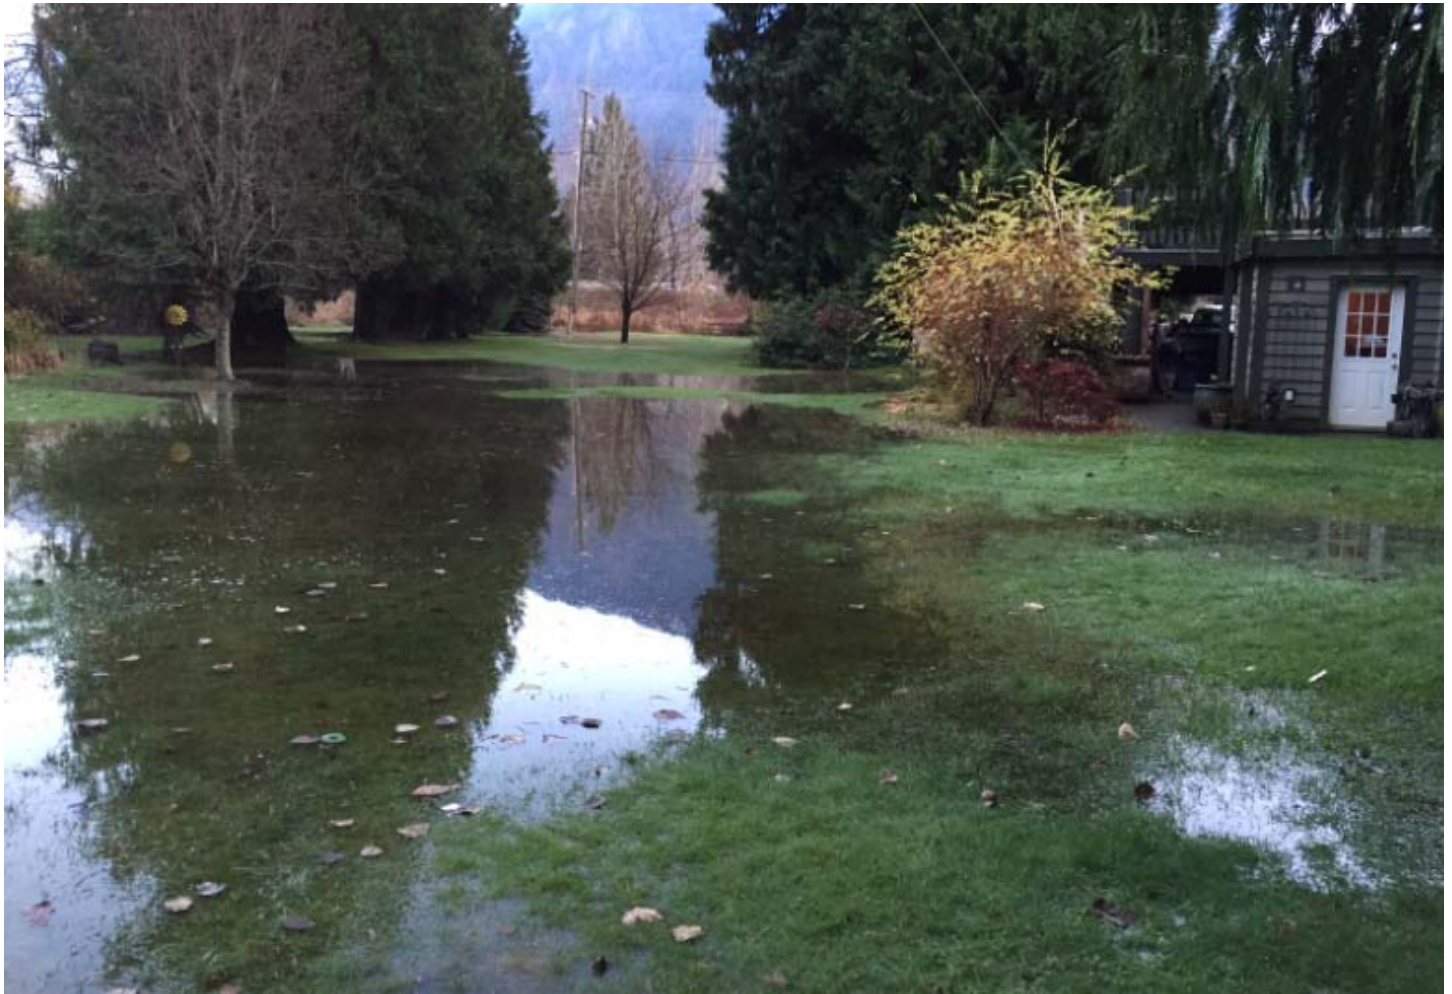
Miller Lillooet Dike Piping causing flooding on Oberson Property Nov 9 4:30pm.

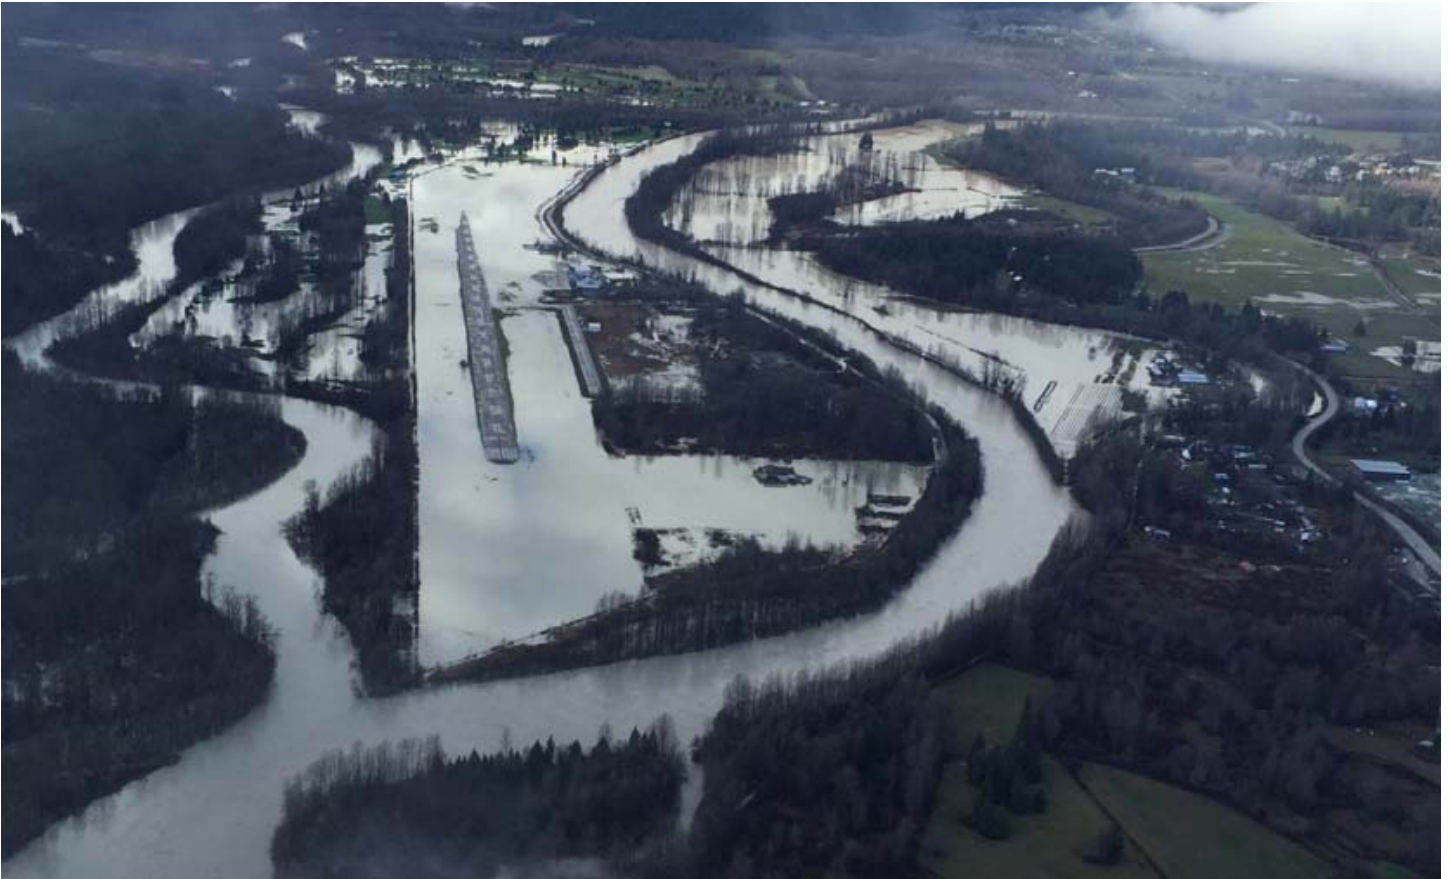
- **Pemberton Airport/Golf Course/FLNRO Fire Base** – The airport road was closed at 12:00pm on Nov 9th as the airport, Big Sky Golf Course, Meadows Golf Course, VOP water treatment plant and Forestry Fire base were all flooded from the Lillooet and Green Rivers.

Pemberton Airport Nov 9 12:00pm.

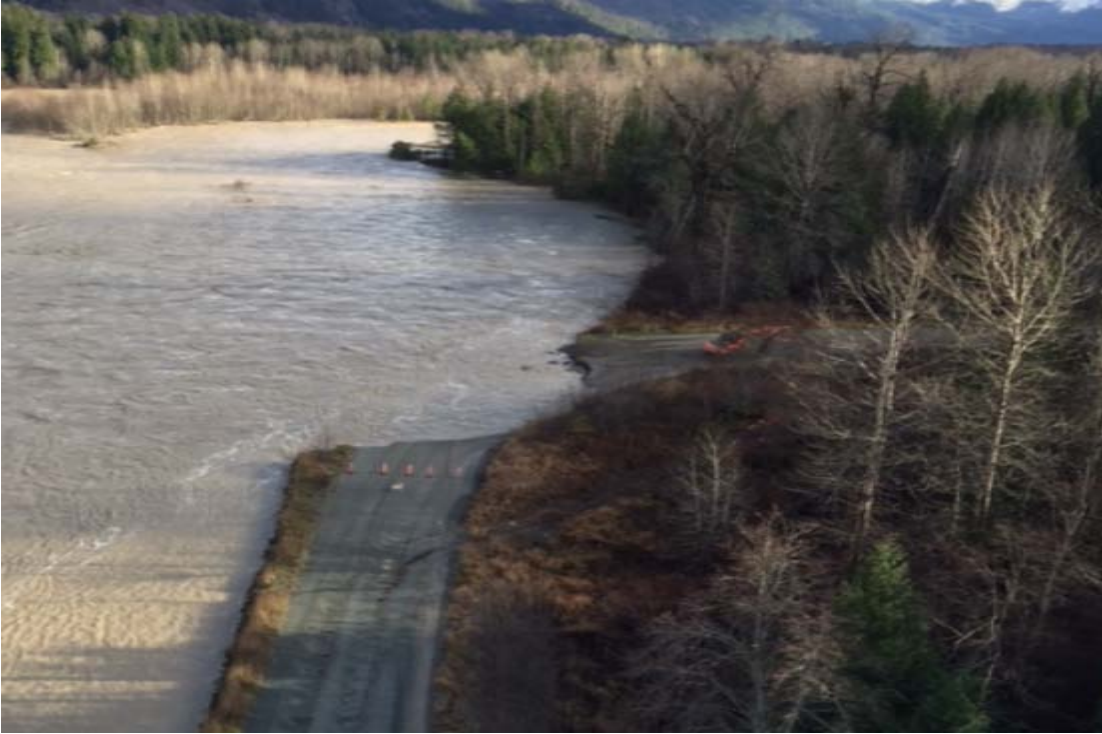
Meadows Road Washout – At approx 10:00pm Nov 8th, the Lillooet River washed out Meadows Road just north of Geese Road.

Meadows road Washout Nov 9 12:30pm.

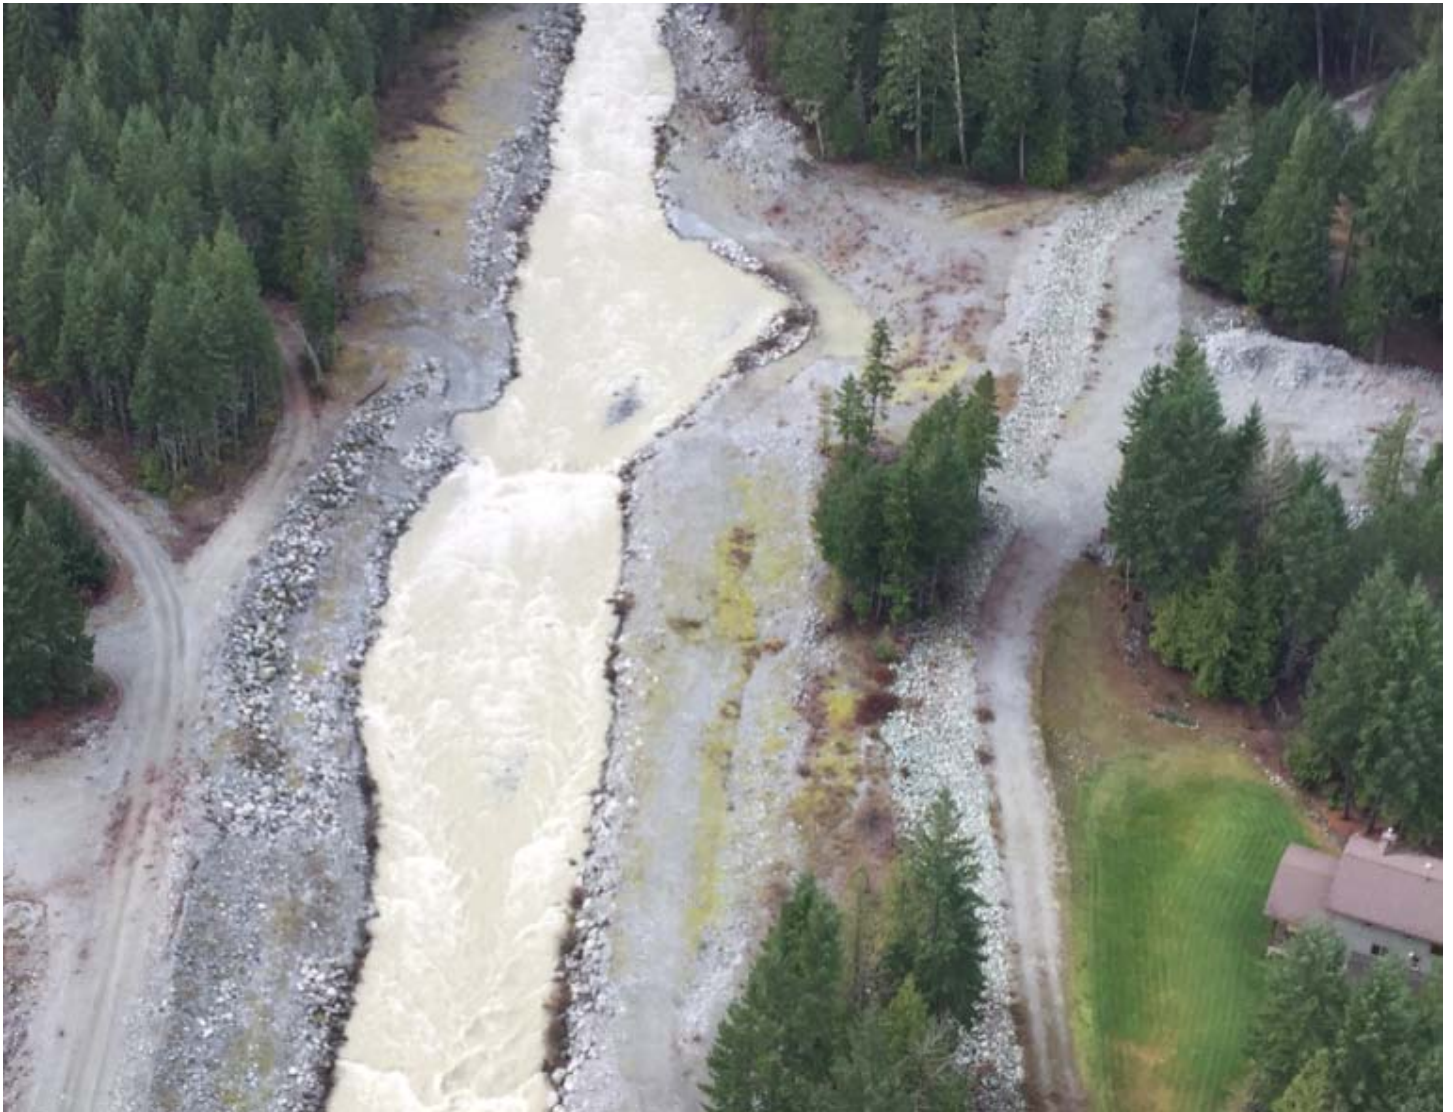
Miller Creek Weir – The Miller Creek weir was destroyed by extreme flows and completely filled with gravel. This weir had been excavated and cleaned out Sept 23rd, 2015 just after the September 15 2016 high water event.

Miller Weir Nov 9 12:00pm.

1. Miller Weir – The miller weir was severely damaged and requires repair.

- Weir repair
- Removal of 1000 m3 of sediment was removed from the sediment catchment basin.
- Bank Armoring along the creek above the catchment basin.

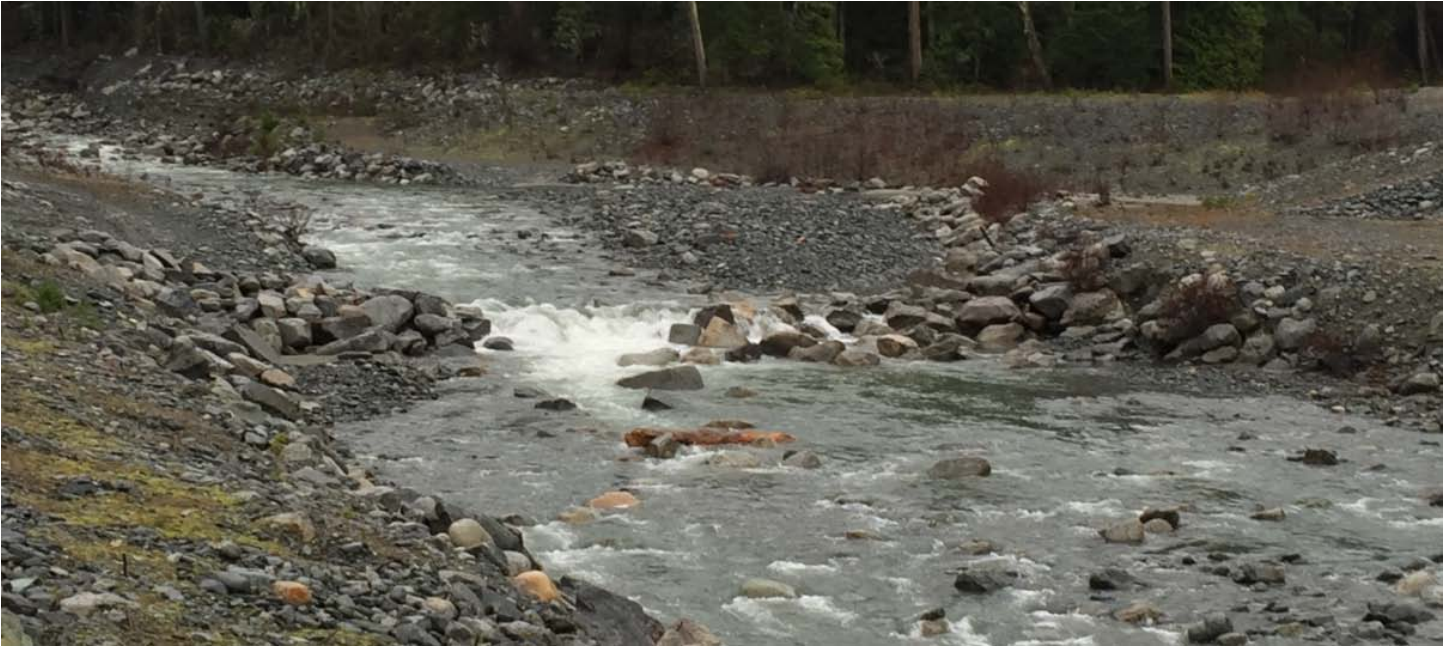
Miller Weir December 1 2016

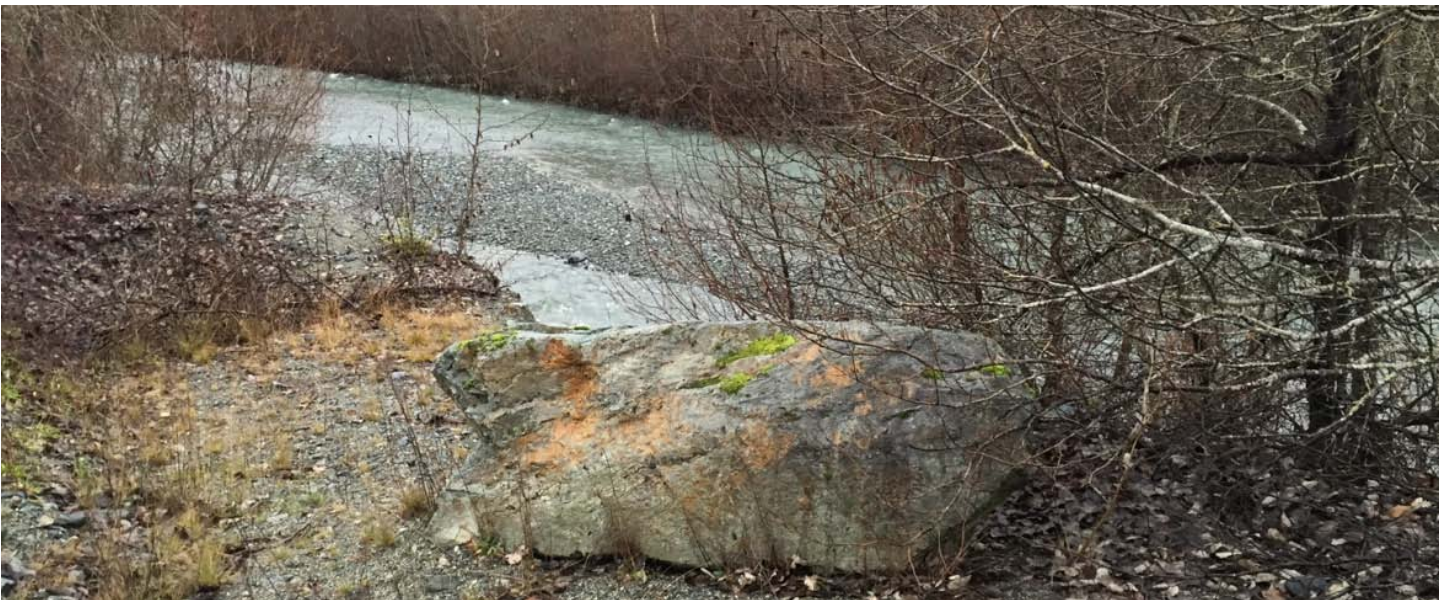
Miller Gravel Deposition – Miller Creek experience severe gravel deposition just above and below the Highway 99 Bridge. The bar below the bridge was removed as Response after the Sept 20th, 2015 high water event.

Miller gravel Deposition Above Highway 99 Bridge Nov 17 2016

2. Miller Gravel Removal – Two bars require removal to maintain dike , one above the Highway 99 Bridge and one below the bridge.
3. Ayers Dyke Bank Failures – In a 300 m section of the Ayers Dyke there are multiple banks failures that now threaten the dyke. This area was never armored and has now eroded the bank to the point of threatening the dyke.
4. Dream Catcher Armor Repair – Repair approx 50m of bank armor.
5. Pemberton Creek Gravel Deposition/Survey – A cross section survey was required to assess the scope of the Gravel deposition in Pemberton creek and it was determined that approx 1200 m³ of material was deposited.
6. Lillooet River Gravel Deposition – In February/March 2016 the PVDD removed 18,000 of gravel from 3 bar location on the Lillooet River. It was found that all three bars were full of gravel and required removal of approx 14,000 m³ to maintain dike freeboard.

- Removal of an additional 1500 m3 of sediment from the catchment basin.
- Removal of 2 gravel bars, 1 above and 1 below Meadows Road Bridge.
- Add more large rock to Weir.

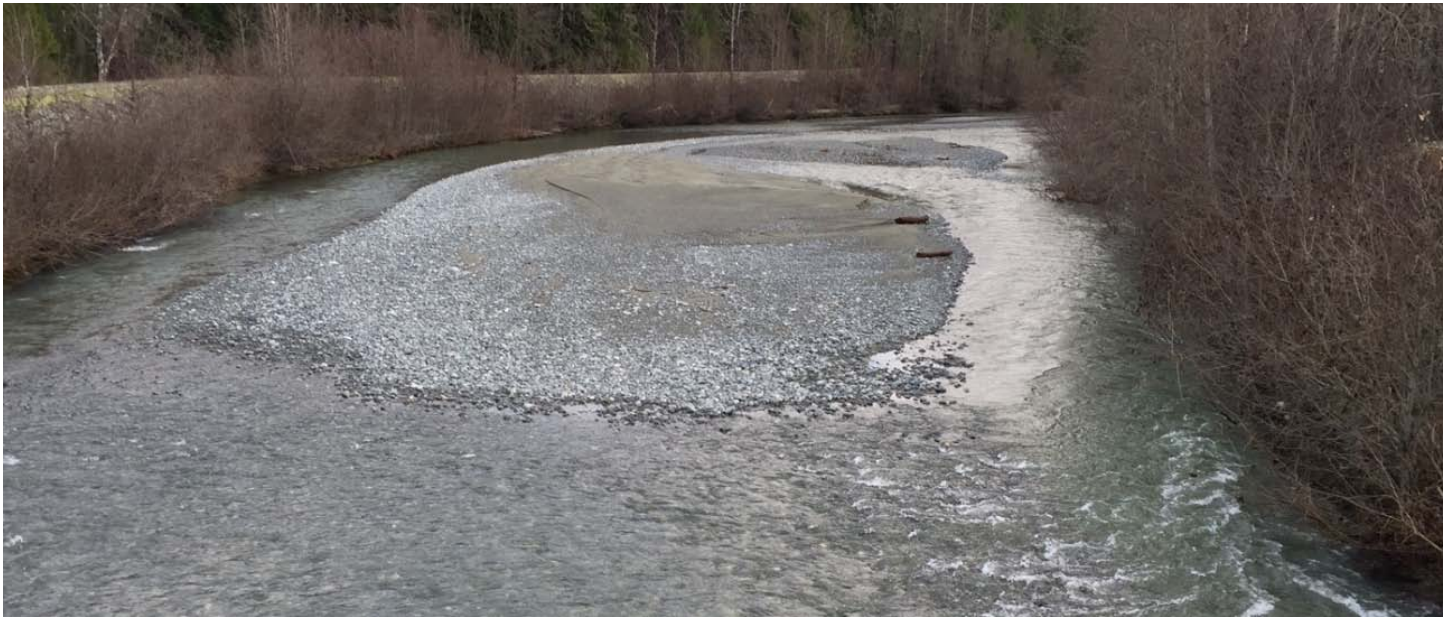
Miller Gravel deposition Below Highway 99 Bridge Nov 17 2016. This bar was completely removed Sept 23rd 2015.
