Pemberton Valley Dyking District April 13, 2017 Annual General Meeting Report

November 9th, 2016 Pemberton Valley High Water Event Summary

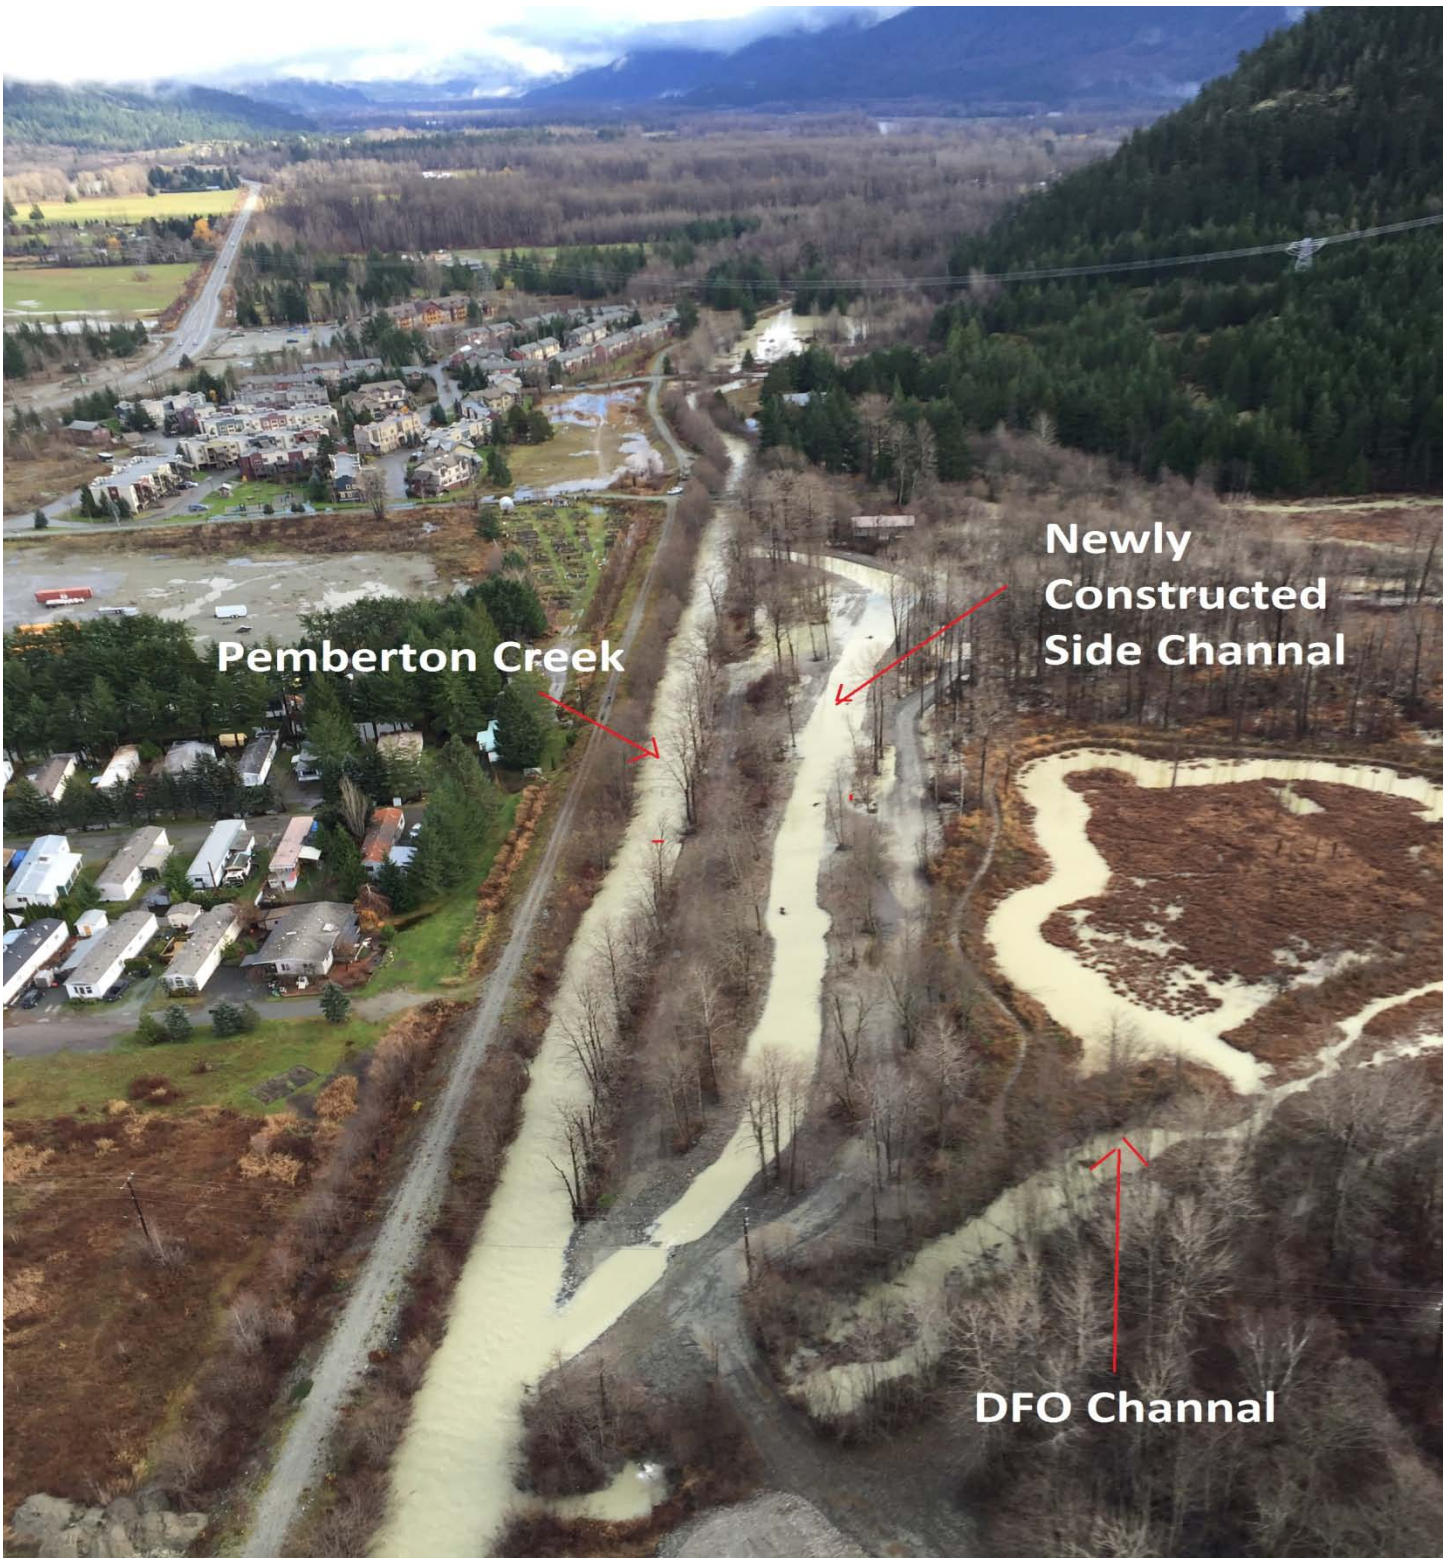
Pemberton Creek Gravel Deposition – Pemberton Creek experience considerable gravel deposition. Deposition amounts have been determined to be in the 1200 m³ range.

Pemberton Creek Lower Zone Nov 9 2016.

As a result of a detailed survey conducted after the Nov 2016 high water event it has been identified that 1200 m³ of sediment must be removed from Pemberton Creek to ensure adequate dyke freeboard. This work will be conducted during the August/September 2017 fish window.

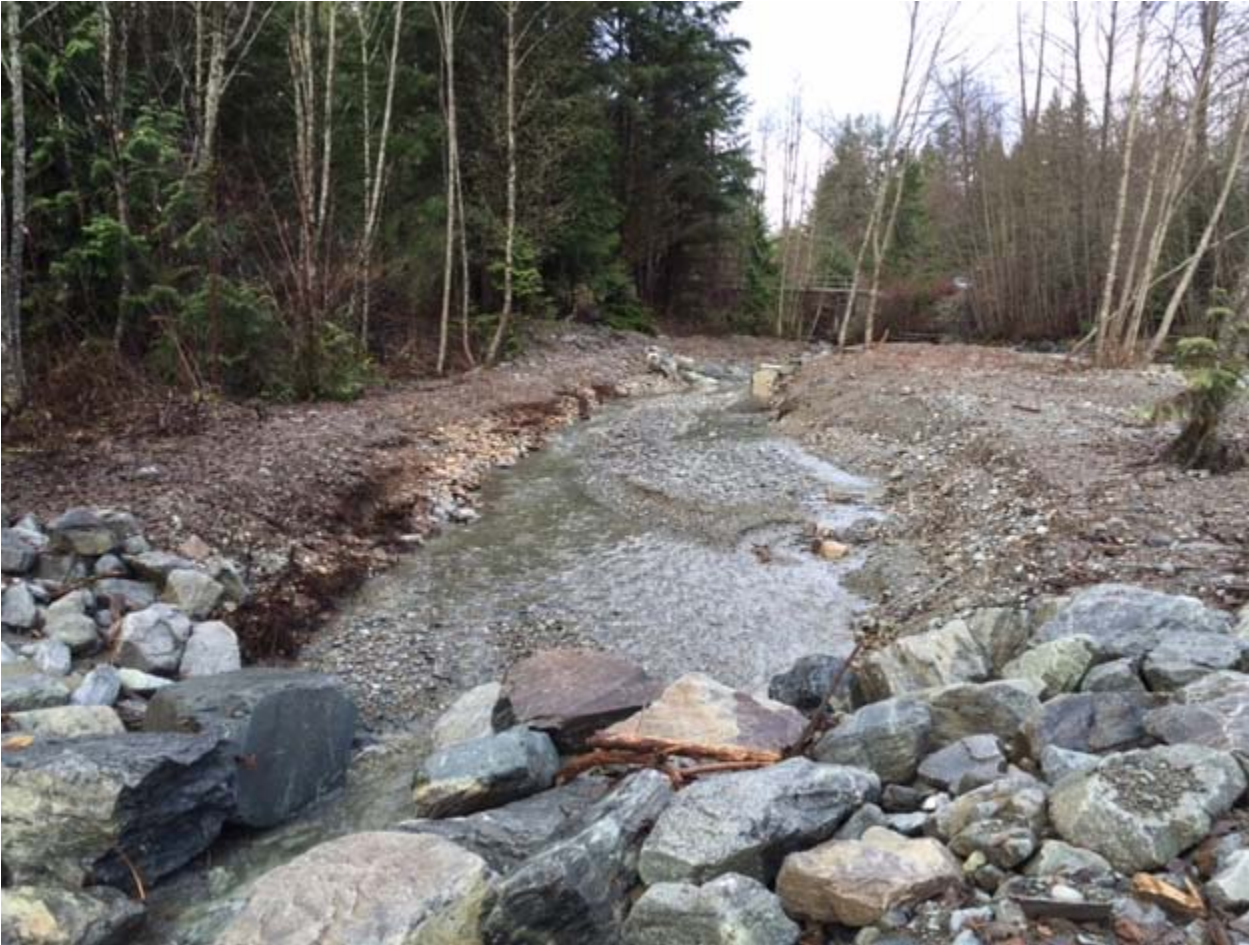
Pemberton Creek Gravel Deposition in upper Zone Nov 17 2016.

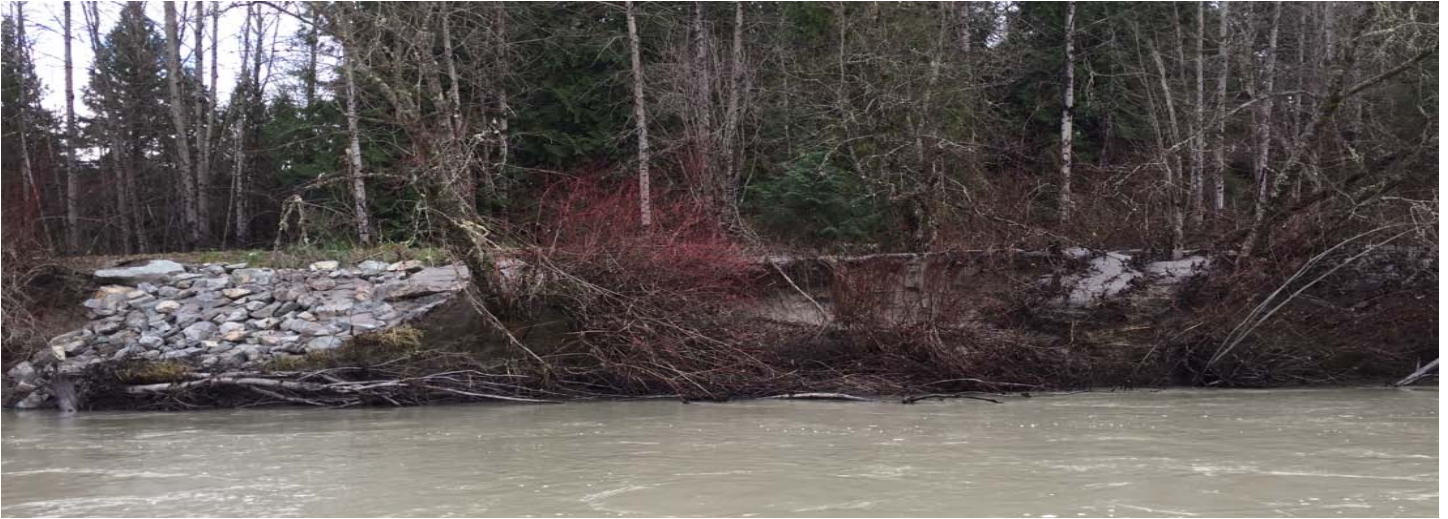
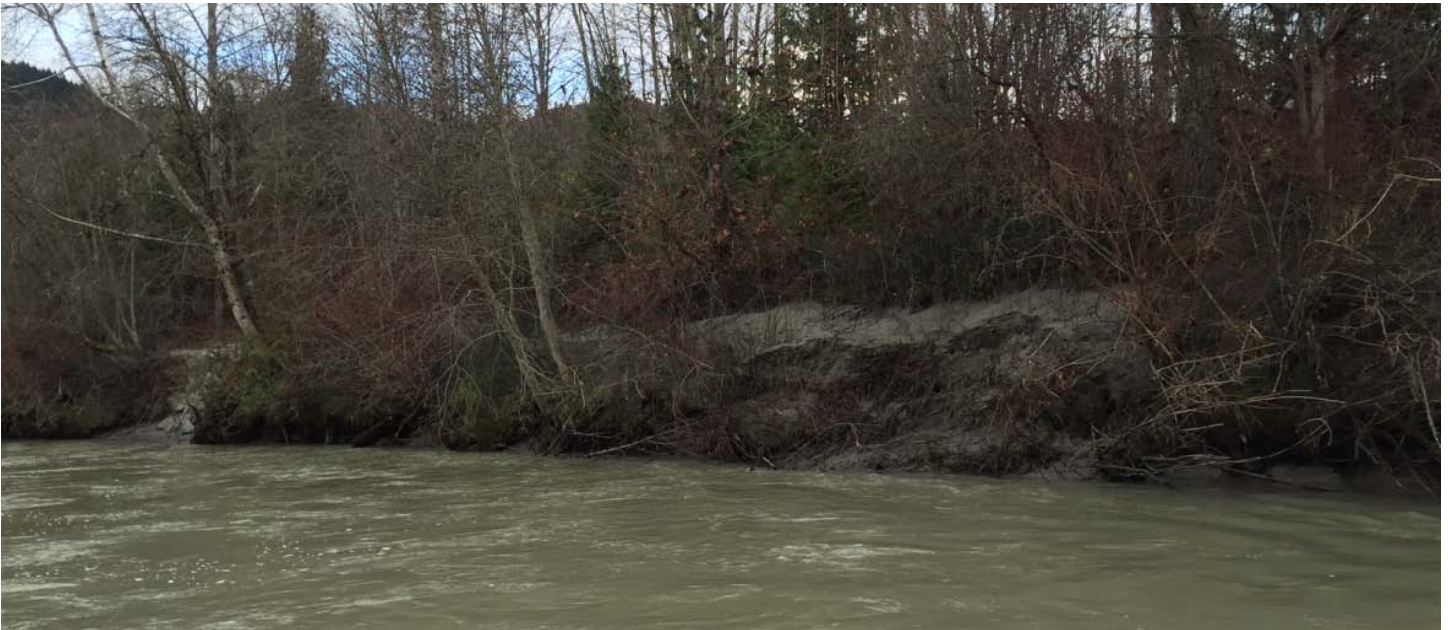
Ayers Dyke Bank Failure – There are 2 areas along the Ayers Dyke that experienced bank failures that are now compromising the dyke.

Ayers Dyke Bank Failure Nov 17 2016

2. Miller Gravel Removal – Two bars require removal to maintain dike , one above the Highway 99 Bridge and one below the bridge.
3. Ayers Dyke Bank Failures – In a 300 m section of the Ayers Dyke there are multiple banks failures that now threaten the dyke. This area was never armored and has now eroded the bank to the point of threatening the dyke.
4. Dream Catcher Armor Repair – Repair approx 50m of bank armor.
5. Pemberton Creek Gravel Deposition/Survey – A cross section survey was required to assess the scope of the Gravel deposition in Pemberton creek and it was determined that approx 1200 m³ of material was deposited.
6. Lillooet River Gravel Deposition – In February/March 2016 the PVDD removed 18,000 of gravel from 3 bar location on the Lillooet River. It was found that all three bars were full of gravel and required removal of approx 14,000 m³ to maintain dike freeboard.

Two areas adjacent to the Ayers Dyke were damaged by erosion as a result of the Nov 2017 high water event and required repair prior to the 2017 freshet. This work was completed in the first week of April 2017.

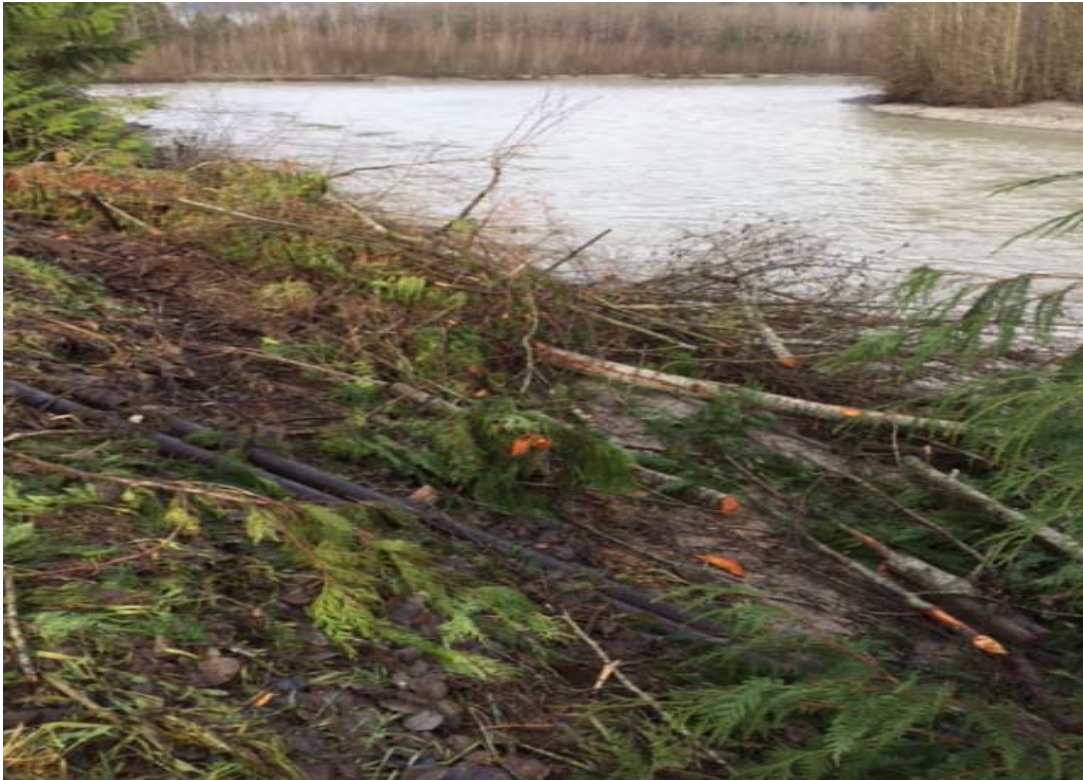
Dream Catcher Farm Lillooet River – The armored bank of the Lillooet River at Dream Catcher farm experience dramatic impact from large woody debris. Bank armor repairs are required along the top 1/3 of the Armor where armor rock has been dislodged.

Dream Catcher Armor Damage – Nov 12 2016

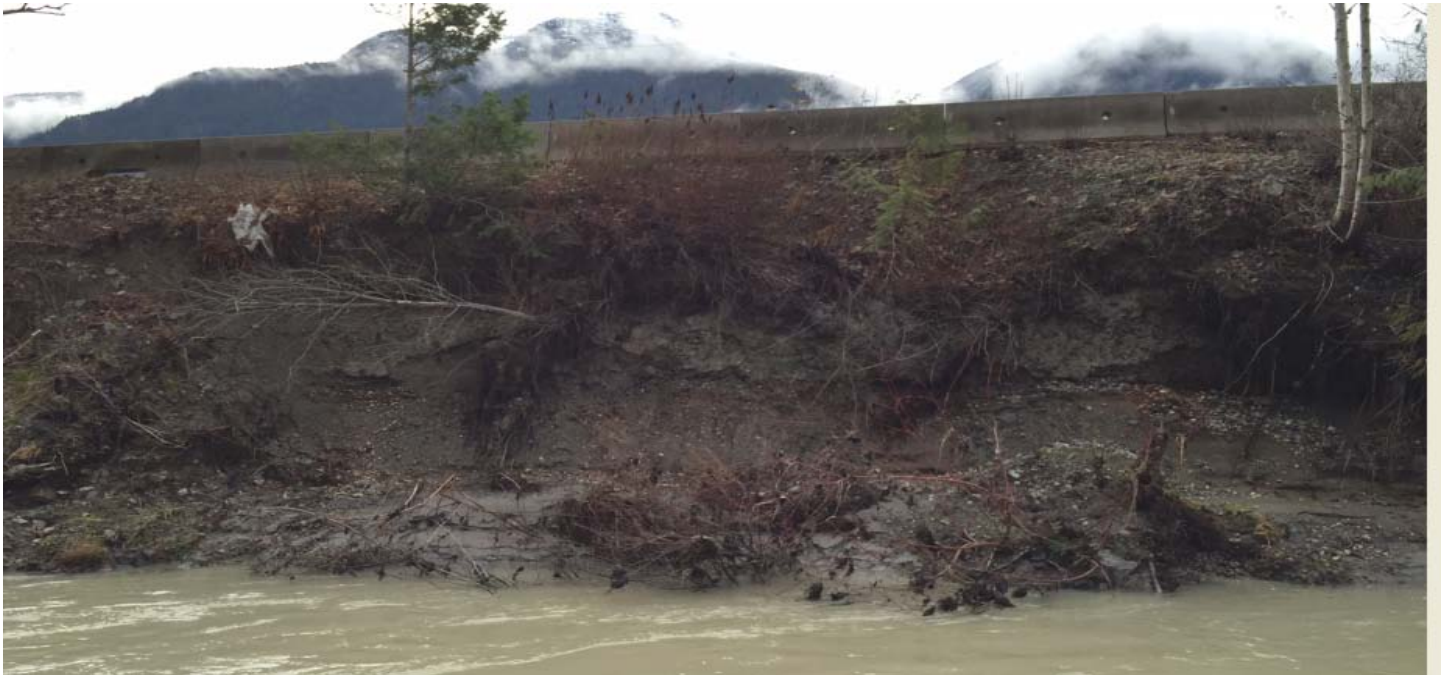
Meadows Road Bank failure – Meadows Road experienced a bank failure at the Ronayne farm. MOTI issue and they were notified by the PVDD.

Meadows road Bank failure at Ronayne farm Nov 17 2016.

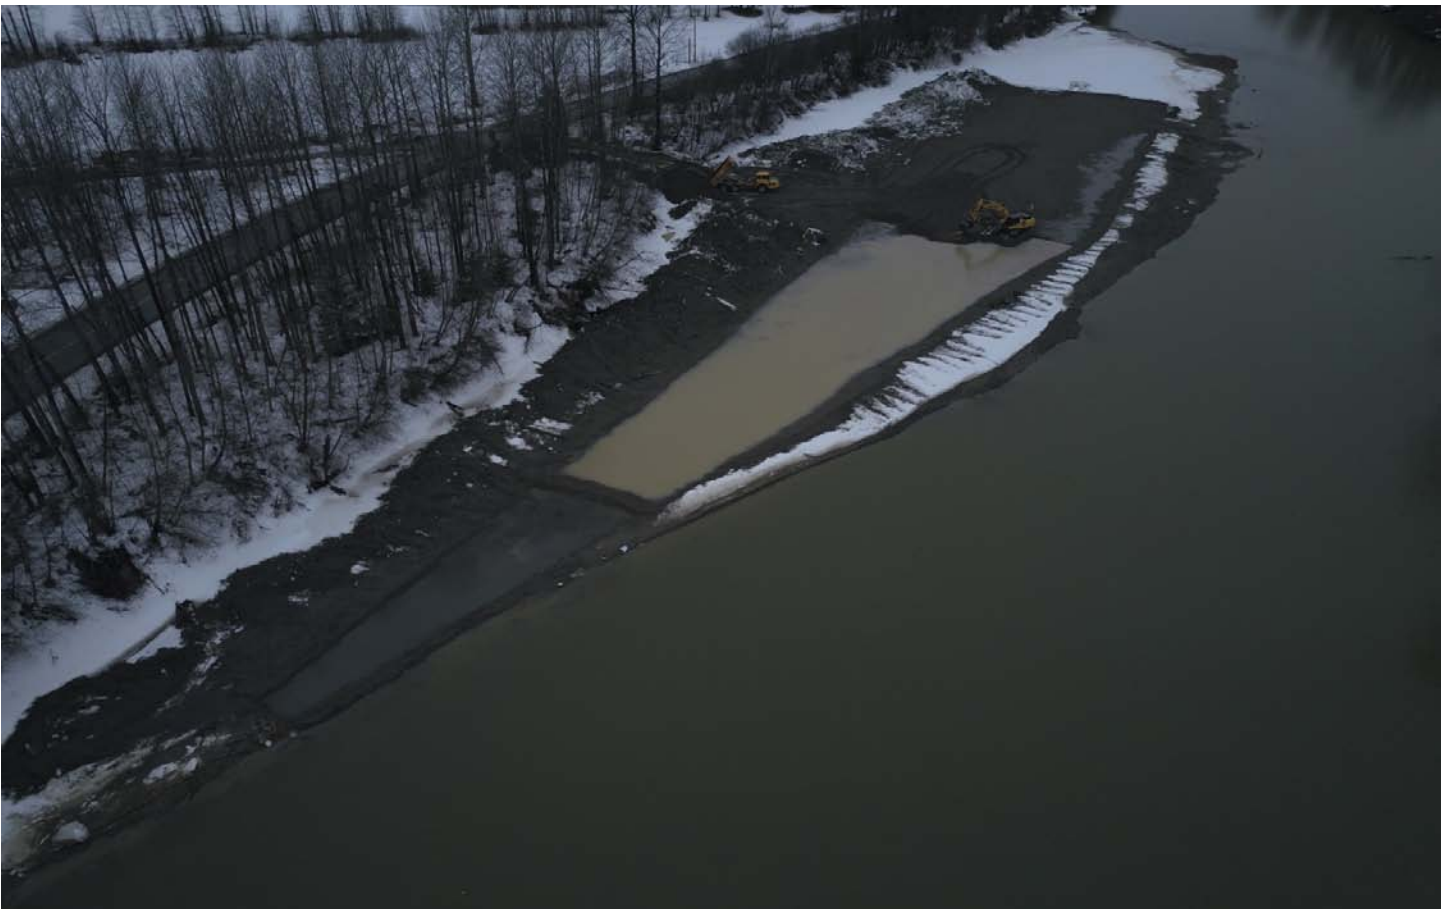
Big Sky Bar

A post high water survey was conducted of the 3 bars where 18,000 m³ of sediment was removed from the Lillooet river in March 2016 and indicated that 14,000 m³ of sediment had been deposited on the 3 bars as a result of the Nov 2017 high water event. The PVDD conducted a Request for Proposal process to accomplish this removal as cost effectively as possible, Coastal Mountain Excavation was the successful proponent. The work was completed during the Month of March and first week of April 2017.

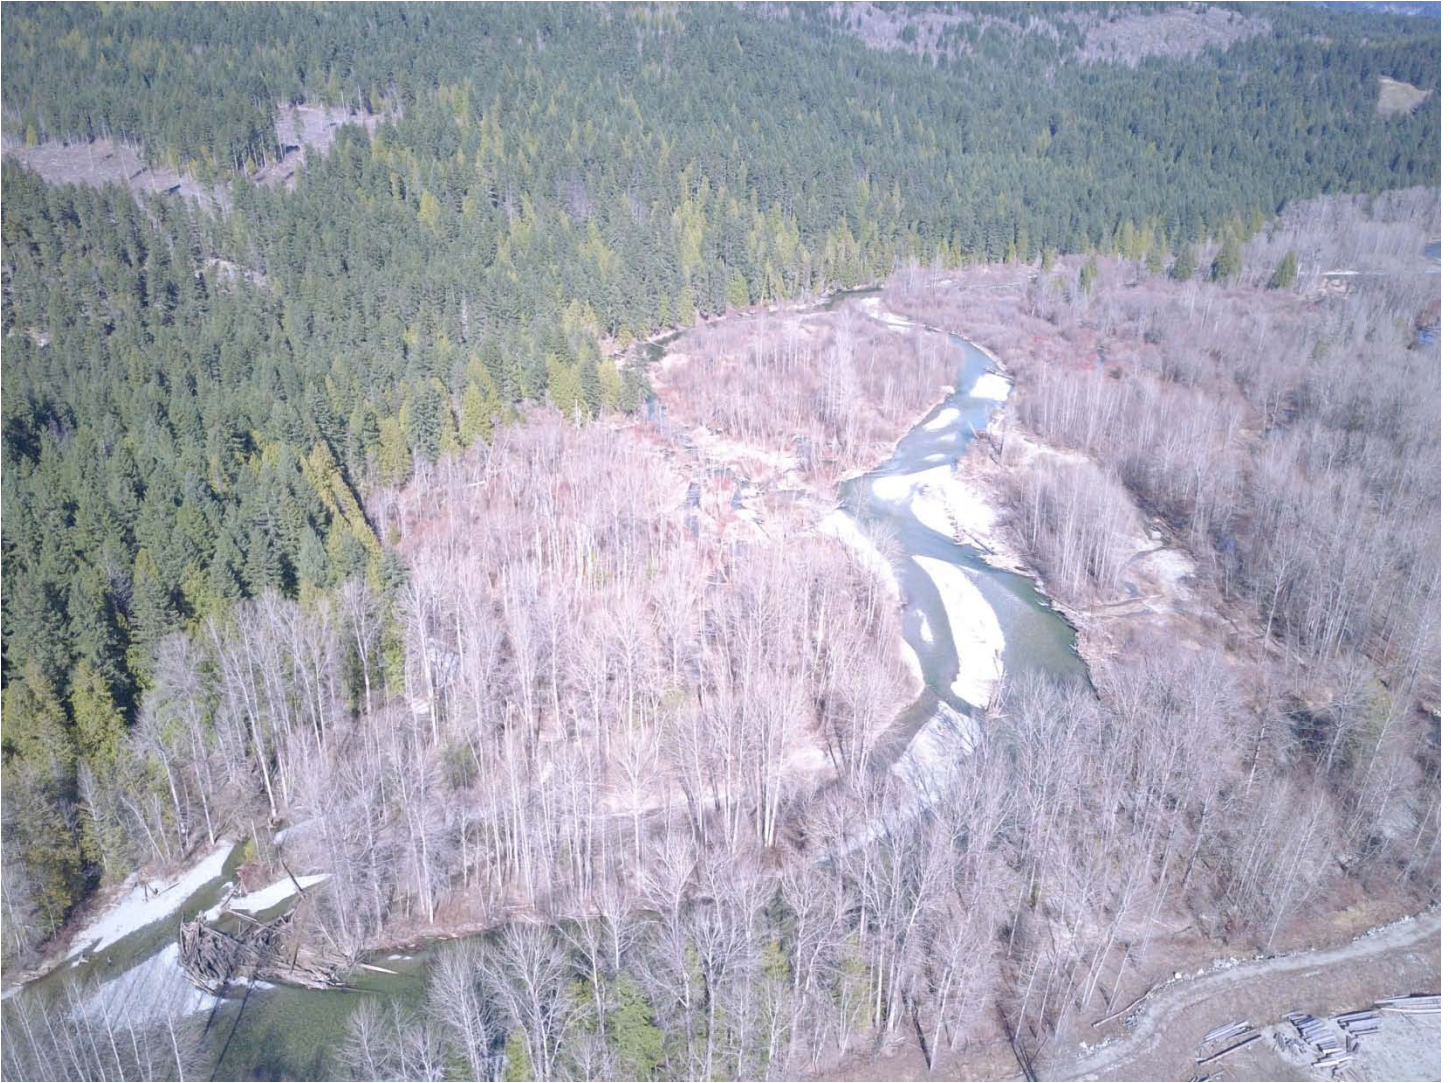
These monitoring requirements were completed in early April 2017 during low flow conditions and no problems were indentified, the river and side channels are all functioning as designed.

Birkenhead River April 5 2017
