Engineering Study for **Lillooet River Corridor**

Final Report
December 2002

Pemberton Valley Dyking District

Mount Currie Band

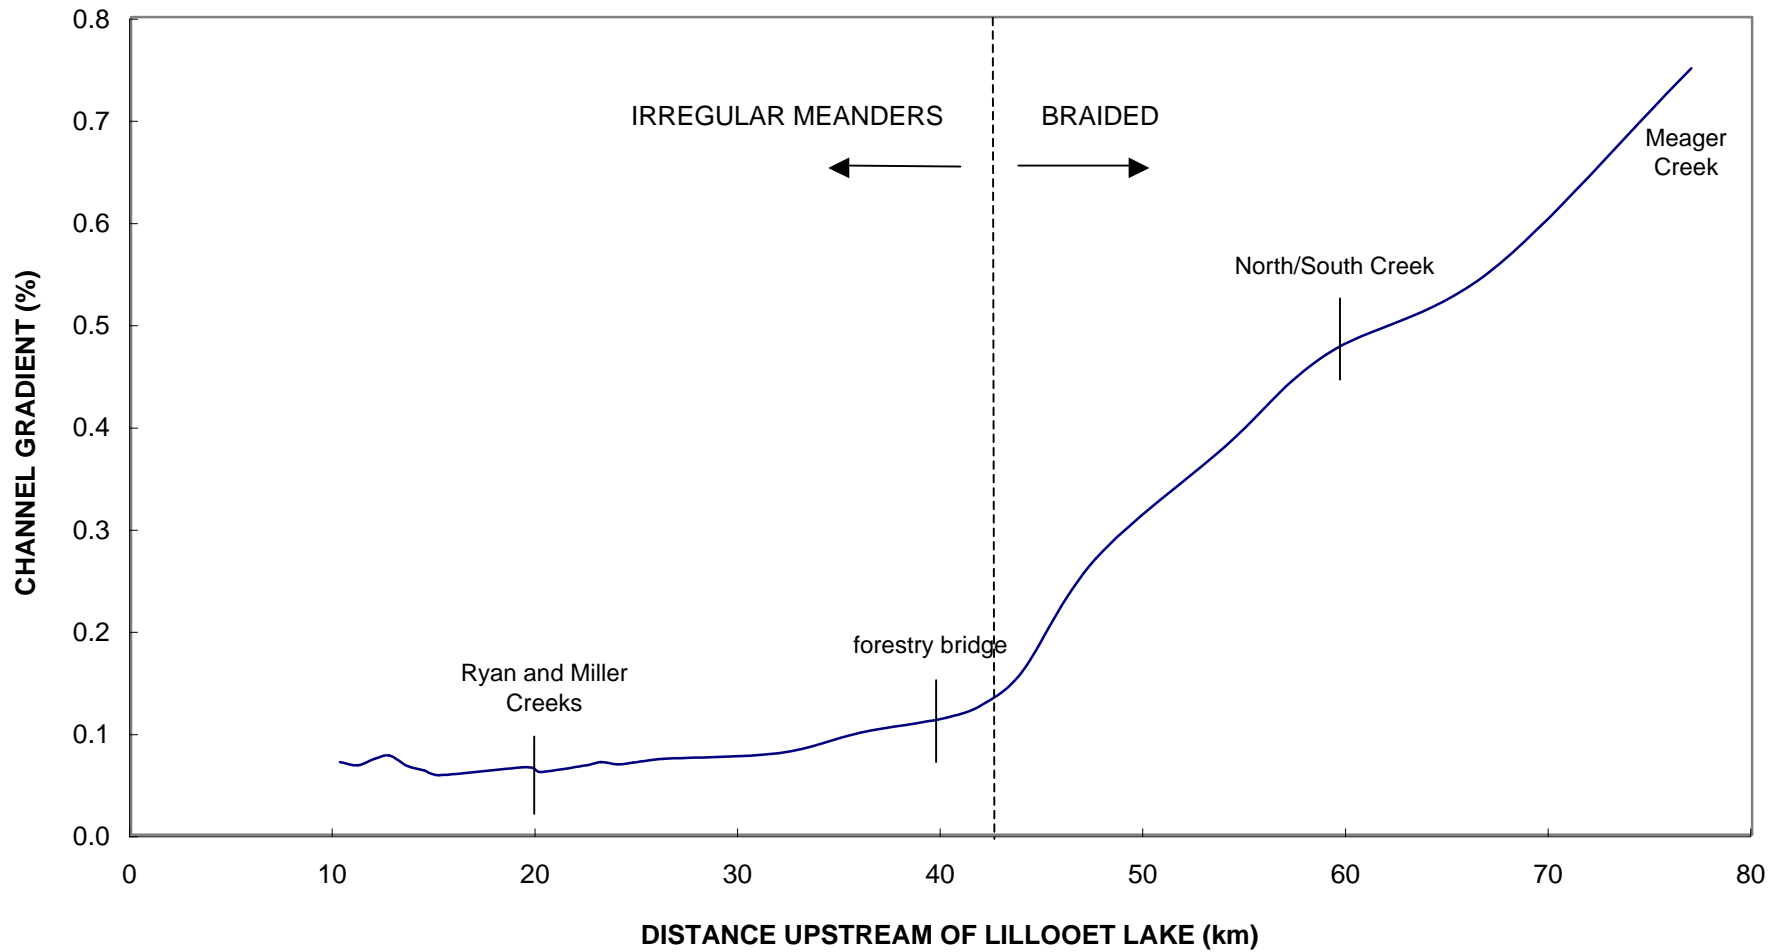
Figure 5-1

Profile of Lillooet River Between Meager Creek Confluence and Lillooet Lake

All of these criteria appear to be met in the upper, braided reach of the Lillooet River, resulting in its characteristic planform. As with Squamish River, the transition to a braided morphology occurs at channel gradients in excess of 0.0013 m/m (Figure 5-1). Below this transition, the channel gradient decreases from about 0.0011 m/m at the forestry bridge to 0.00055 m/m at the delta.

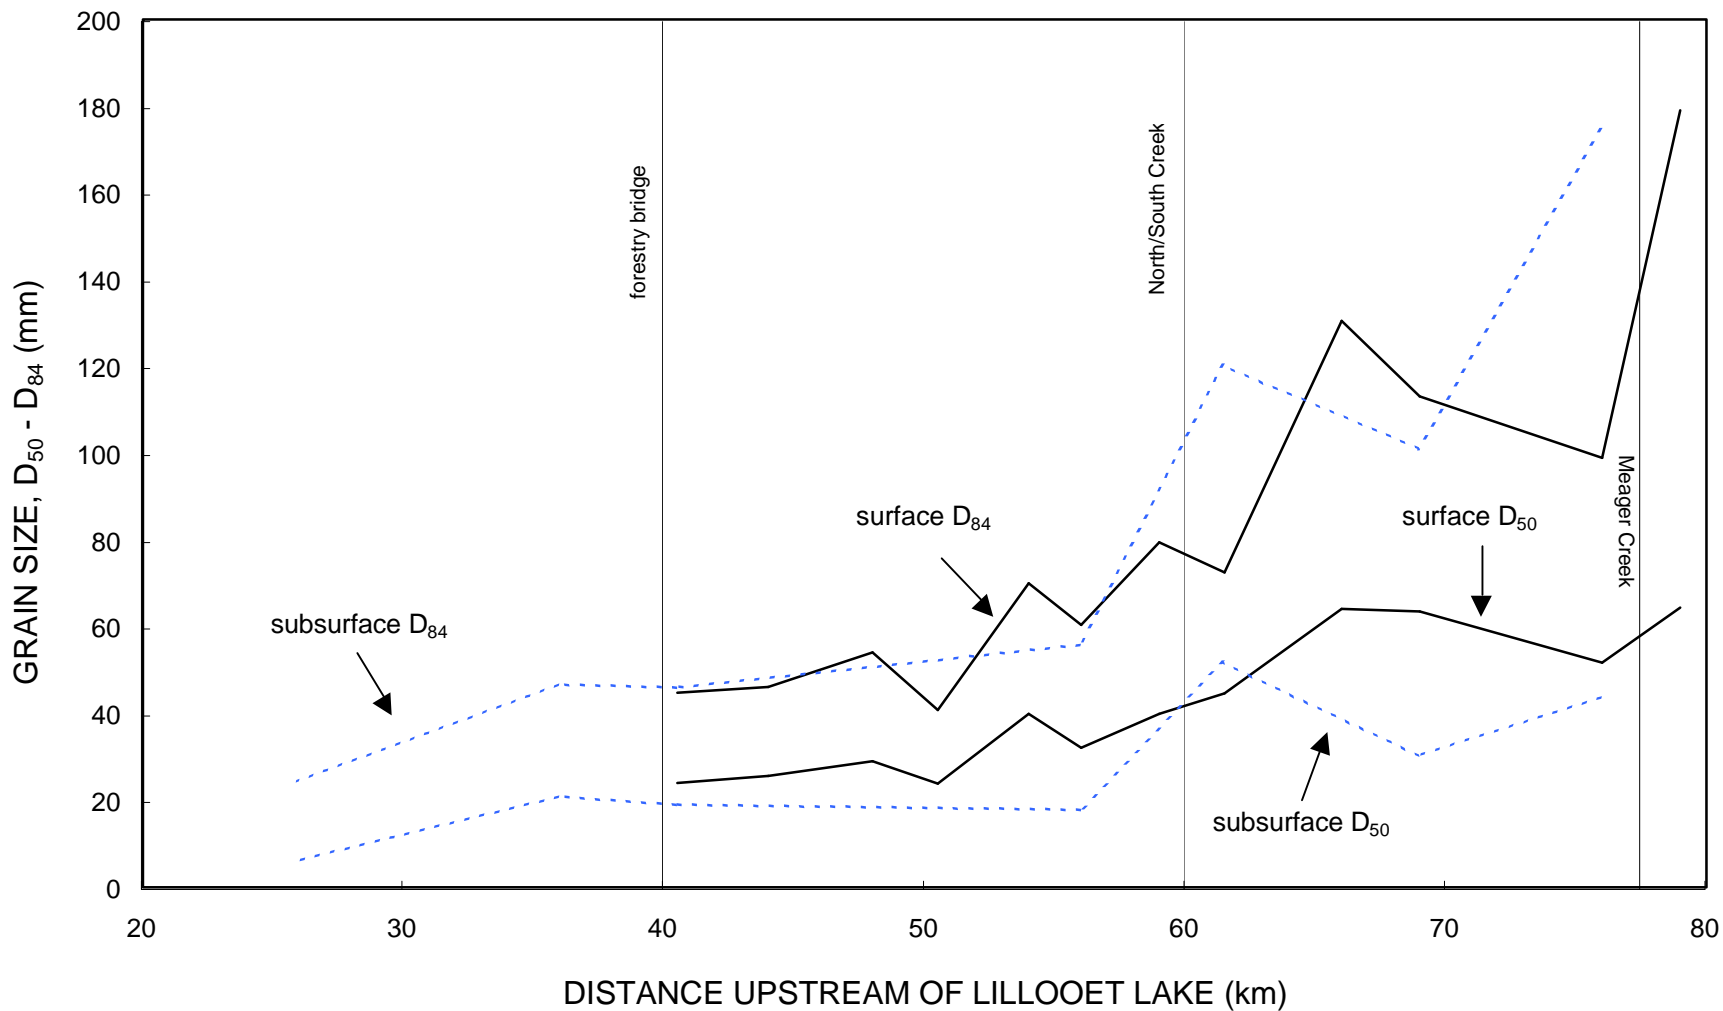
Figure 5-4

Downstream of the forestry bridge, bulk sampling indicates an average grain diameter smaller than 20 mm. Although relatively fine, this grain size is sufficiently coarse to accumulate along the channel bed and not be transported through to the lake. Approximately 25 to 30% of the subsurface material is sand-sized below the forestry bridge with percentages decreasing in an upstream direction (Figure 5-5). Measures of sediment texture are important for both potential instream channel work and for future

Downstream Variation in Surface and Subsurface Grain Size - Lillooet River

studies that may wish to monitor a potential downstream increase in grain sizes (i.e. because the channel gradient has been steepened, gravel may be moving further downstream).

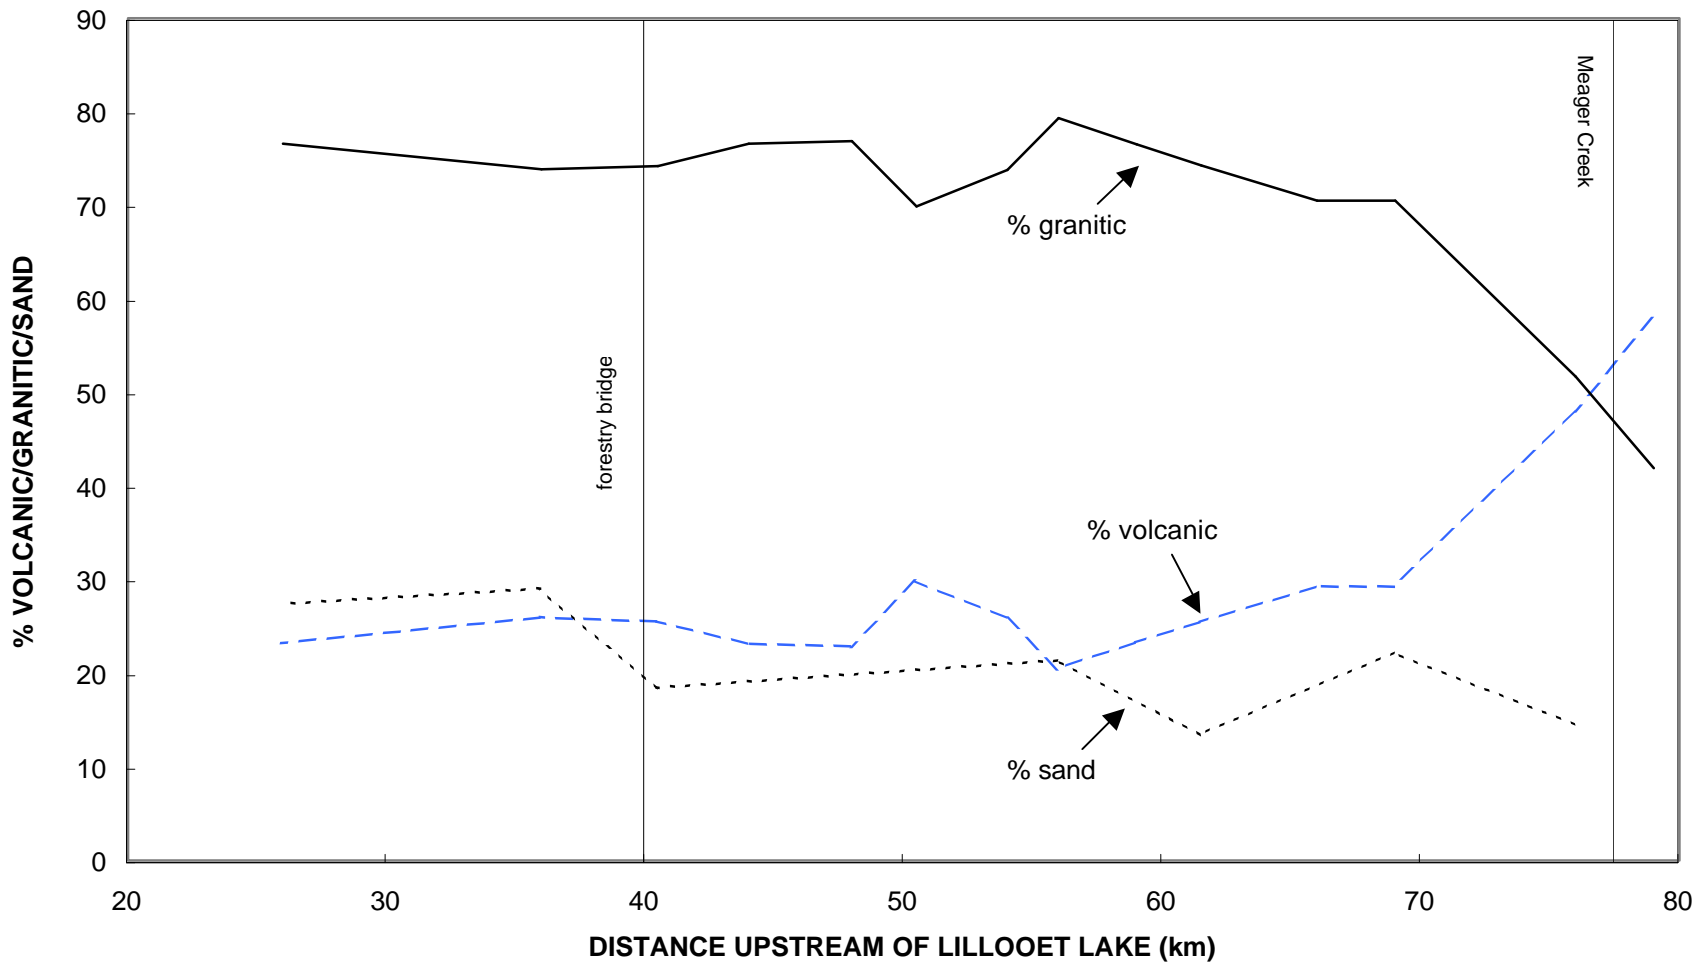
Figure 5-5

Downstream Variation in Sand, Volcanic and Granitic Percentages - Lillooet River

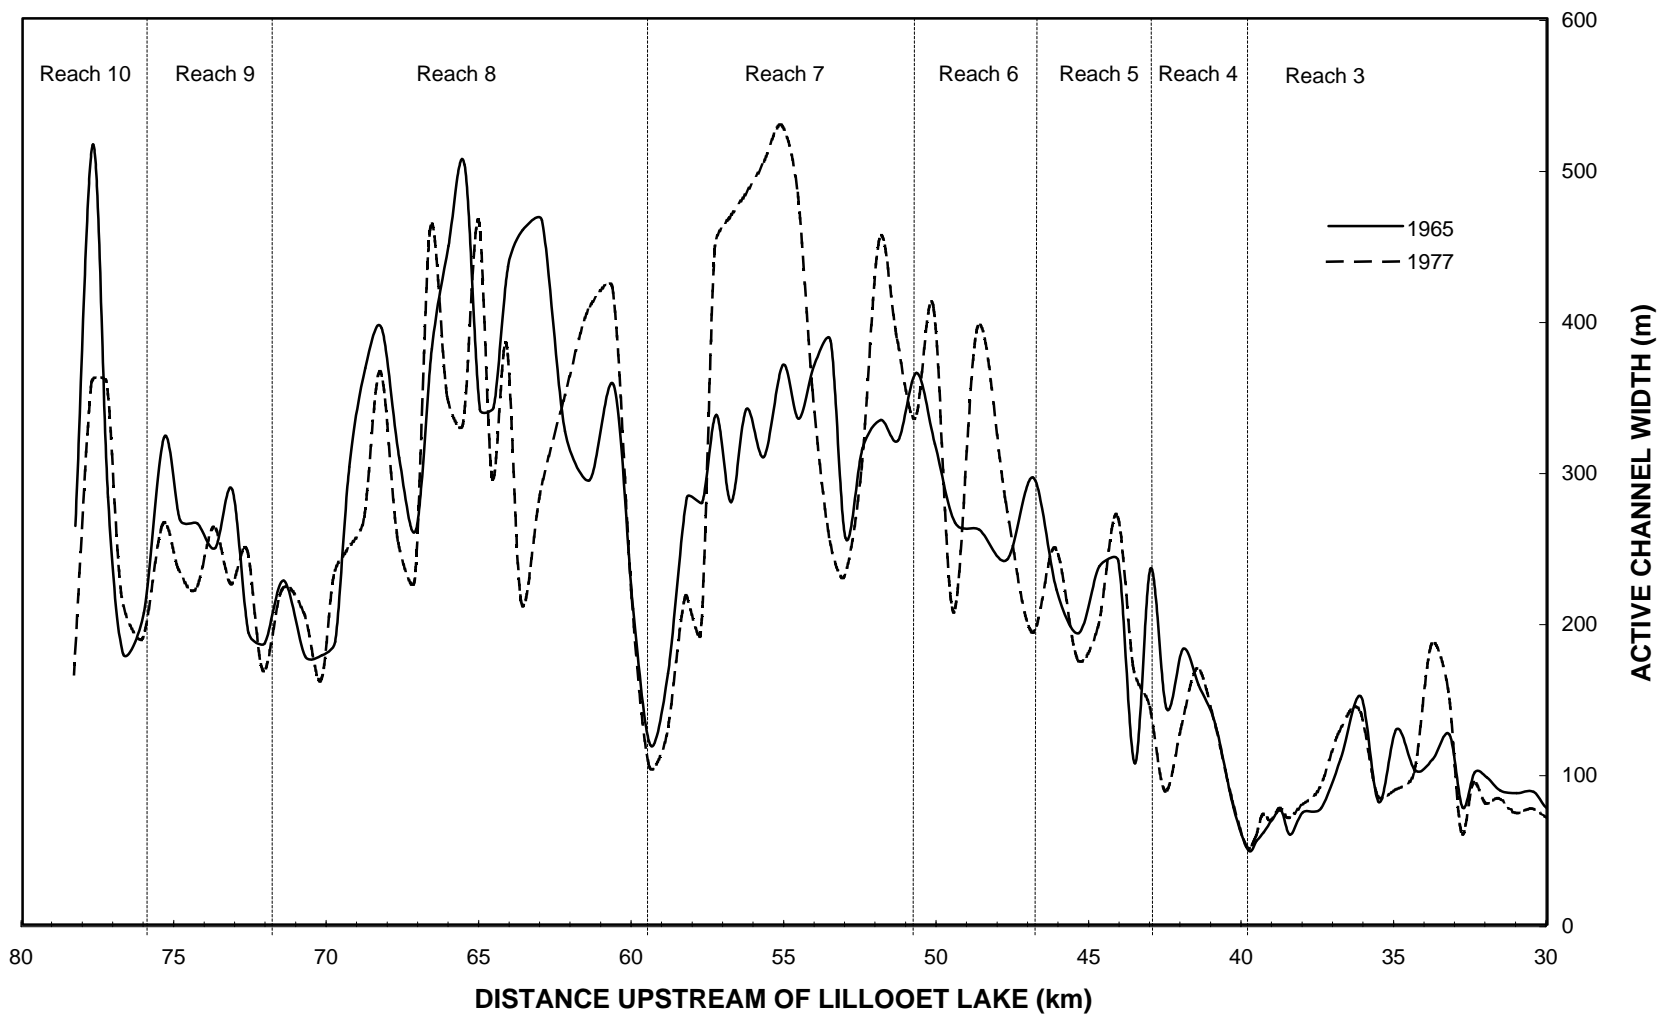
Figure 5-7

Changes in Active Channel Width 1965 to 1977

Figures 5-6 through 5-9 illustrate changes in active channel width downstream of the Meager Creek confluence for various time periods: 1947-1965, 1965-1977, 1977-1988, and 1988-1994. An obvious trend toward a narrower channel is apparent downstream of 43 km between 1947 and 1965. This represents the effects of channel straightening during the late 1940's and is discussed in more detail in the following section. For the other reaches and time periods, fluctuations in active channel width appear to be random at first glance. Table 5-3 summarizes changes in active channel width as reach-averaged values.

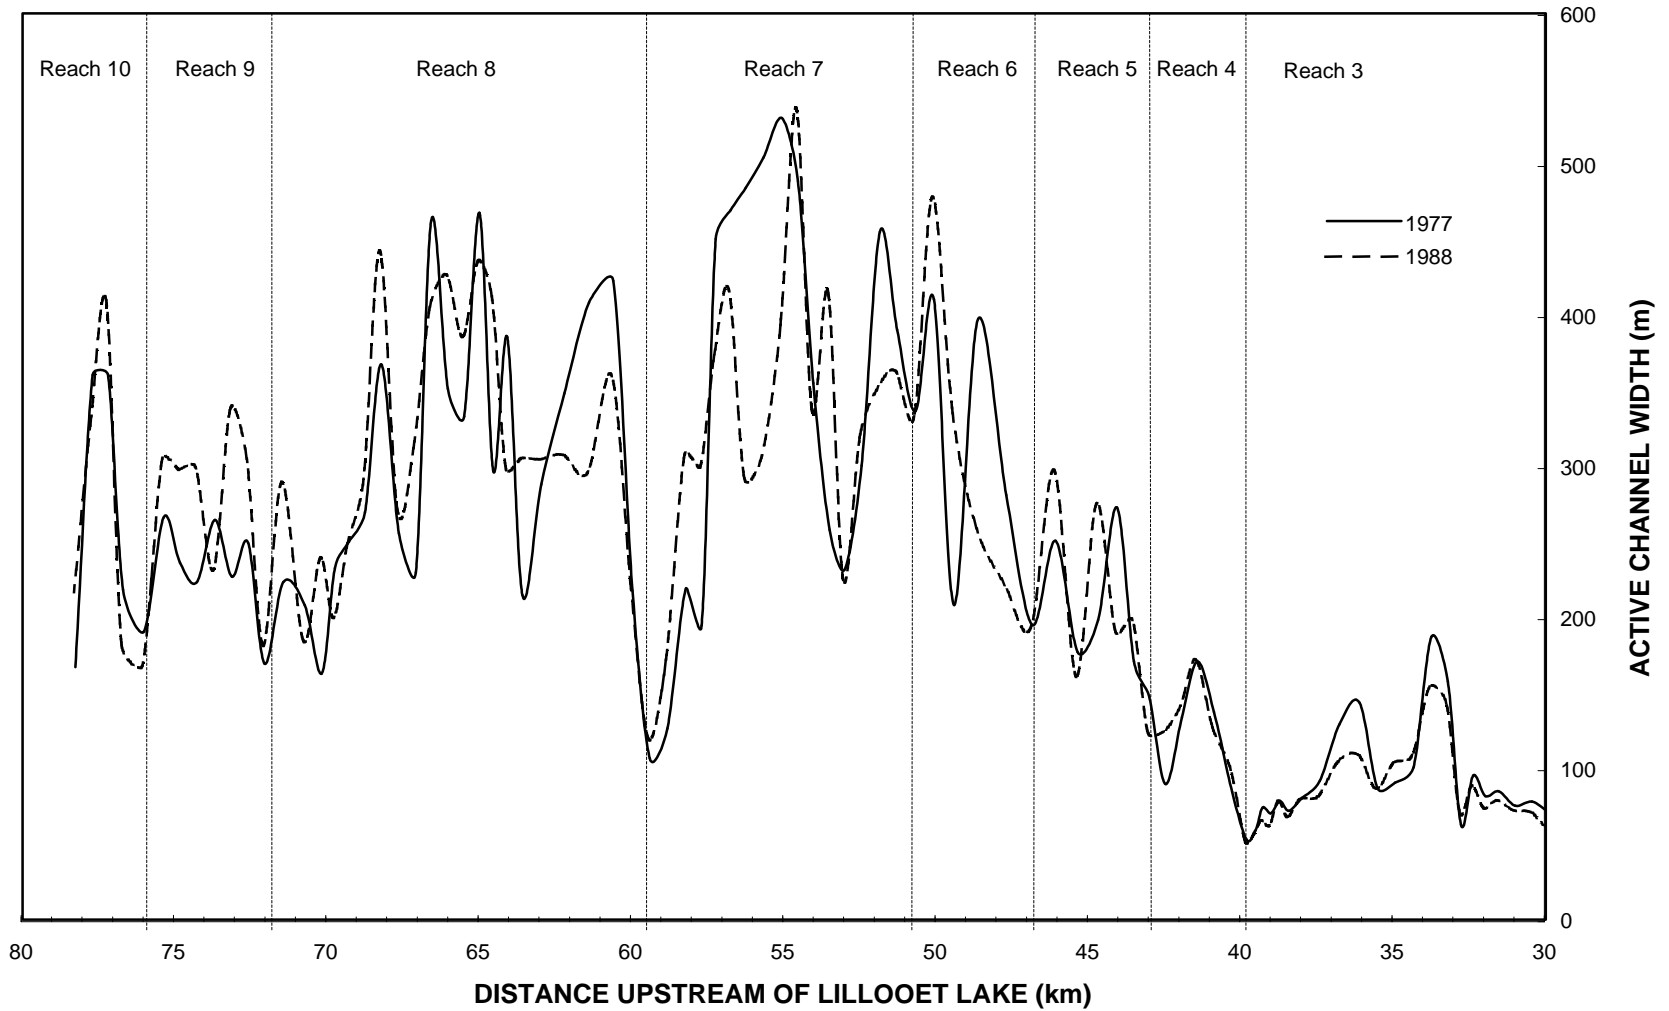
Figure 5-8

Changes in Active Channel Width 1977 to 1988

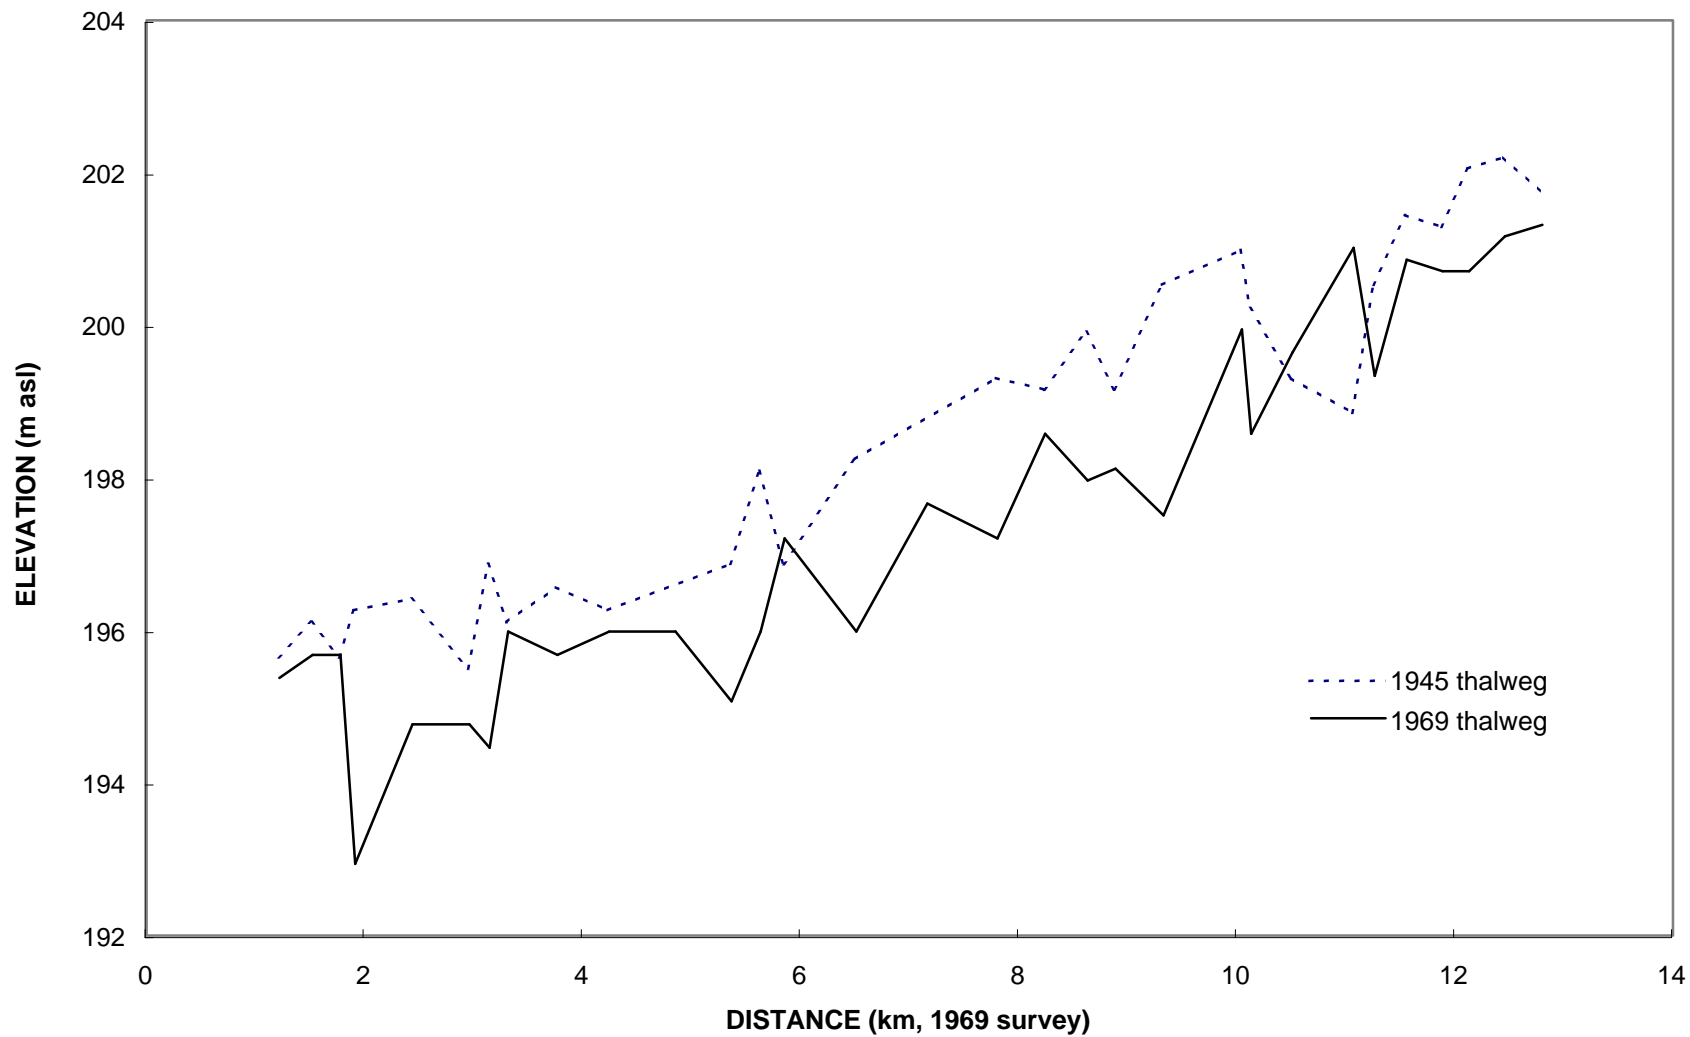
Figure 5-11

Lillooet River Profile - 1945 vs 1969

The flood benefits of lowering the lake level by 2.5 m were short-lived however. Wester (1970), in an internal Water Management Branch memorandum, noted that the delta had extended some 600 m since the lowering of the lake in 1946. Because of this extension, the water surface slope decreased and up to 2.5 m of sediment re-deposited in a reach of the lower river. As shown on Figure 5-11, there is little degradation between 3 km and 5 km and near the delta. It was concluded that any further dredging of the lower river would only have very short term benefits, and rapid degradation would renew the cycle of aggradation and channel surface slope reduction.

This is not a surprising result when once considers that upstream gravel deposition exerts a considerable influence on downstream deposition patterns in the sand reach. The downstream extent of gravel deposition currently occurs in the general vicinity of the Green River confluence (8 km). Downstream of this point the channel slope is insufficient to transport significant quantities of gravel. When the lake level was lowered by 2.5 m, rapid degradation of the sand bed occurred upstream of the lake due to local steepening of the slope. Over time the abrupt break in slope migrated upstream, flattening along the way (the rate of degradation reaches a peak relatively quickly but then declines slowly over time and also decreases with distance from the outlet). In the case of Lillooet River, the headward degradation would have eventually encountered the more resistant gravel deposits. Because the gravel deposits were near their downstream threshold of transport, the local increase in slope would have been insufficient to induce significant degradation (unlike sand the eroded gravel could not be flushed into the lake).

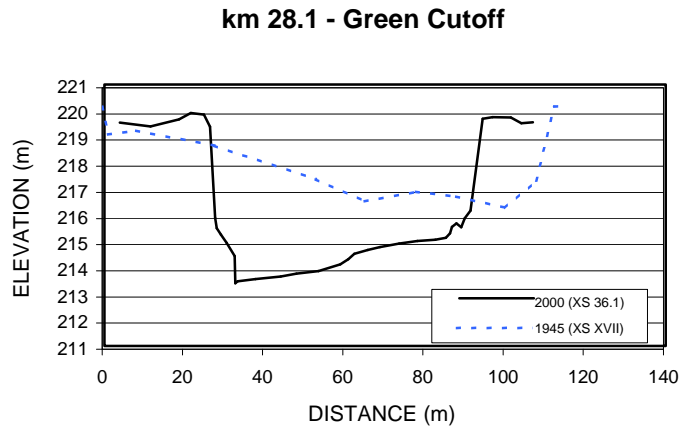
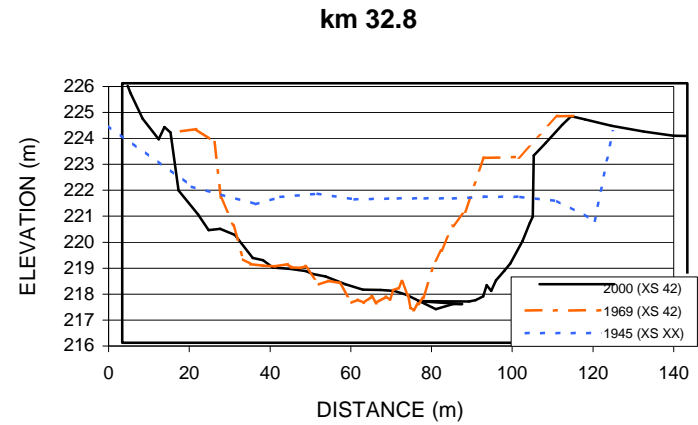
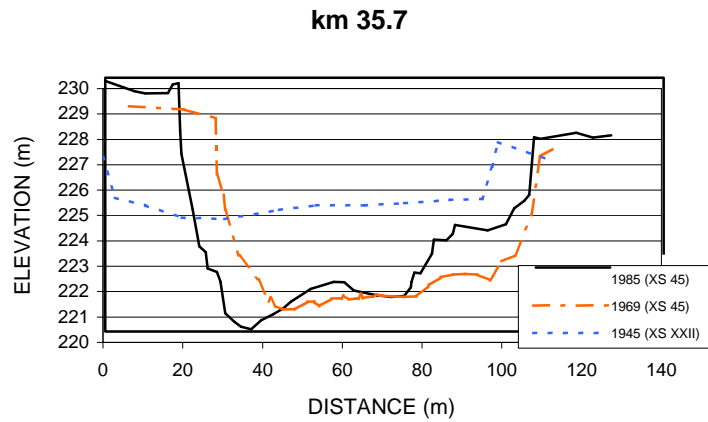
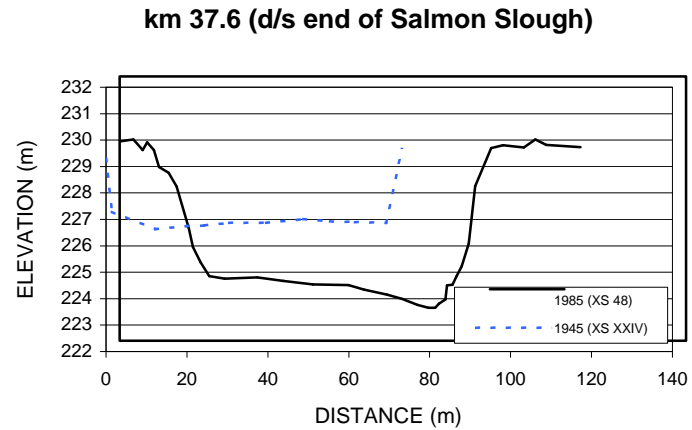
Figure 5-12 compares selected 1945 cross sections with more recent surveys at four locations between MacKenzie Cut (km 20) and the downstream end of Salmon Slough (km 38). At each of these locations, the 1945 data is compared to survey data from either 1969, 1985, 2000 or a combination of these three dates. [Survey data from 2000 is limited for upper reaches and as such is not available for all four plots.] The attached

Upstream Response of Lillooet River to Meander Cutoffs

figure clearly shows that 3 to 4 m of degradation has occurred as a result of the channel straightening. A majority of the degradation would have occurred rapidly as indicated by the 1969 data in two of the plots.

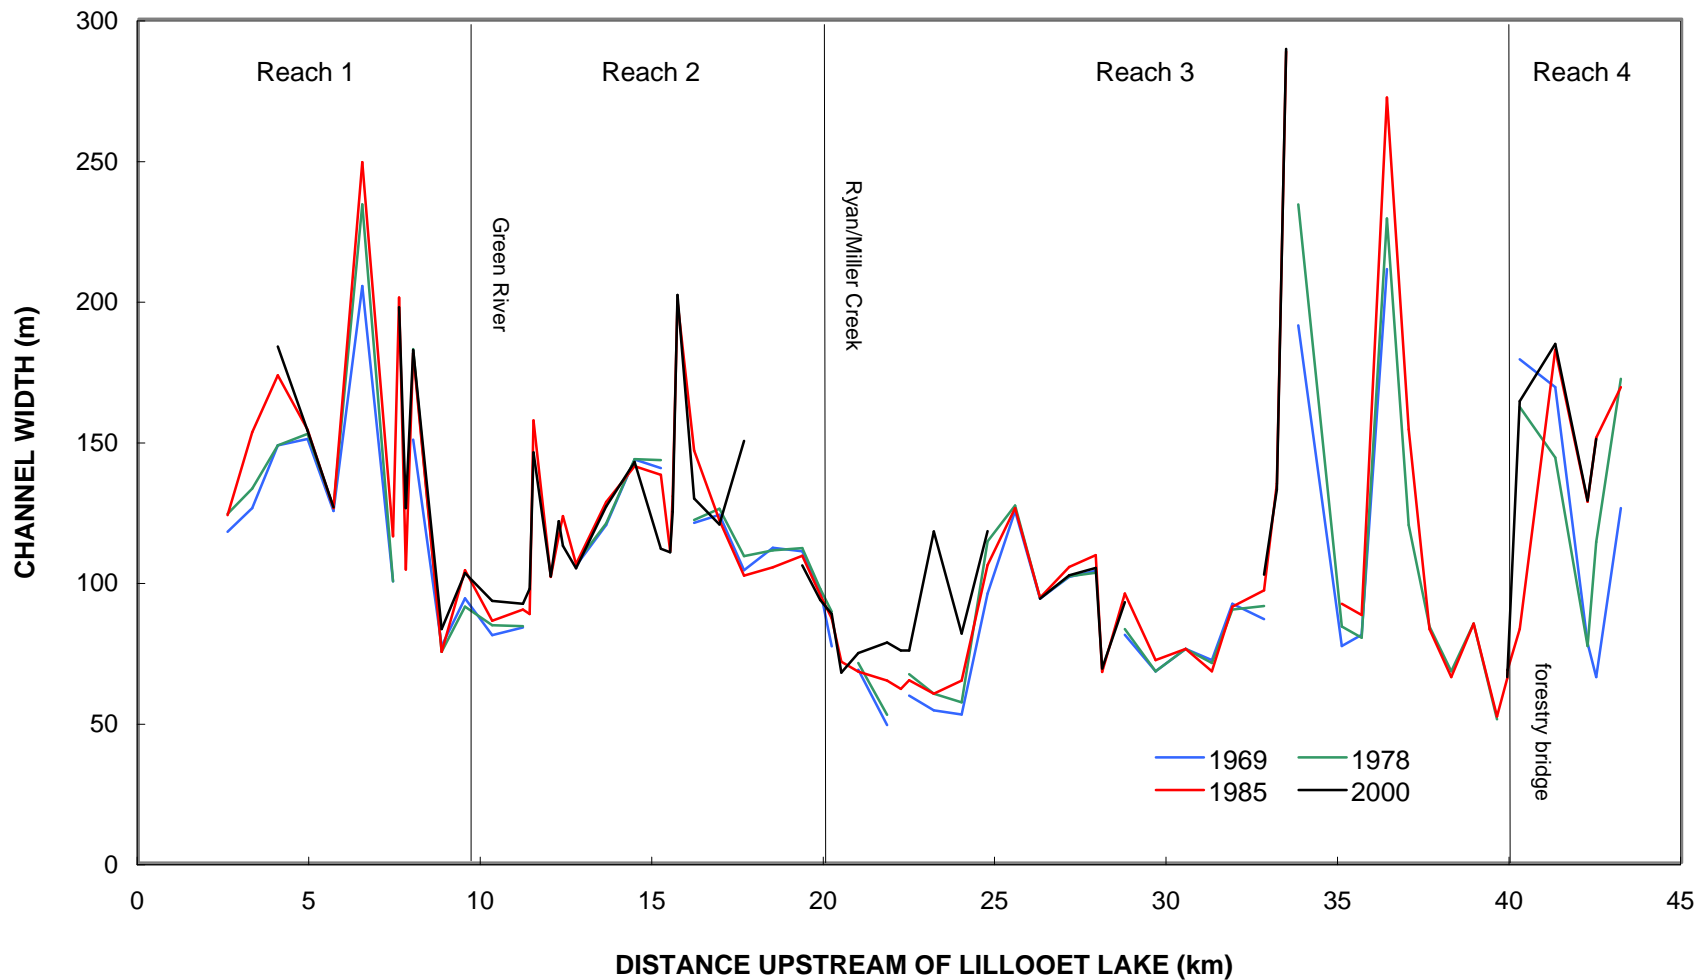
Figure 5-15

Cross-Sectional Changes in Channel Width Along Lower Reaches of Lillooet River - 1969 to 2000

It is also possible that some of the observed degradation between km 12 and 20 is a result of undocumented gravel removals. This is particularly true prior to 1980 when gravel removals were not systematically recorded.
