Lillooet River Channel Monitoring Program – 2021 Monitoring Report Pemberton, BC

January 26, 2022
Final Report, Rev. 0

Pemberton Valley Dyking District

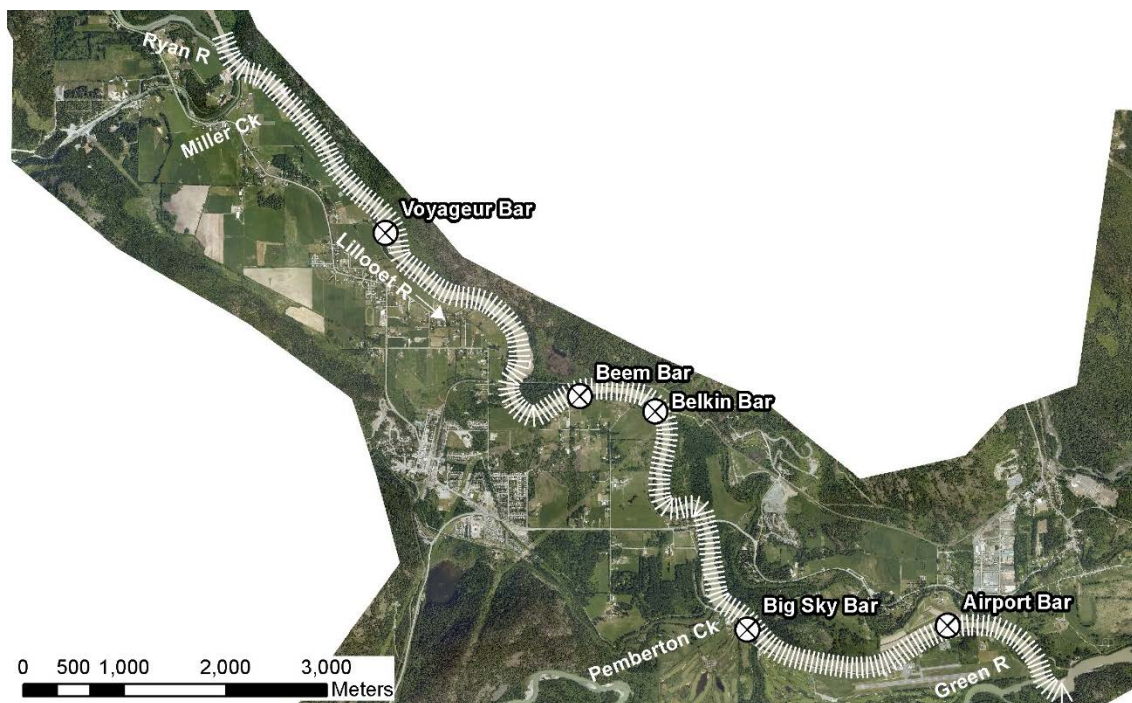
Figure 1.3 Lillooet River 50 metre transect spacing between the Ryan River and Green River confluences. Sediment removal sites and 2009 orthophoto background are shown for reference.

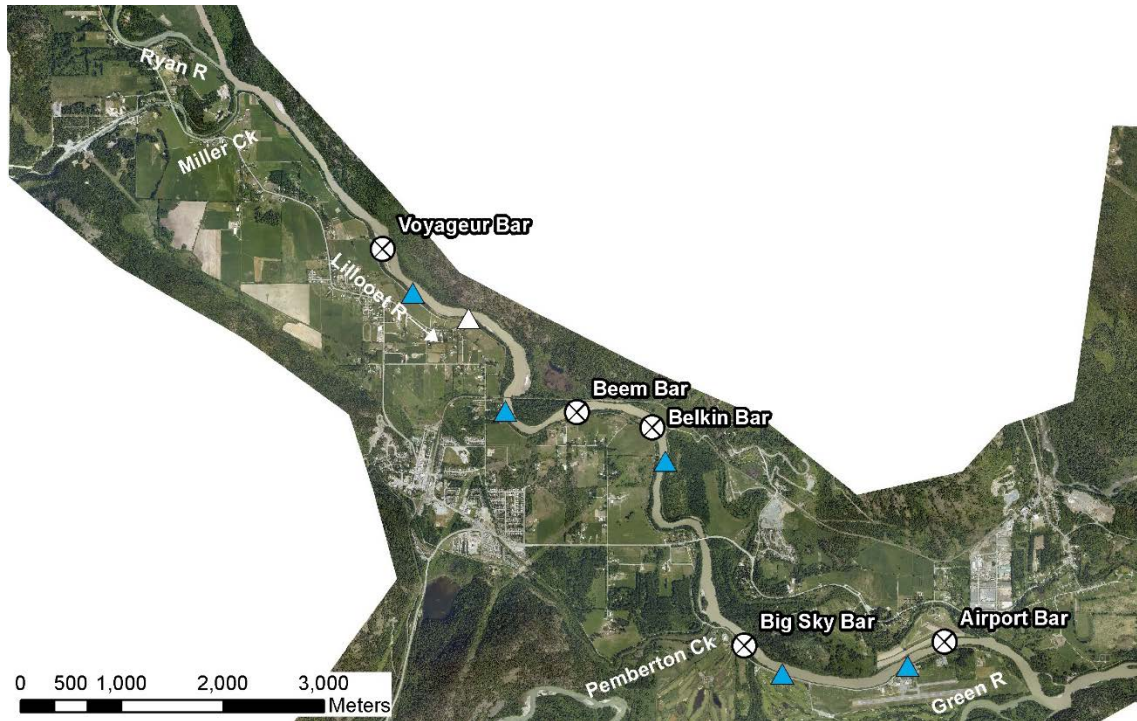
Figure 1.5 Location of water level logger monitoring sites between the Miller Creek and Green River confluences (blue triangles). The Water Survey of Canada gauge 08MG005 (white triangle), sediment removal sites (labelled white circles), and 2009 orthophoto background are shown for reference.

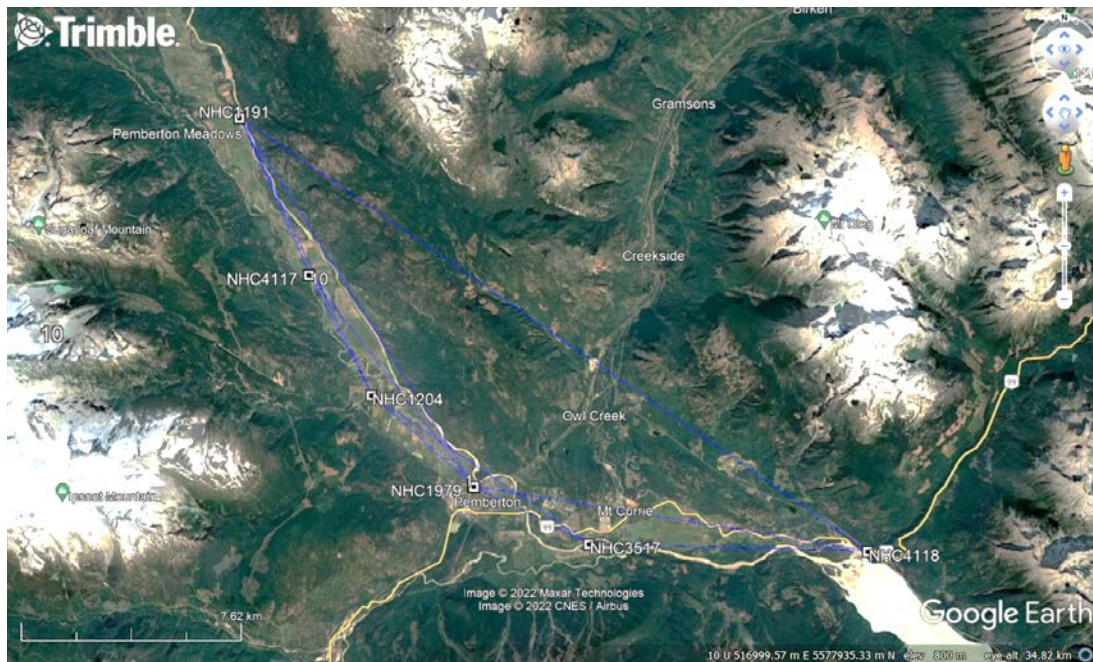
Figure 2.1 2021 Pemberton Valley control network.

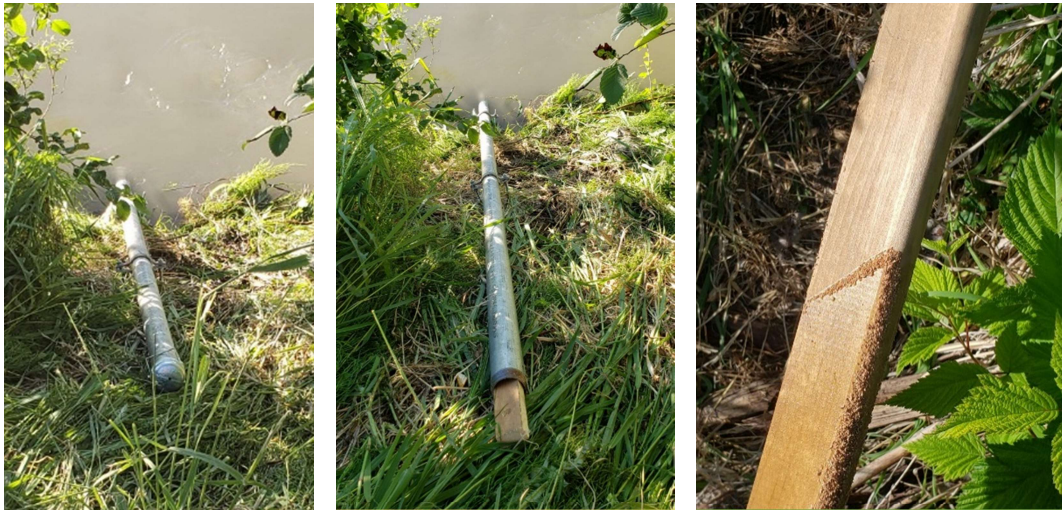
Crest stage gauges are 15' (4.5 m) long galvanized steel pipes with perforated caps at both ends and a wood staff inside the entire length of pipe (**Photo 2.2**). They are fastened to the bank similarly to the levellogger pipes. Granulated cork is sprinkled into the bottom of the crest stage gauge pipe during site inspections. The cork rises within the pipe as water levels rise and adheres to the wood staff as water levels fall, leaving a distinct line at the maximum water level reached since the last inspection. Station data are summarized in a series of station data sheets presented in **Appendix A**.

Photo 2.2 From left to right: Installed crest stage gauge; crest stage gauge with inner wood staff extending out; high water mark on wood staff left by cork.

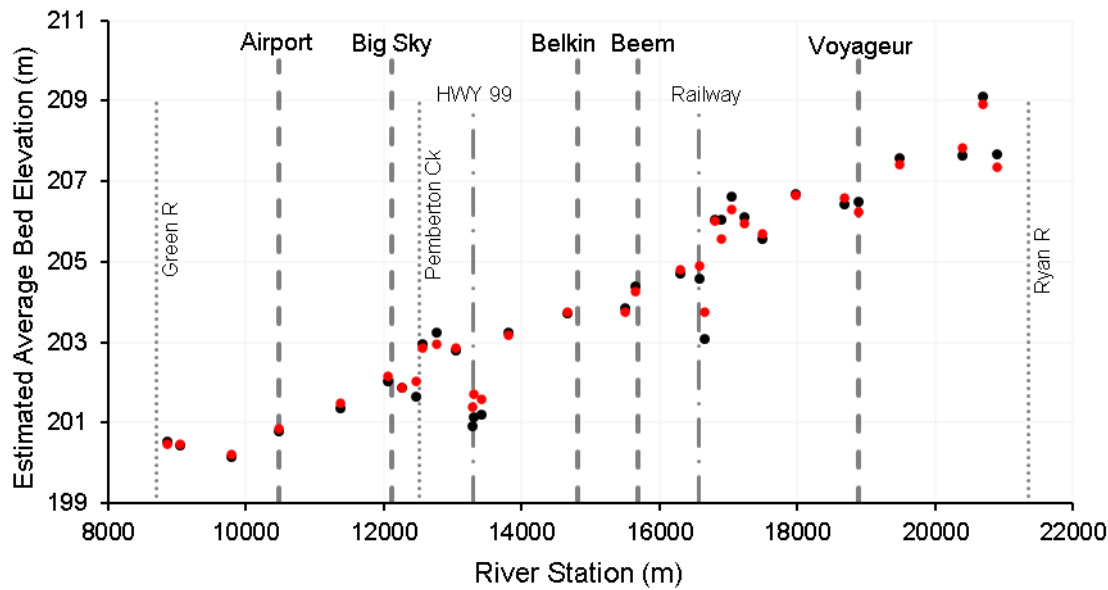
Downstream of the Pemberton Creek confluence, average bed elevation changes range between -0.09 to 0.01 m, representing a predominant pattern of degradation within this sub-reach. For context, **Figure 4.2** presents a longitudinal profile plot of 2011, 2017 and 2021 survey data between Airport Bar and the Green River confluence. This plot illustrates that the surveyed 2021 channel bed level remains substantially higher than the 2011 channel bed condition, despite observed channel lowering since 2017.

Figure 4.1 2017 (red dots) and 2021 (black dots) estimated average channel bed elevation at the historical monitoring sections on the Lillooet River Lower Reach, between Ryan River and Green River confluences.

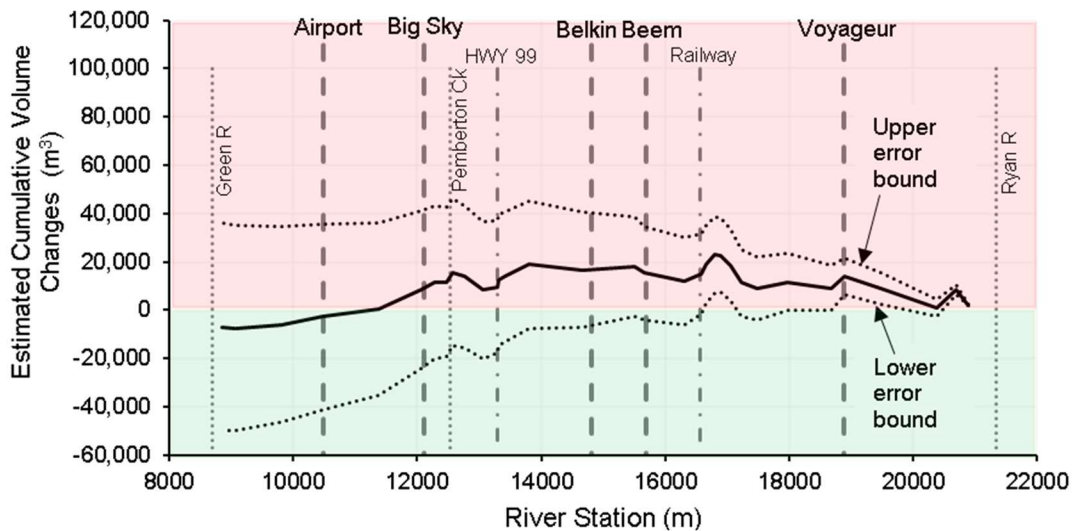
Figure 4.4 2017 to 2021 estimated cumulative volume of observed channel bed infilling (positive values) and scour (negative values), excluding sediment volumes that have been removed over the monitoring period. Upper and error bound estimates are shown for context.

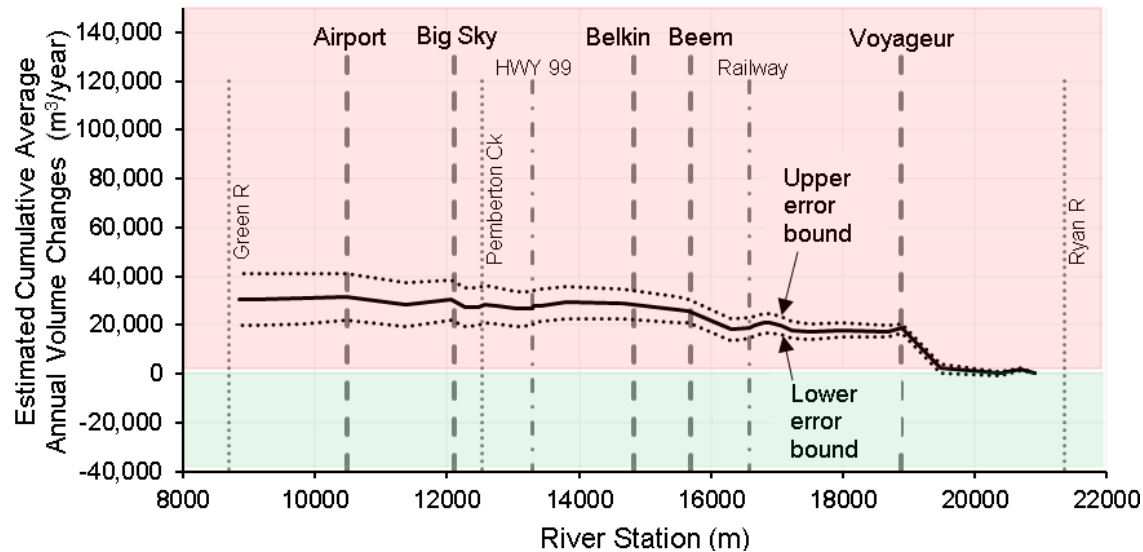
Figure 4.5 presents the theoretical average annual estimated cumulative volume of channel bed infilling that could have occurred had no sediment been removed, including upper and lower error bound. Data from this plot has been used to estimate the annual average channel aggradation rate.

Figure 4.5 Estimated theoretical annual average cumulative channel bed infilling (positive values) and scour (negative values) rates between 2017 and 2021, had no sediment removals occurred. Upper and error bound estimates are shown for context.

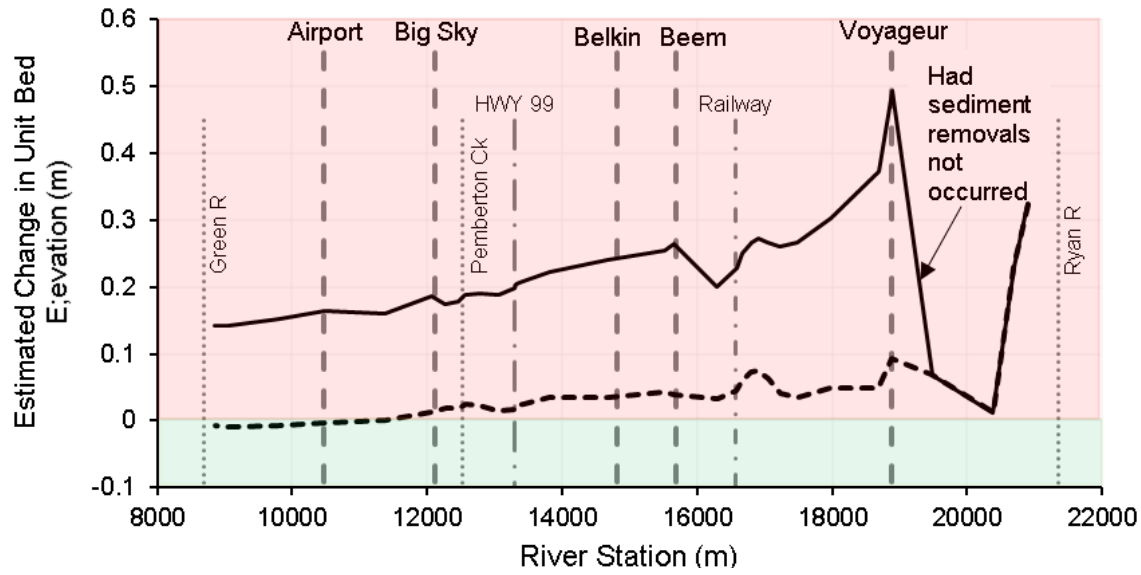
Figure 4.6 presents the estimated change in unit bed elevation between 2017 and 2021 for two conditions: one representing observed channel infilling and one representing a theoretical infilling assuming no sediment removals had occurred over the monitoring period. Unit bed elevation changes are a representative value of the channel infilling that could occur assuming aggradation occurred uniformly over the area being represented (i.e., for this study the channel is comprised of a series of ‘units,’ each represented by one of the monitoring sections). For a given volumetric change at a monitoring section, larger unit bed elevation changes would occur at narrower channel locations. This metric provides useful context to illustrate the potential responsiveness of the channel bed to sediment volume accumulations. The plotted line that shows the condition ‘had sediment removals not occurred’ is a theoretical representation of the total potential that the channel bed could have infilled since 2017. Over the monitoring period, the unit channel bed within the study reach theoretically could have aggraded by an average of 0.2 and as much as 0.5 m, had no sediment removals occurred during the course of the monitoring period. The plot shows the apparent influences of the sediment removals increase farther upstream, reaching a theoretical maximum at Voyageur Bar.

Figure 4.6 Estimated change in unit bed elevation between 2017 and 2020. Upper and error bound estimates are shown for context.

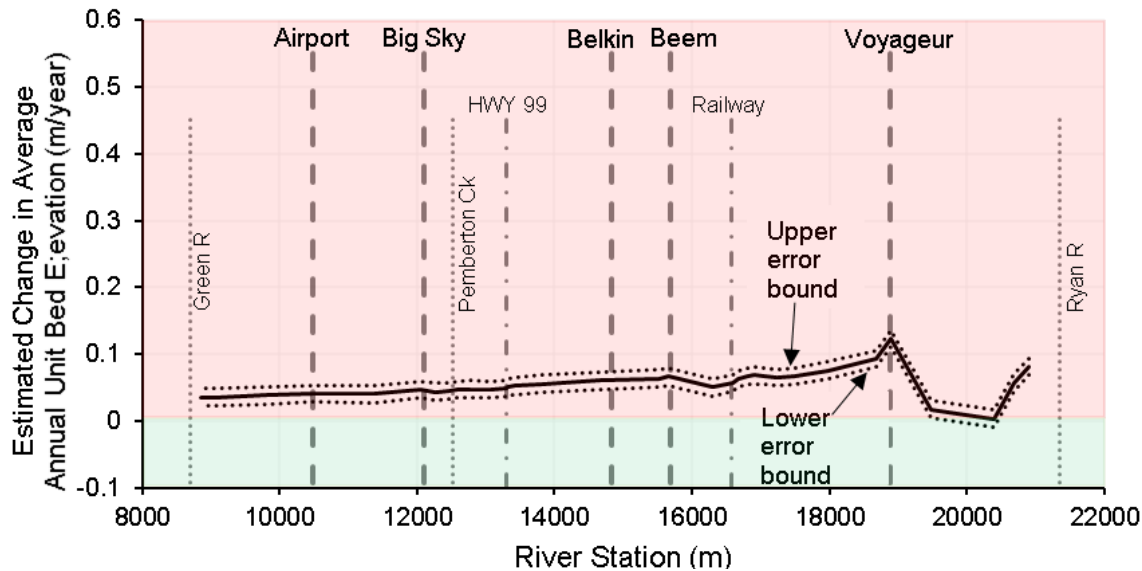
Figure 4.7 presents the estimated average annual change in unit bed elevation between 2017 and 2021, had sediment removals not occurred, including the upper and lower error bound estimates for context. This plot represents the same data that is presented in the previous plot, with the data averaged over the monitoring period. The plot provides context on theoretical annual bed infilling rates.

Figure 4.7 Estimated average annual rate of change in unit bed elevation between 2017 and 2020 had sediment removals not occurred. Upper and error bound estimates are shown for context.

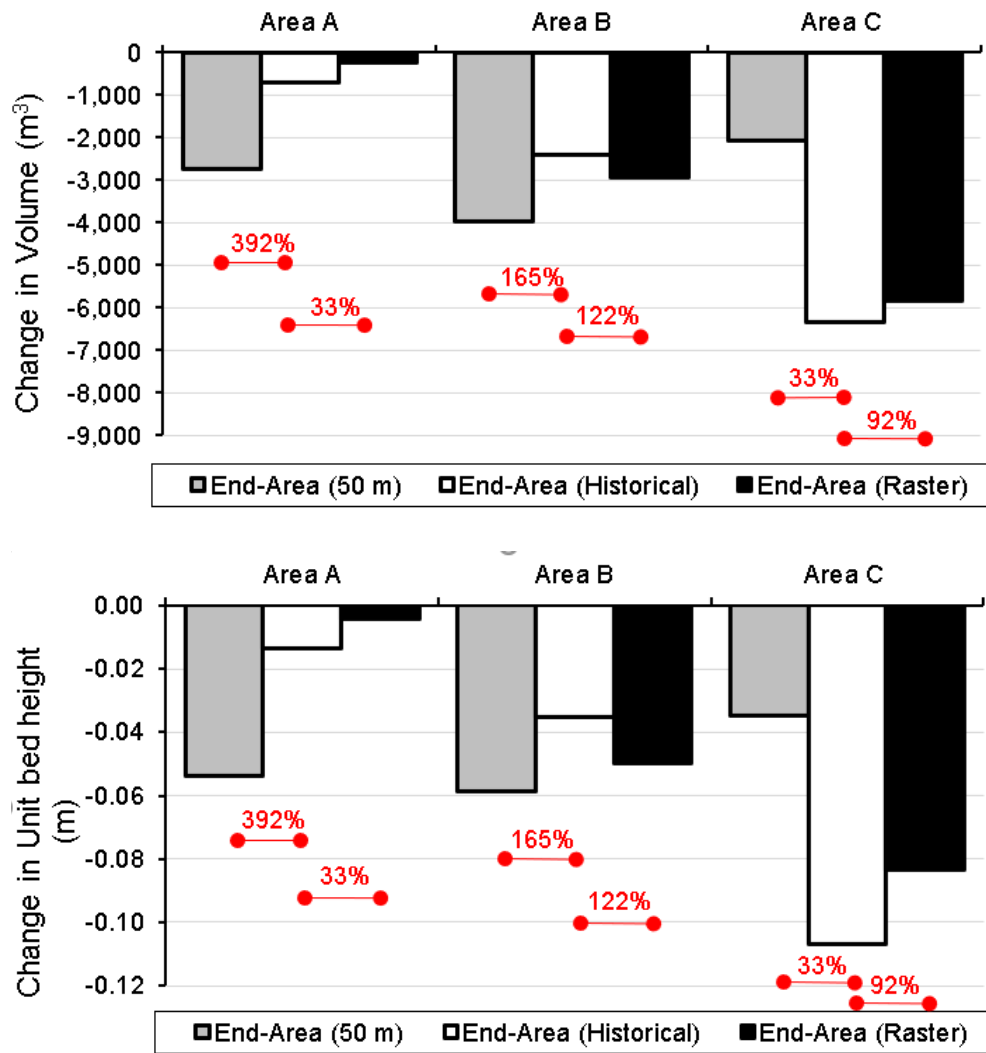
Figure 4.8 2017 to 2021 comparisons of changes in channel bed volume and unit bed height for three analytical approaches.

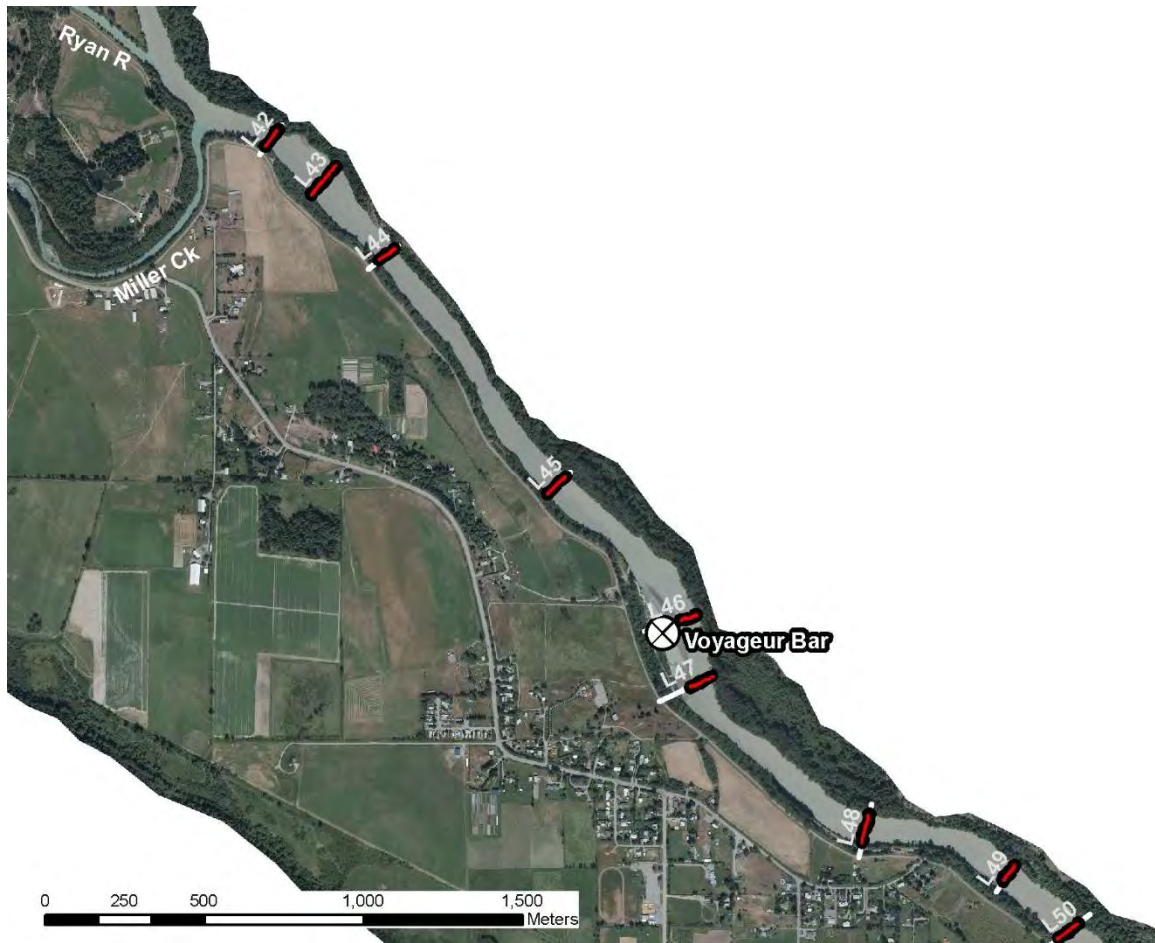
Figure 1 Lillooet River Lower Reach Historical Monitoring Section L42 to L50. 2016 EMBC orthophoto for reference. 2021 data shown as black dots and 2017 data shown as smaller red dots. Flow direction is from top to bottom.
