# Large Woody Debris Assessment and Mitigation Plan

Final Report  
June 2011

KWL File No. 713.054

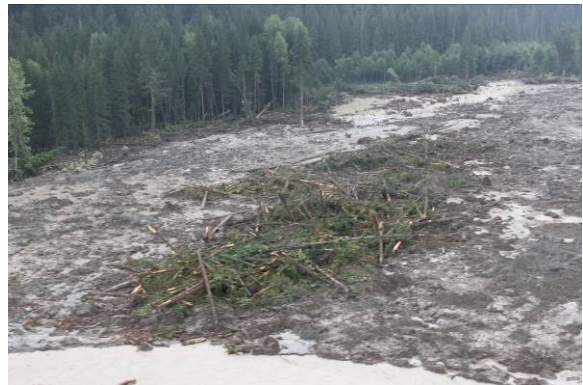
**Photo E-4**  
**Landslide LWD**

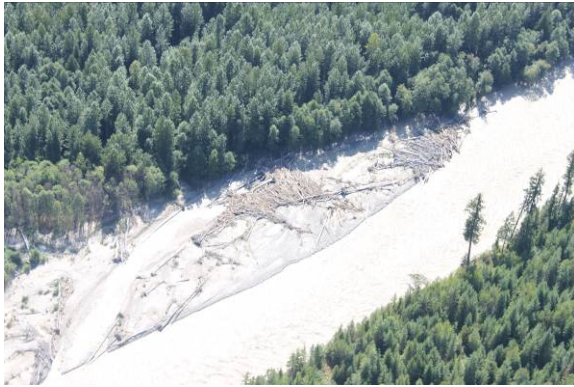
**Photo E-7**  
**Braided Reach Upstream of the Forestry Bridge (August 13, 2010) Shows New and Older Raked Material**

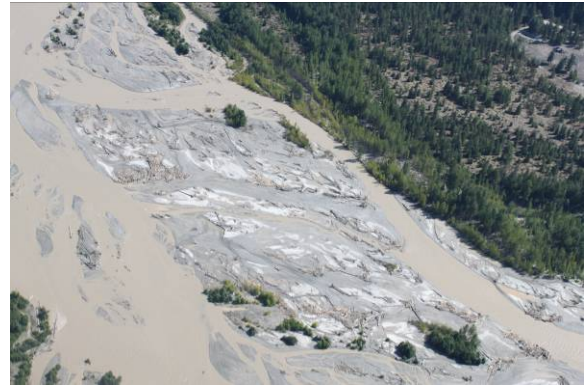
**Photo E-8**  
**Braided Reach Upstream of the Forestry Bridge (August 13, 2010)**

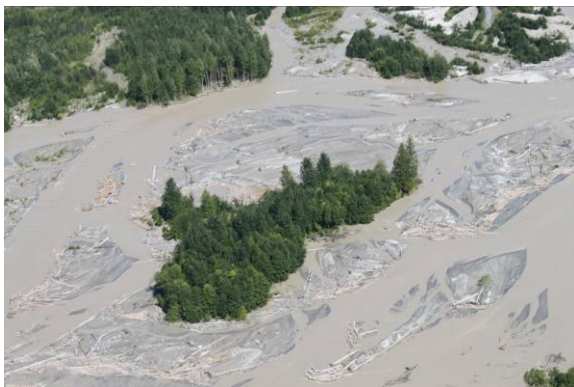
**Photo E-11**  
**Braided Reach Upstream of the Forestry Bridge (August 13, 2010) Shows New and Older Raked Material**

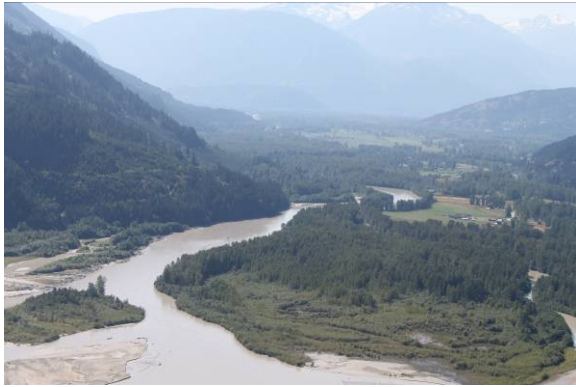
**Photo E-13**  
**View Upstream from the Delta (August 13, 2010)**

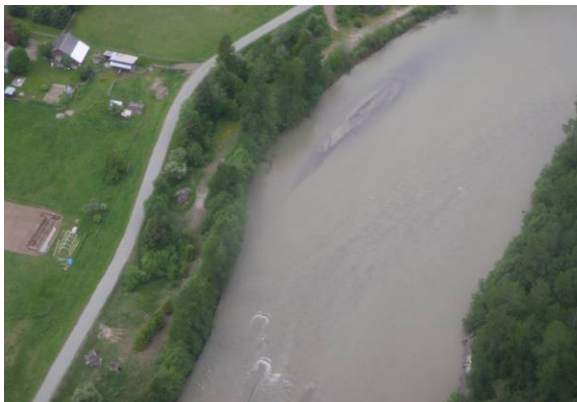
**Photo F-5**  
**Single Log LWD in Dyked Reach**

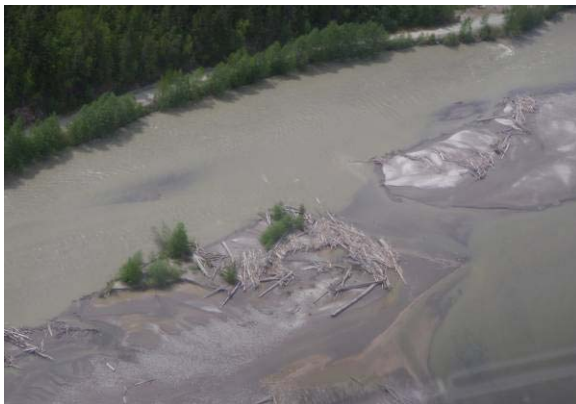
**Photo F-9**  
Log Jam Upstream of Forestry Bridge  
Showing Evidence of Newer Racked Wood

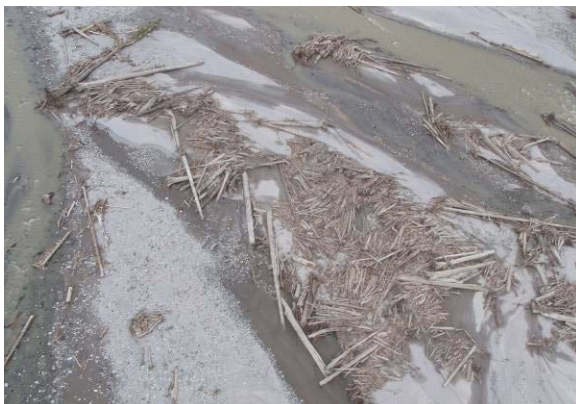
**Photo F-11**  
Much of the Wood Material Appears to Have  
Shattered into Smaller Pieces During the  
Landslide Event (1)
