PEMBERTON VALLEY FLOOD MITIGATION PLANNING

FINAL REPORT

5 June 2020

NHC Ref. No. 3004610

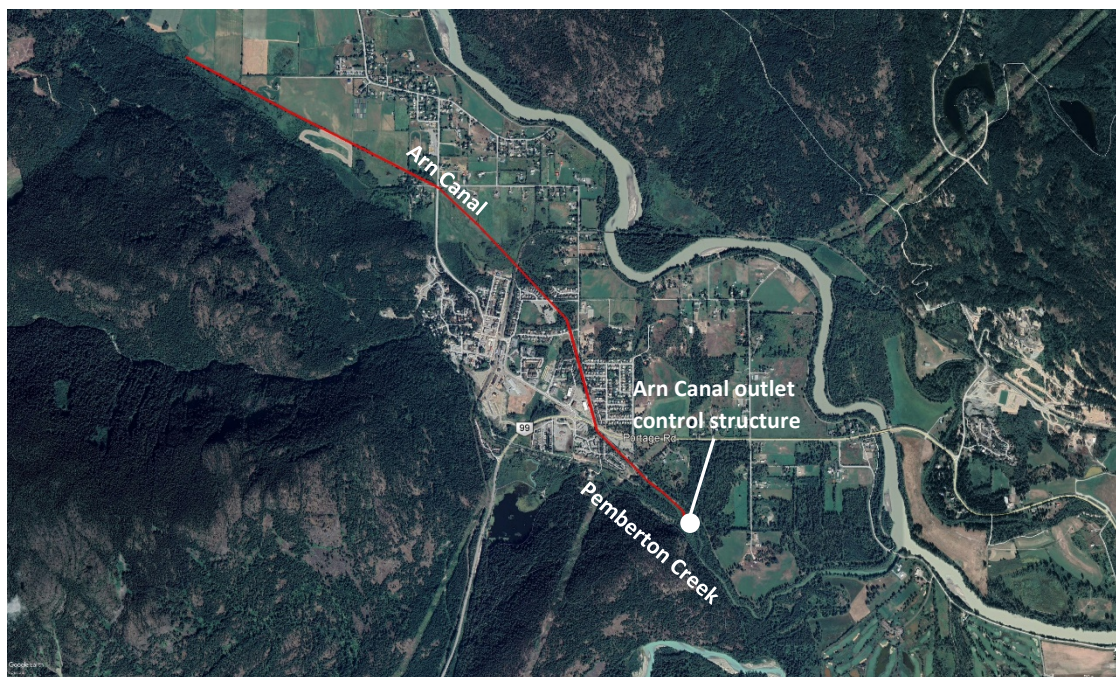
Figure 3. Arn Canal Approximate Alignment

The Arn Canal (**Figure 3**) is a man-made drainage channel that collects runoff from agricultural and developed areas inside the Pemberton Creek and Lillooet River dikes (KWL 2009). The canal is important for conveying internal drainage flows during high precipitation events and discharging these flows through the floodbox culverts at the Pemberton Creek dike into the lower end of Pemberton Creek, in a location backwatered by the Lillooet River during higher flows.

According to observations by PVDD, at Lillooet River flows of about 500 m³/s, the flap-gates at the Arn Canal outlet close to prevent Lillooet River backflow, in turn causing drainage flows to pond and flood adjacent areas, including nearby development. PVDD has identified a need to increase the floodbox capacity and explore pumping options for when Lillooet River water levels are too high to allow gravity flow.

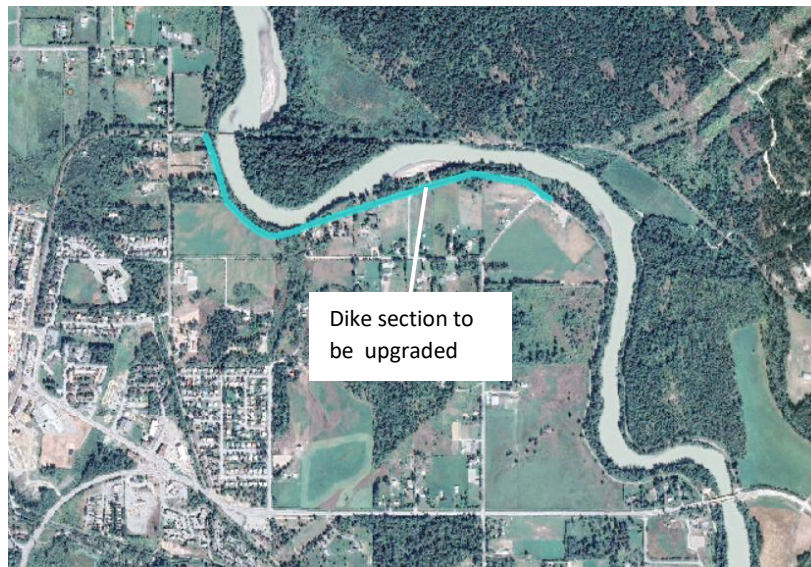
Figure 4. Location of Proposed Miller – Lillooet Dike C Upgrade.

The Miller-Lillooet Dike C is located on the right bank of Lillooet River (viewed downstream) between the railway bridge (River Chainage Km 16.7) and the Highway 99 crossing (Km 13.3). A significant concern is that the upstream 1.4+ km length as shown in **Figure 4** is susceptible to overtopping during floods with a return period of about 50 years ($1,540 \text{ m}^3/\text{s}$) or less.

As described in **Appendix D** the recommended upgrade forms a strategic improvement to delay rapid flooding of a particularly vulnerable area and increase public safety. The Miller-Lillooet Dike C is considered ‘high-consequence’ and upgrades typically require a seismic assessment. To date, the seismic stability of the underlying ground has not been tested. However, preventing an initial breach in this location is urgent and forms part of PVEMC’s emergency work.

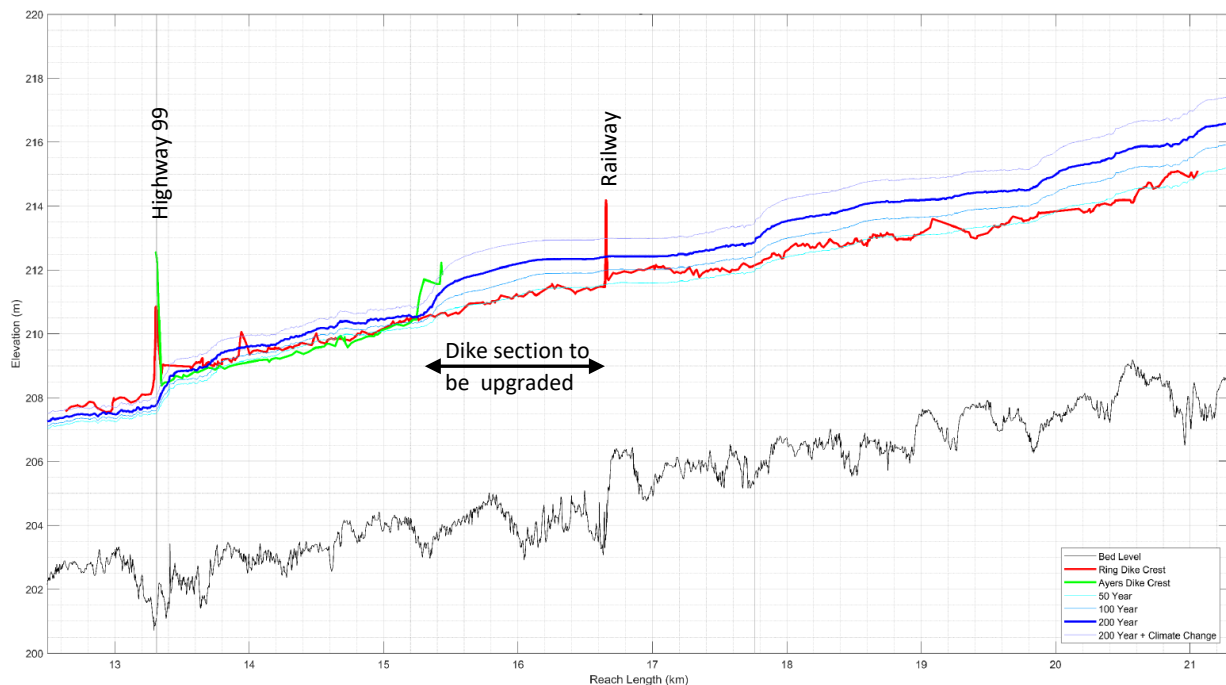
Figure 5. Lillooet River water surface profile for several scenarios (Km 12.5 to Km 21.5).

Figure 5 shows the dike crest height and water level along the channel centreline during selected peak Lillooet River flood events. Water levels in the figure were computed assuming the Miller-Lillooet, Adventure Ranch, Airport Road Dike A and Pemberton Creek dikes were raised to prevent overtopping; all other dikes in the valley were allowed to overtop.

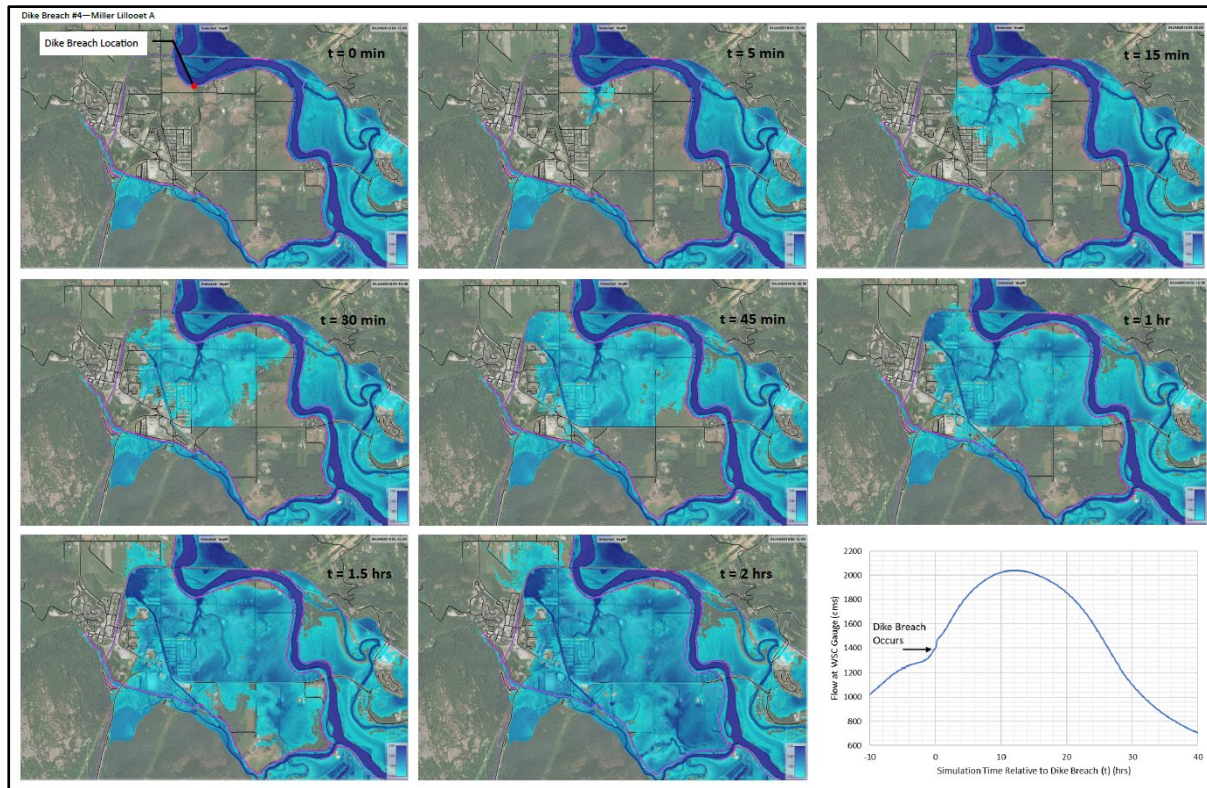
Figure 6. Miller – Lillooet Dike C breach scenario.

overtopping and breaching would occur at this particularly critical location, where a dike breach would rapidly, and with minimal warning time, flood the Village of Pemberton, potentially resulting in loss of life. The inundation sequence is illustrated in **Figure 6**. If a breach were to occur at a location in the approximately 6 km section of the Miller-Lillooet Dike upstream of the railroad or in the sections further downstream (which are also susceptible to overtopping), flood waters would progress more slowly through the floodplain, allowing for more evacuation time for the densely populated floodplain areas.

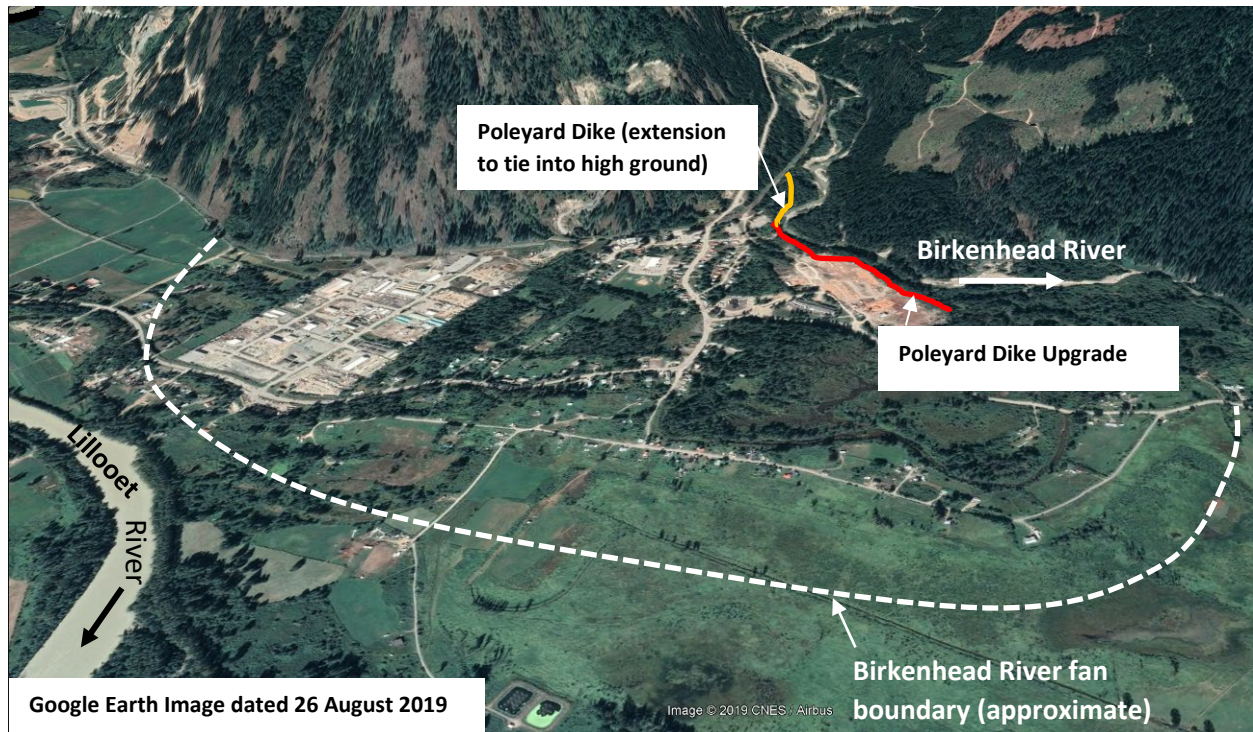
Figure 7. Oblique Google Earth image of Birkenhead River fan (with vertical exaggeration).

The Poleyard Dike (**Map 5**) is located on the right bank (viewed downstream) of the Birkenhead River and protects the Lil’wat Nation community of Mount Currie, on the Birkenhead River fan (**Figure 7**). Recent simulation of the Birkenhead River 200-year flood indicated that the Poleyard Dike would overtop in some locations, likely resulting in a breach of the dike. A breach in the dike could lead to an avulsion of the river and flooding across the fan with severe erosion and damage to built-up areas. The floodplain mapping study showed that the area is also exposed to relatively shallow water flooding from Lillooet River. Upgrades to the Poleyard Dike would not prevent Lillooet River flooding. Similarly, the dike would not alleviate internal drainage problems in the inter-river area.

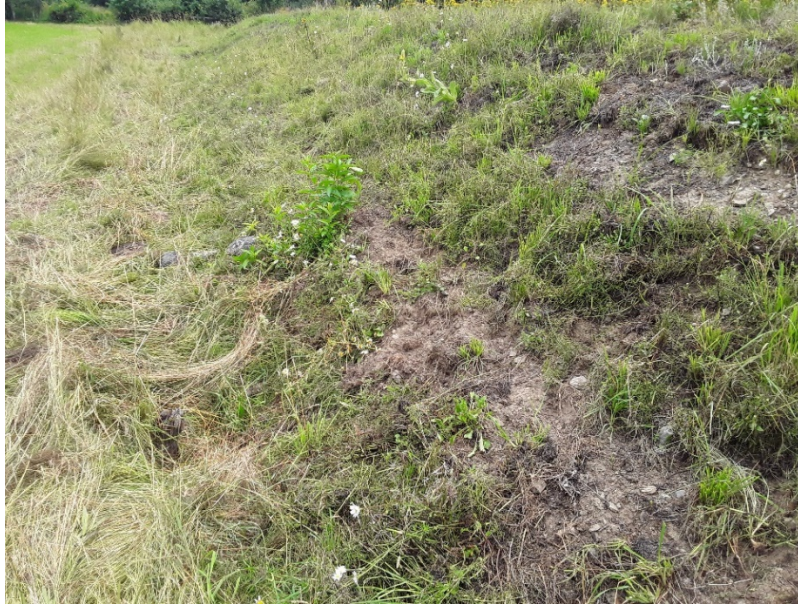
Location of Concern

Description: Hole in the ground which is 0.8 metres in diameter and 0.3 metres deep. The hole's origin is unclear, it is located at the toe of the land-facing side of the dike and could be related to subsurface flow from river, causing boil/ sinkhole.
