# Large Woody Debris Assessment and Mitigation Plan

Final Report  
June 2011

KWL File No. 713.054

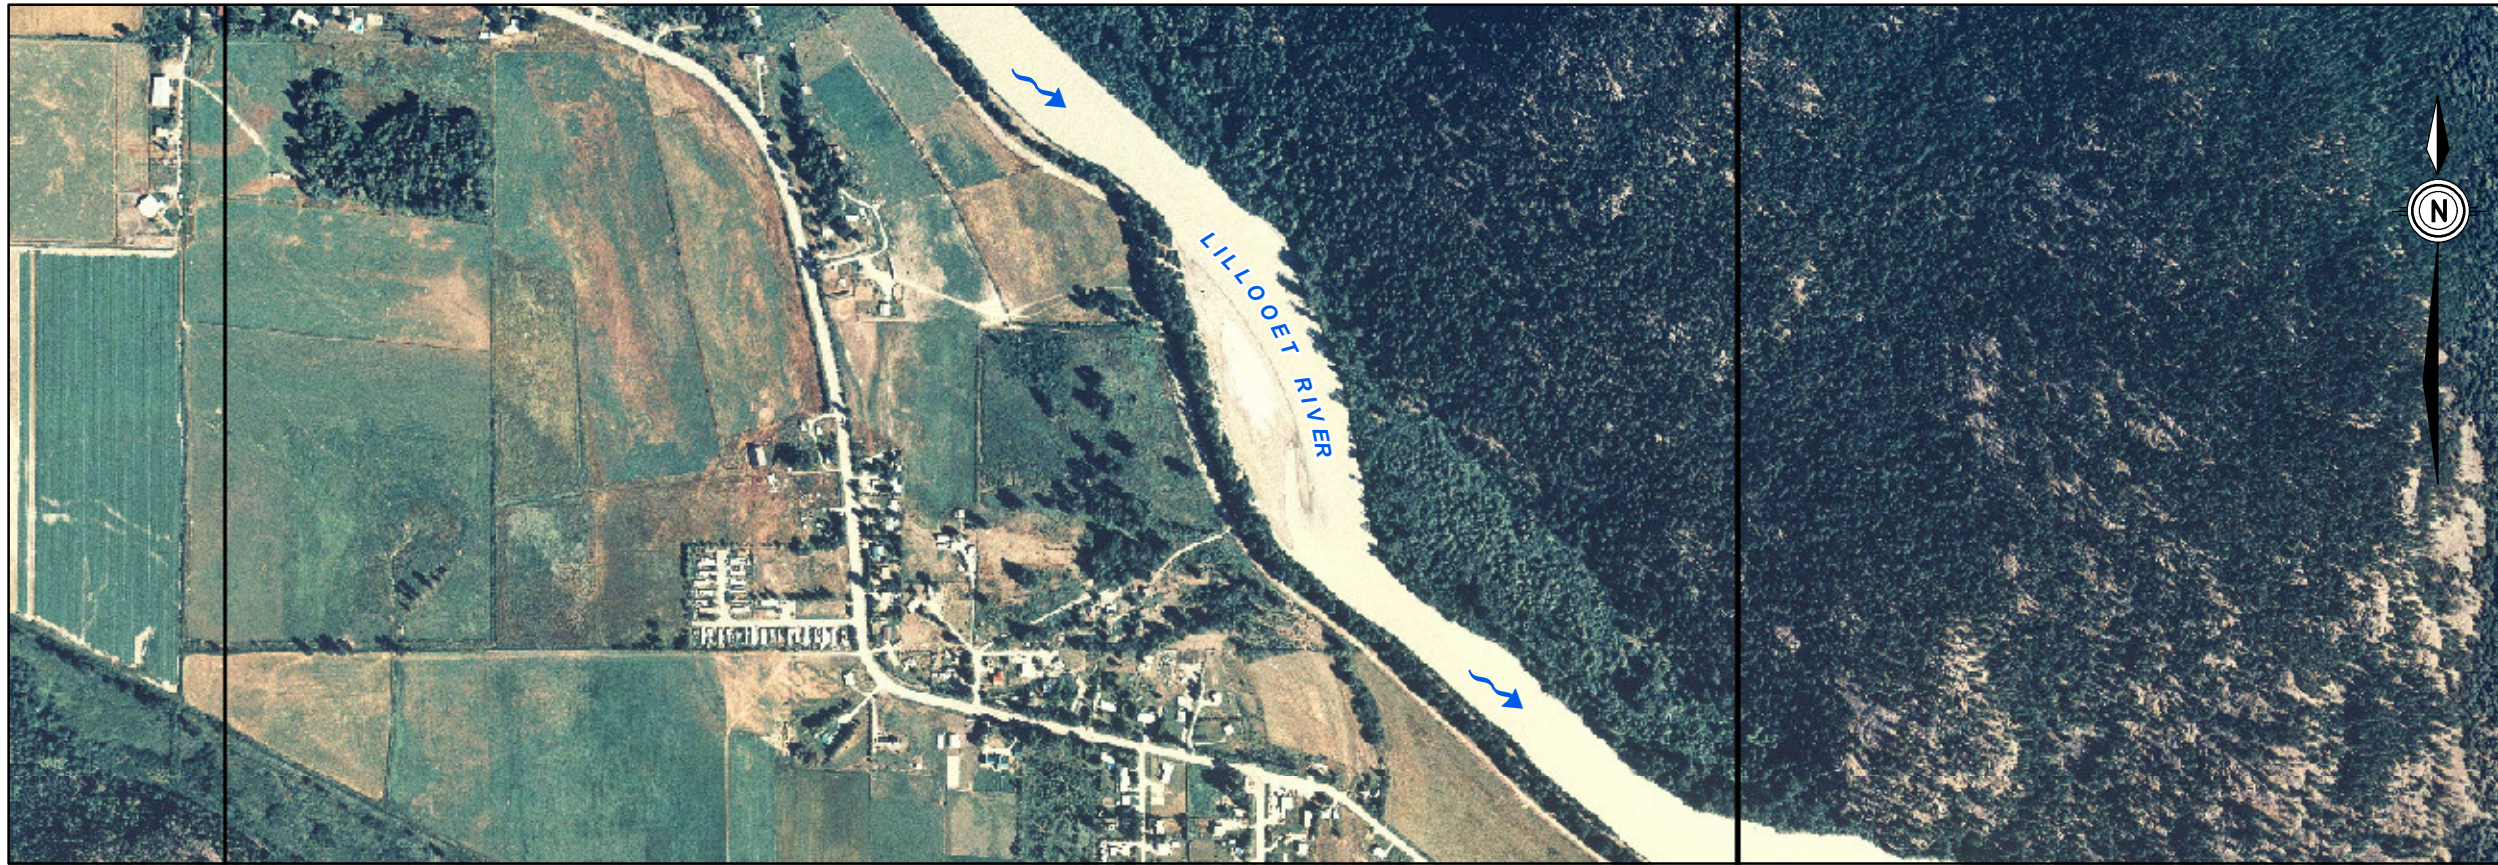
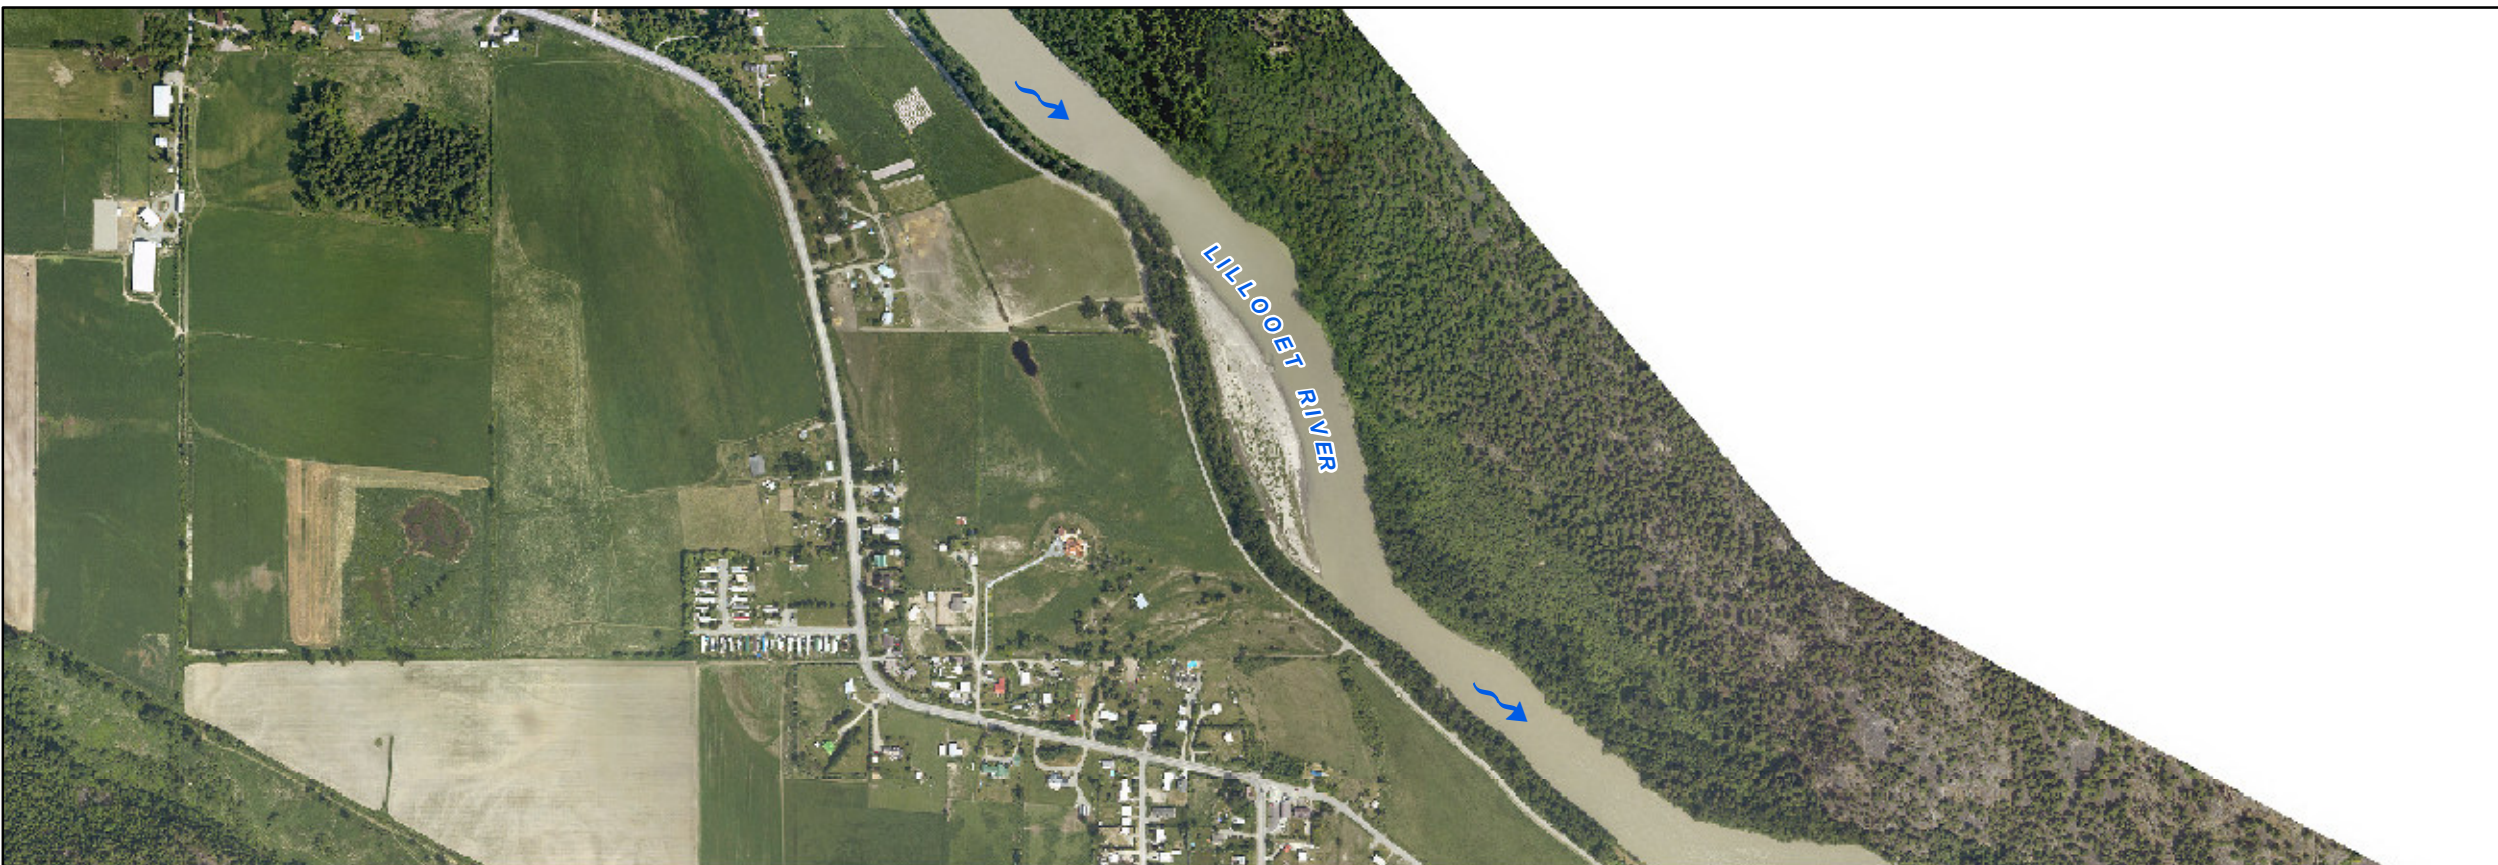
**Figure 3-3**

The largest change noted between 1999 and 2009 in the dyked reach is shown in Figure 3-3. At this location a single log is visible in the 1999 photos and a bar apex jam has formed in the 2009 photos. The single log (in combination with a small gravel bar) may have recruited more LWD to form a stable jam. This log jam, referred to as the ‘Miller Log Jam’, was examined in more detail during the May 2011 field investigations.

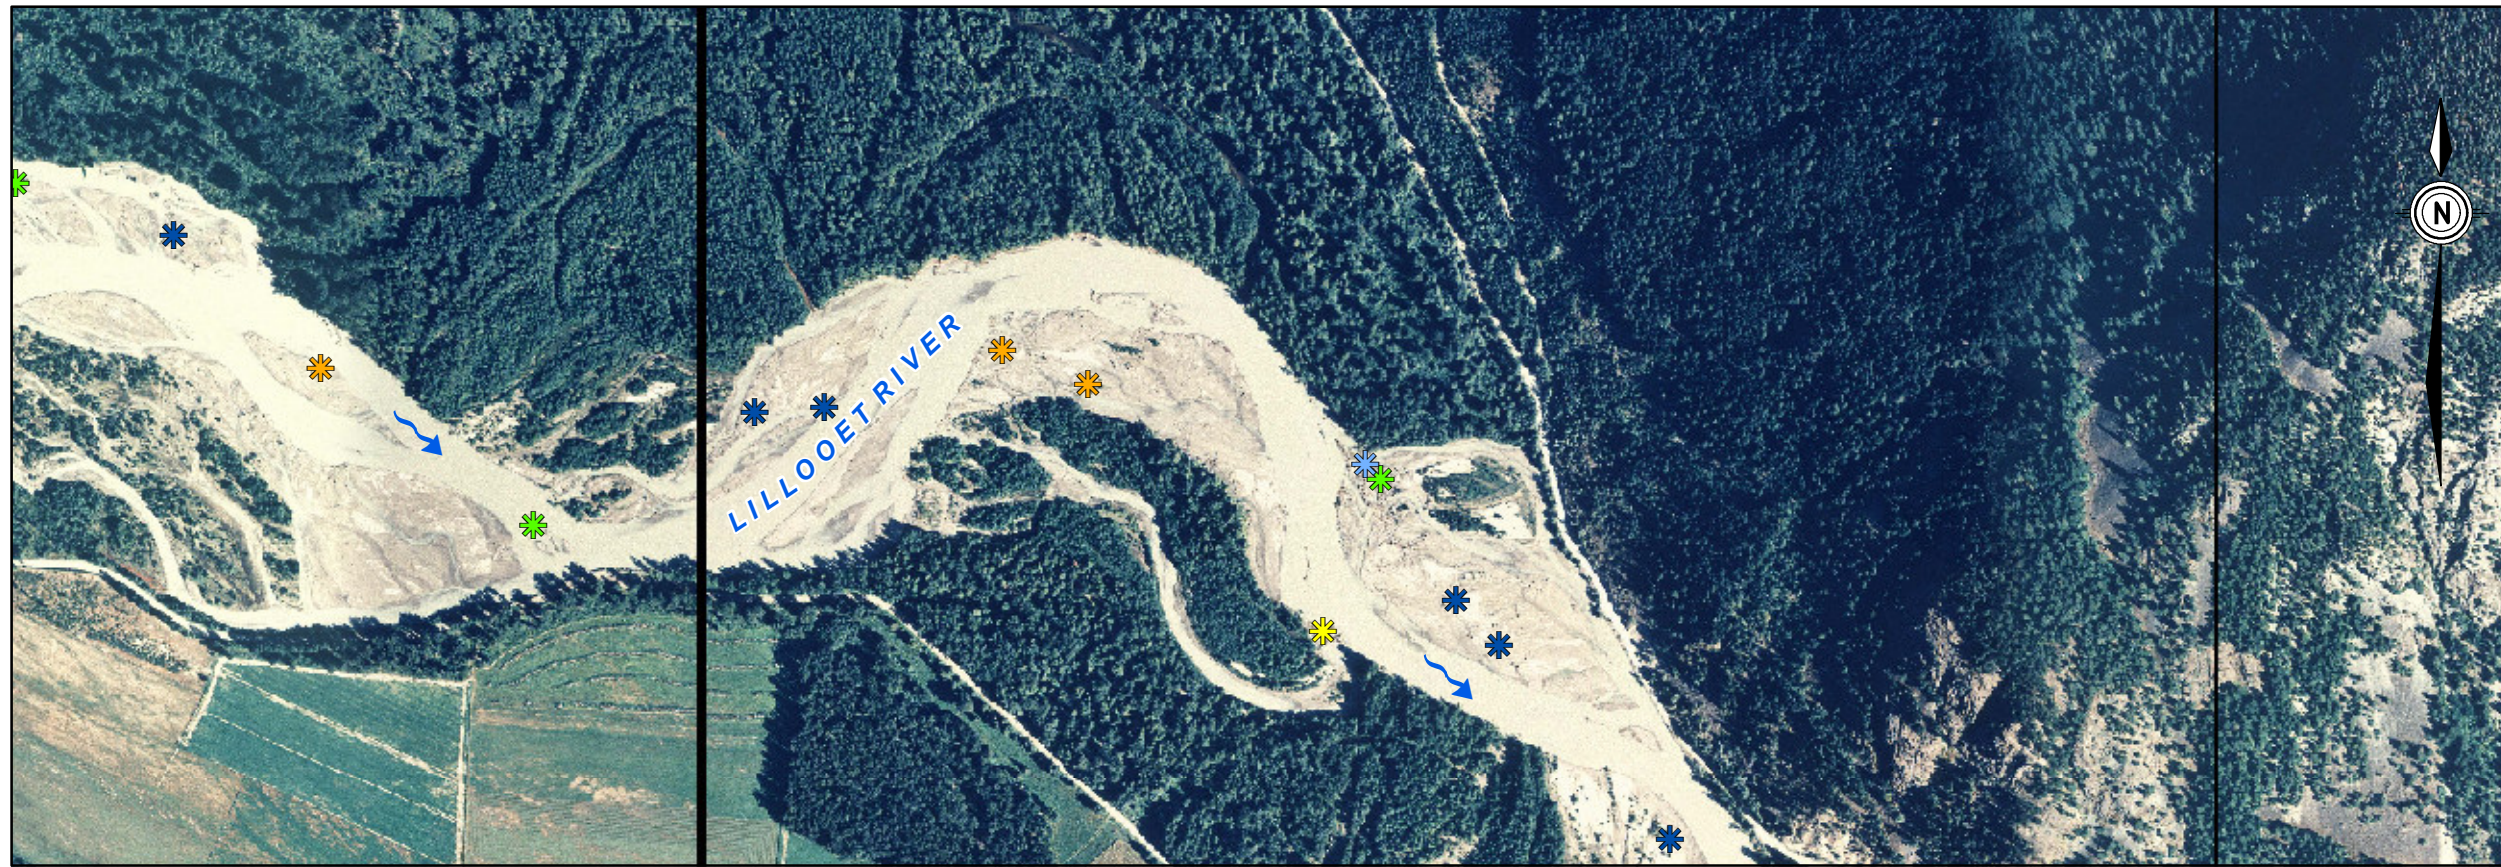
**Figure 3-4**

From the 1999, 2009 and 2010 orthophotos, it is evident that prior to the 2010 landslide event there was already a large amount of LWD stored within the active channel in the form of bar apex and bar top jams (e.g. Figure 3-4). Based on photo observations, this reach appears to function as a 'storage reach' for LWD.

Photo observations indicate that the braided reach upstream of the dyked reach is dynamic. Figure 3-4 shows a comparison of the 1999 and 2009 orthophotos that illustrates the shifting nature of the gravel bars within the channel and evidence of mobilization of rafted logs.

The number of log jams identified in Figure 3-4 between 1999 and 2009 has increased over that decade. Along the left bank (looking downstream) the bank has been eroded and two meanders have become more pronounced. It is likely that the increase in single logs and rafted logs immediately downstream of the erosion locations is the result of the mobilization and deposition of riparian vegetation within the river channel. In contrast, some of the log jams and key members appear to be relatively stable and have provided hard points that the channel has shifted around. Backchannels and vegetated island complexes also appear relatively stable and the photo comparison indicates growth of vegetation on a number of the stable island-bar complexes.

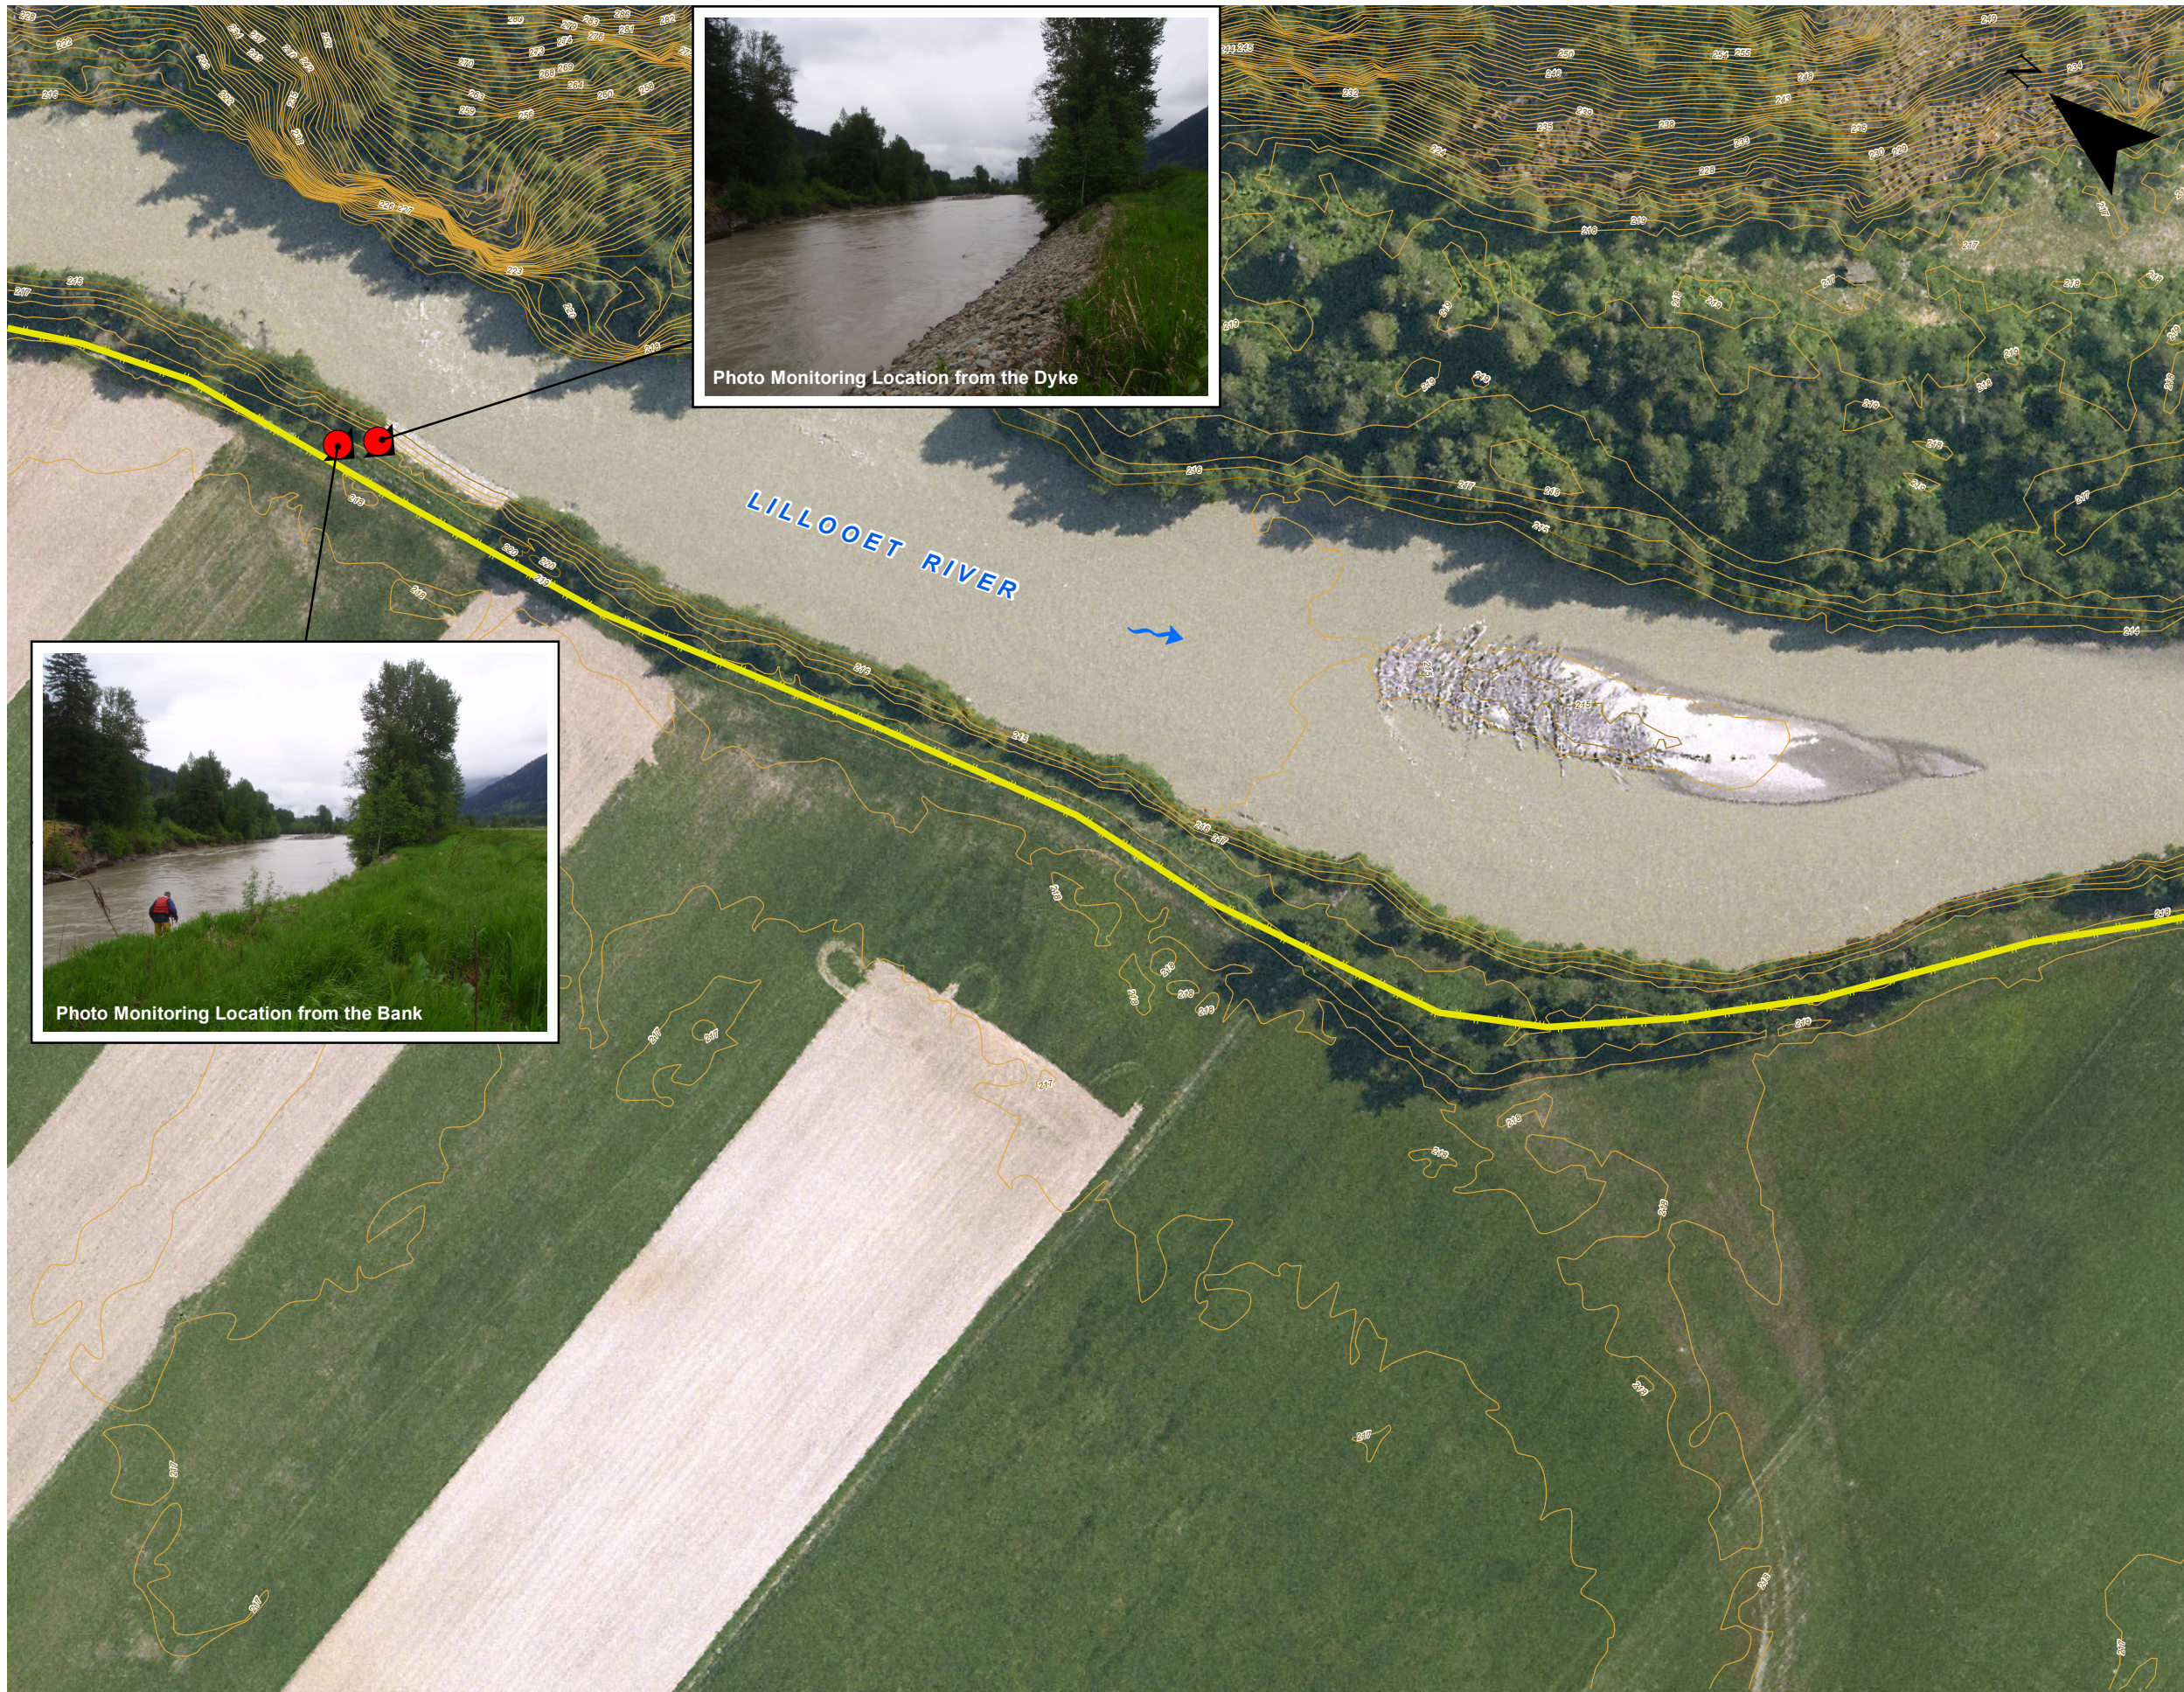
Figure 4-1

One existing jam was identified during the assessment that could potentially cause concern for increased flood risk is the Miller Log Jam, located about 14 km downstream of the Forestry Bridge (Figure 4-1). The Miller Log Jam is creating a channel constriction due to the jam and associated gravel bar. The jam is located downstream of a bedrock outcrop, the dyke is immediately adjacent to the river and the channel at this location is relatively narrow. The dyke is protected by riprap, and the left bank is lower than the right bank dyke, providing some potential overbank flow relief.

The Miller Log Jam should be monitored as one of the five high priority locations as part of the LWD mitigation plan.

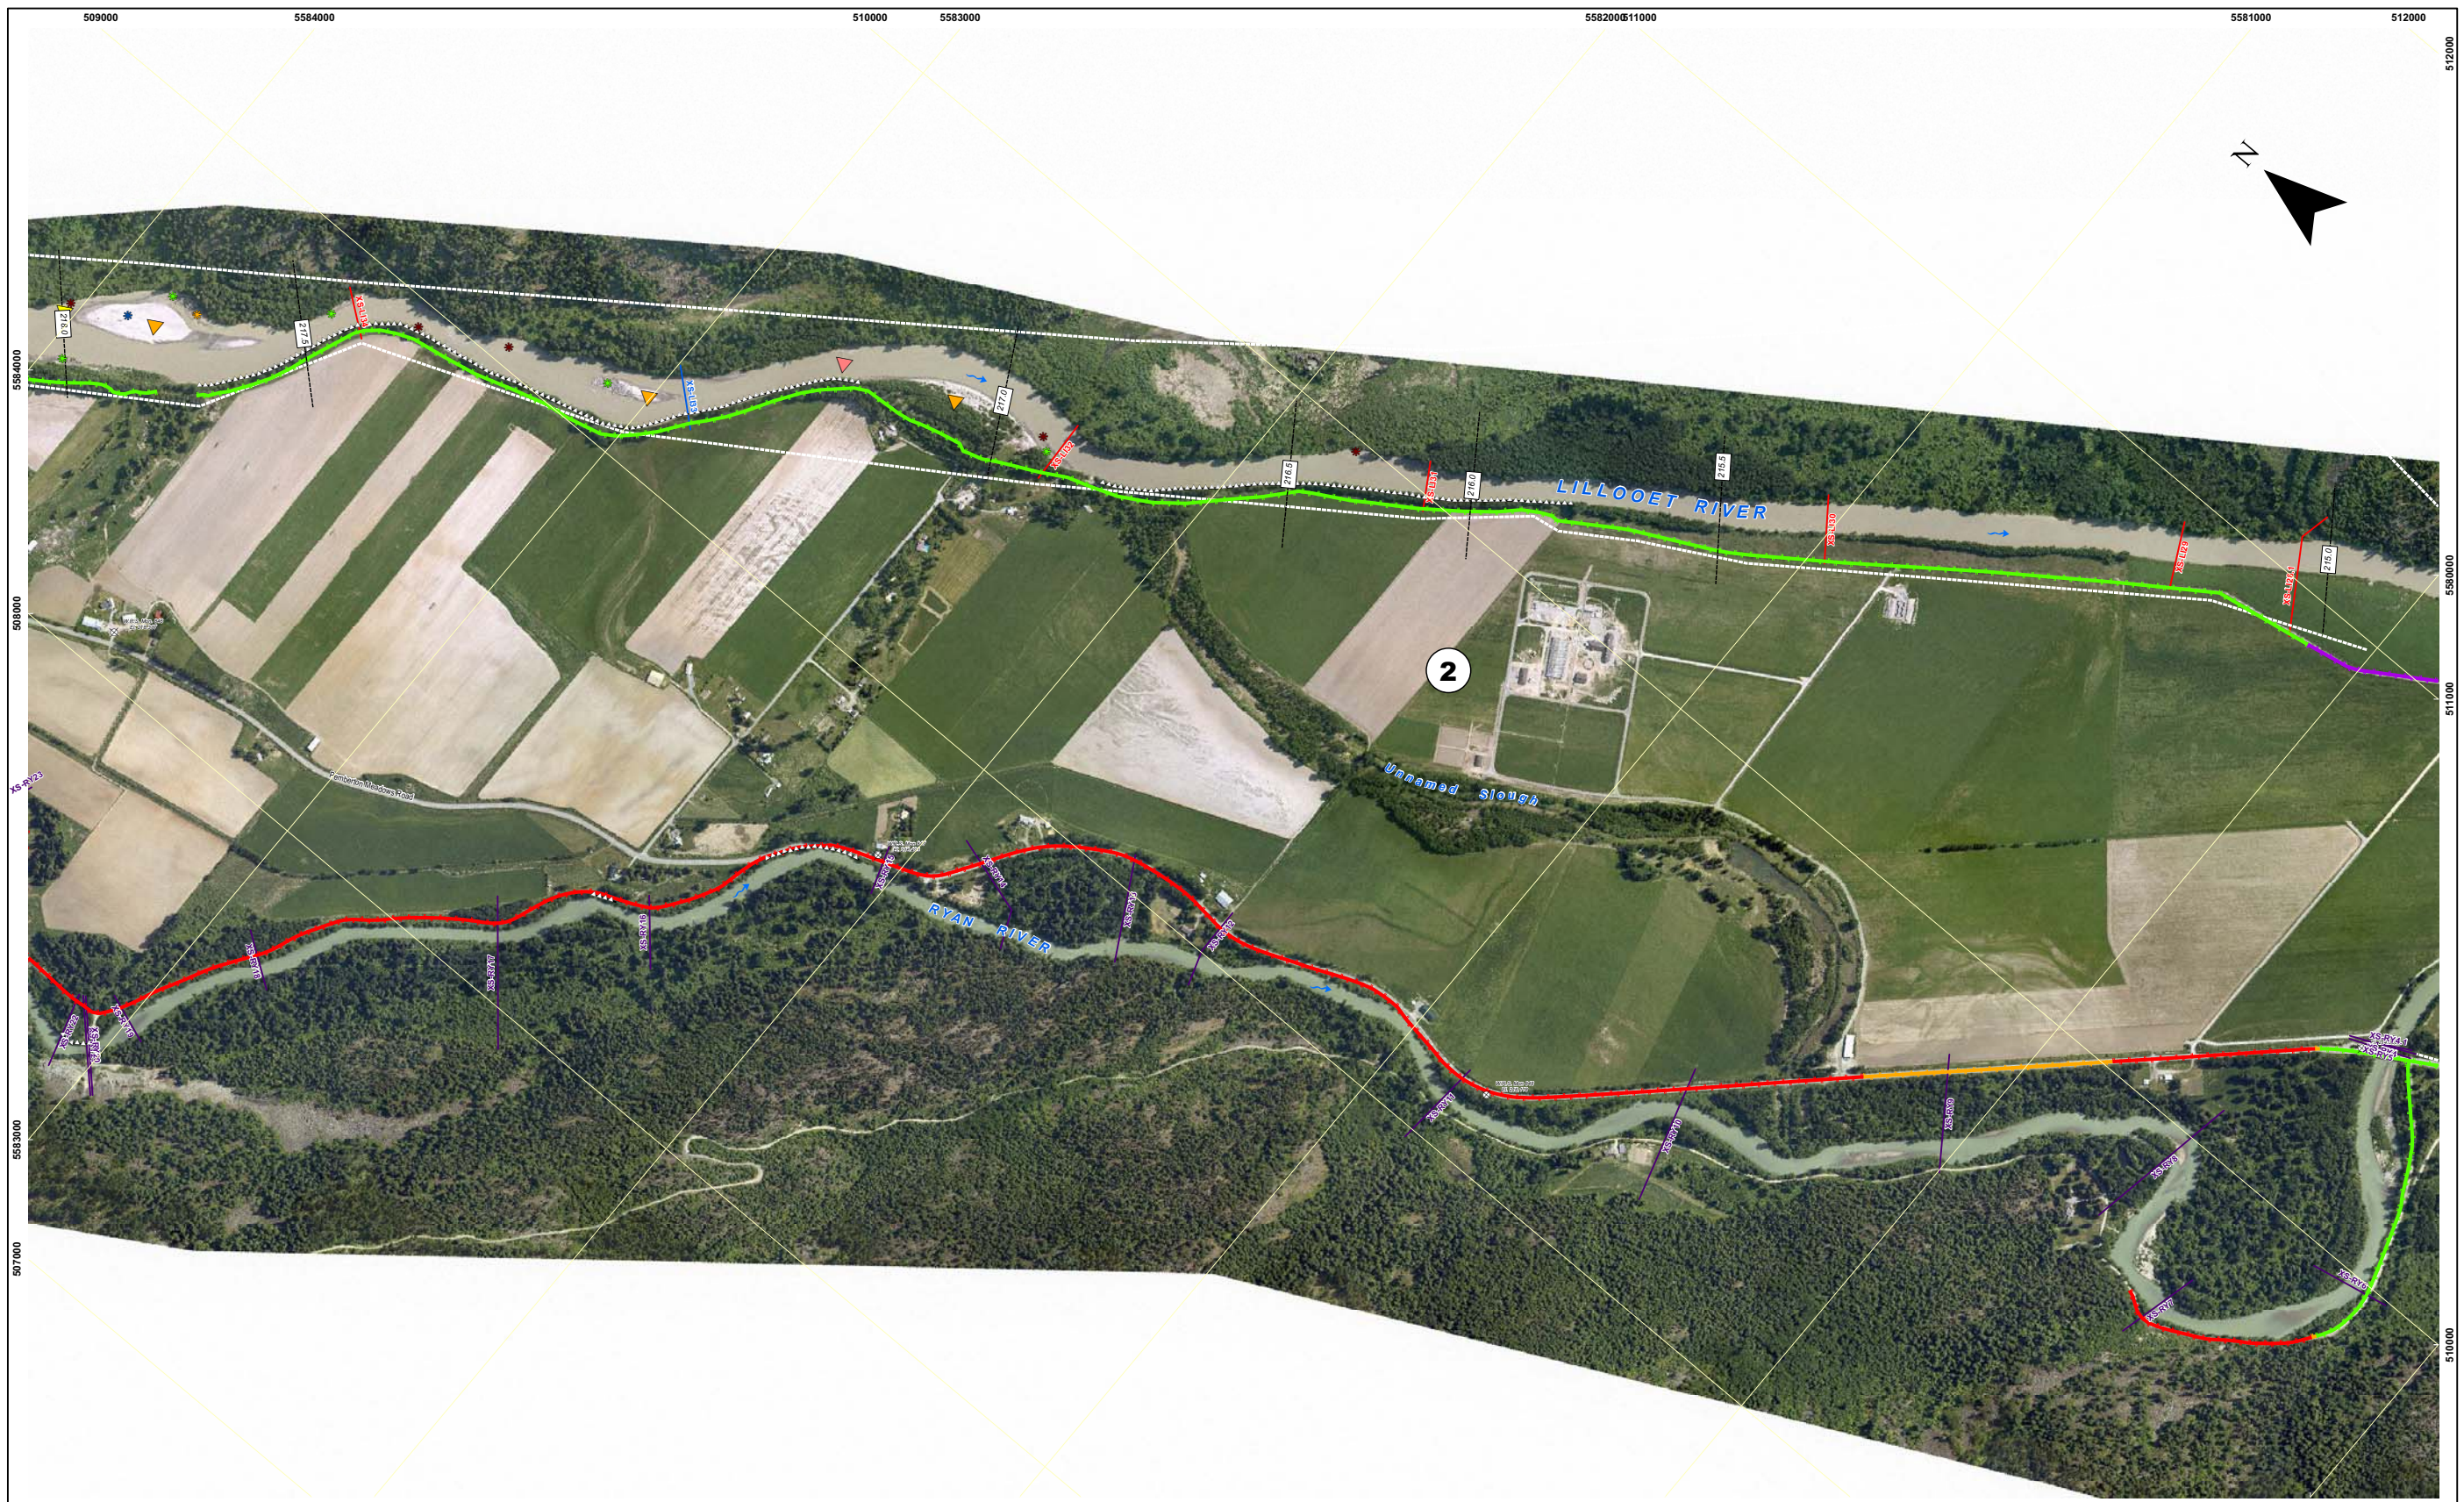
The Miller Log Jam (Appendix B, Map 7 of 11) creates a channel constriction that may result in increased flood levels. The erosion protection along the dyke should be monitored for signs of wear and possible failure.

6. Engage a qualified professional engineer to conduct a hydraulic assessment (using new survey) at the Miller Log Jam to evaluate the degree of hazard to adjacent flood and erosion protection works and recommend appropriate response, if required.

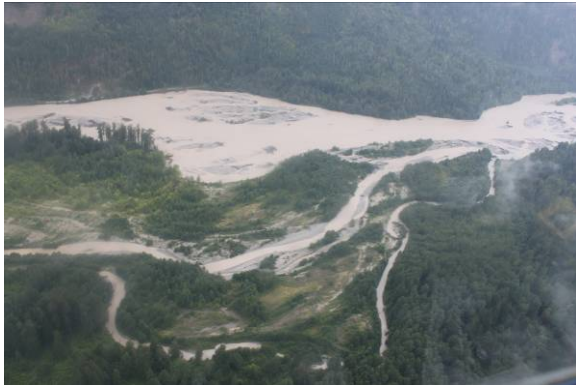
**Photo E-1**  
**Braided Reach (August 7, 2010)**

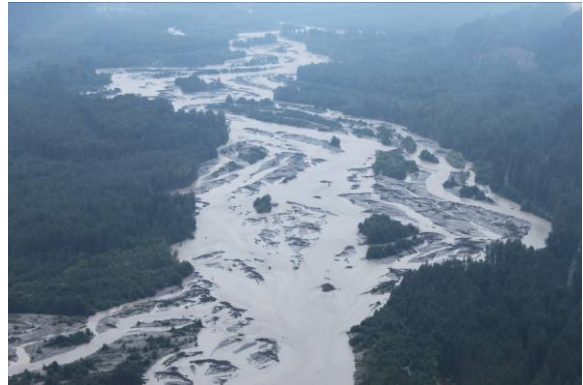
**Photo E-2**  
**Braided Reach (August 7, 2010)**

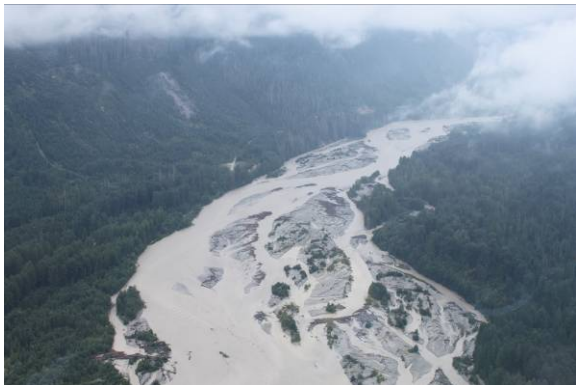
**Photo E-3**  
**Braided Reach (August 7, 2010)**

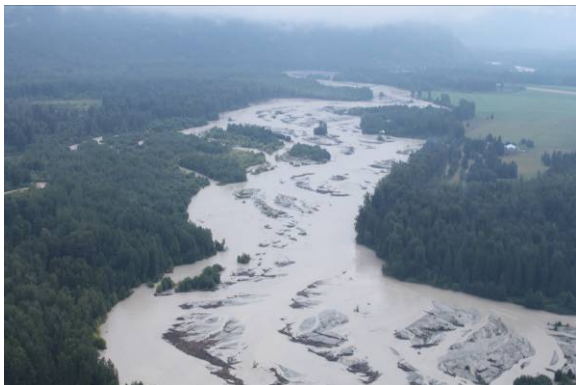
**Photo E-5**  
**Braided Reach (August 7, 2010) (view towards Forestry Bridge)**

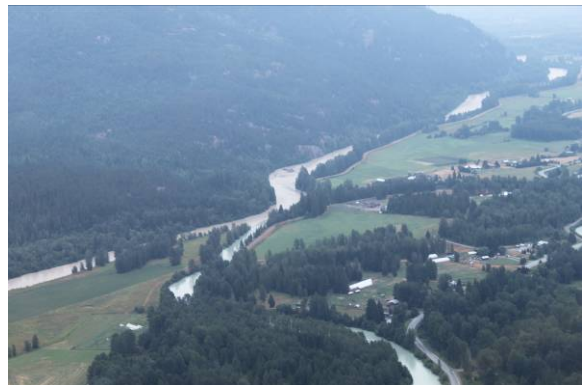
**Photo E-6**  
**Log Jam Below the Forestry Bridge**

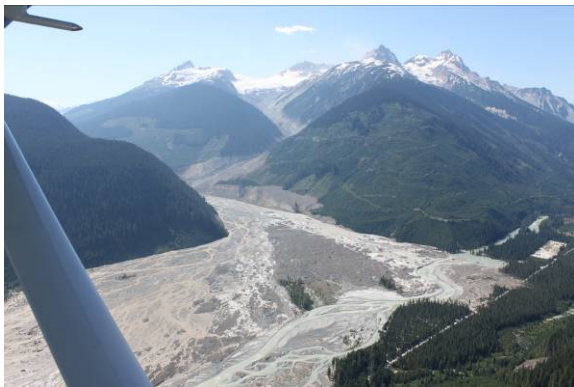
**Photo E-9**  
**Meager/Lillooet Confluence (August 13, 2010)**

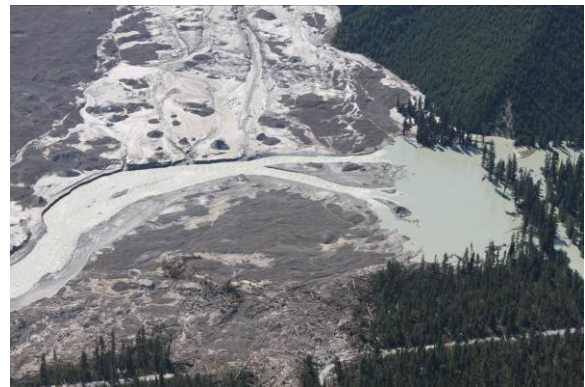
**Photo E-10**  
**Forestry Road and Remnant Lake (August 13, 2010)**

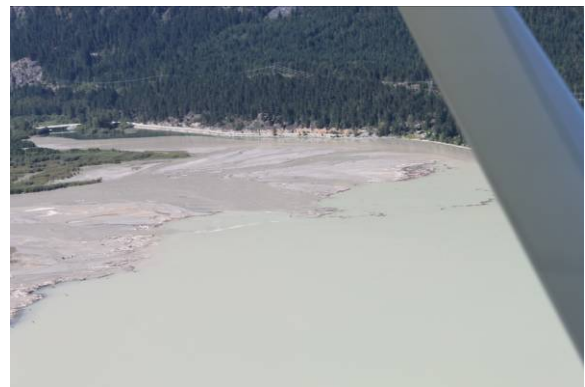
**Photo E-12**  
**Wood in Lillooet Lake/Delta (August 13, 2010)**

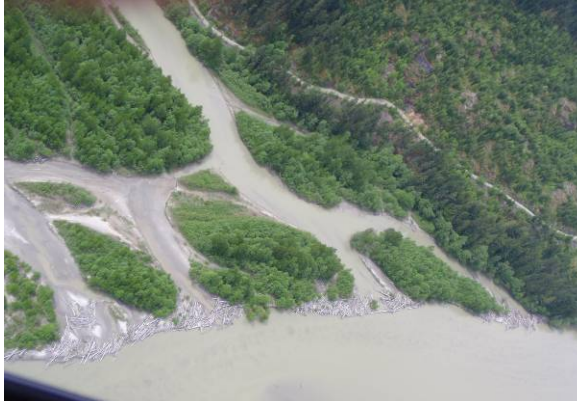
**Photo F-1**  
**Log Jam Downstream of Dyked Reach (1)**

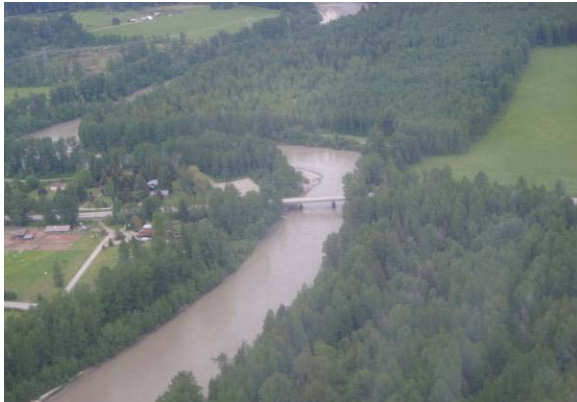
**Photo F-3**  
**Highway 99 Bridge Crossing**

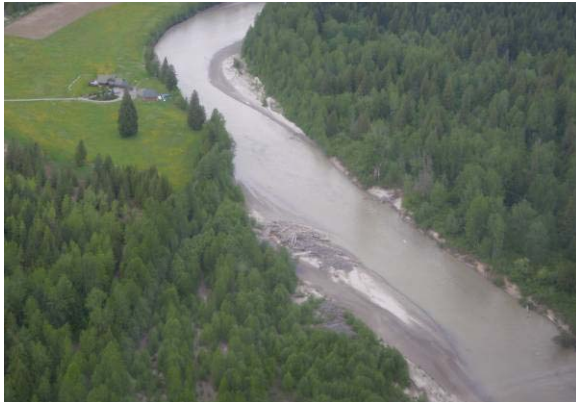
**Photo F-7**  
More Complex Log Jams as Channel Widens  
in Dyked Reach
